**Draft Visual Impact Assessment – US
50/South Shore Community
Revitalization Project**

U.S. 50/South Shore Community Revitalization Project

South Lake Tahoe, California / Stateline, Nevada

**Draft Visual Impact Assessment (VIA) For
U.S. 50/South Shore Community Revitalization Project**

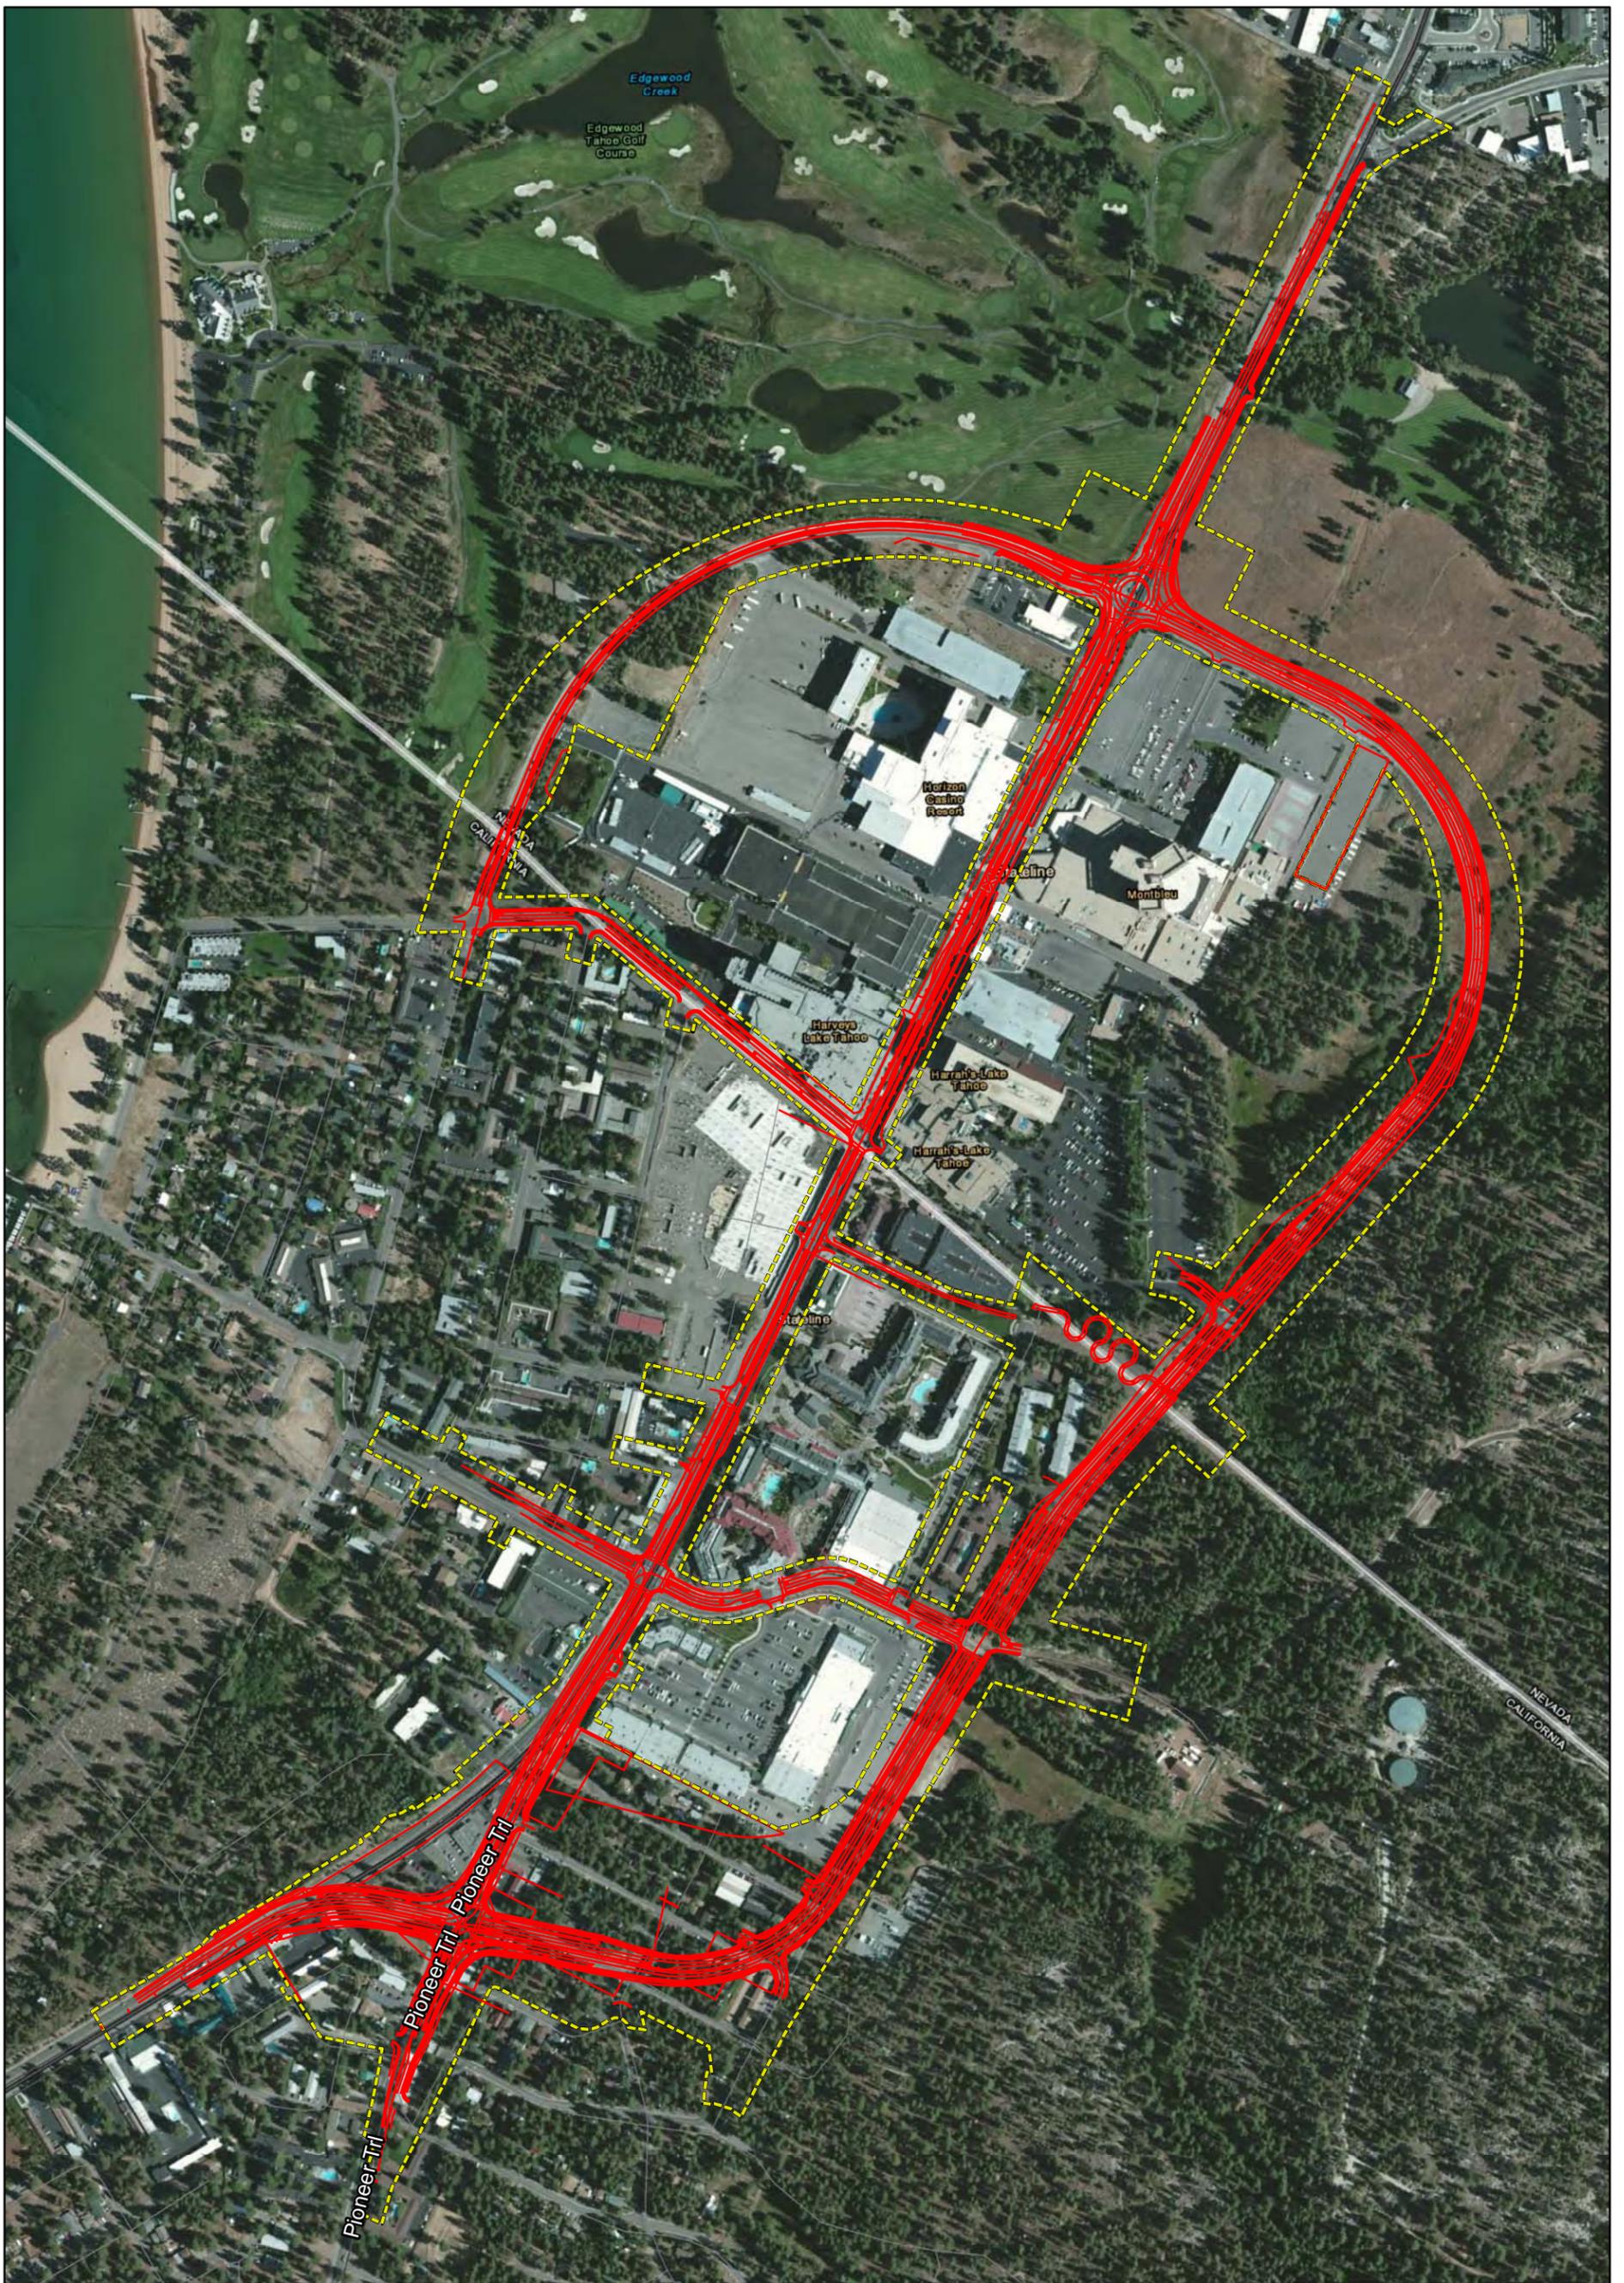
FIGURE 3

It should be noted that implementation of Alternative B would require partial and full parcel acquisition on the California side and partial parcel acquisition on the Nevada side of the Project footprint. Figure 3: Alternative B – Triangle Design shows the design of the proposed Project if implemented under Alternative B.

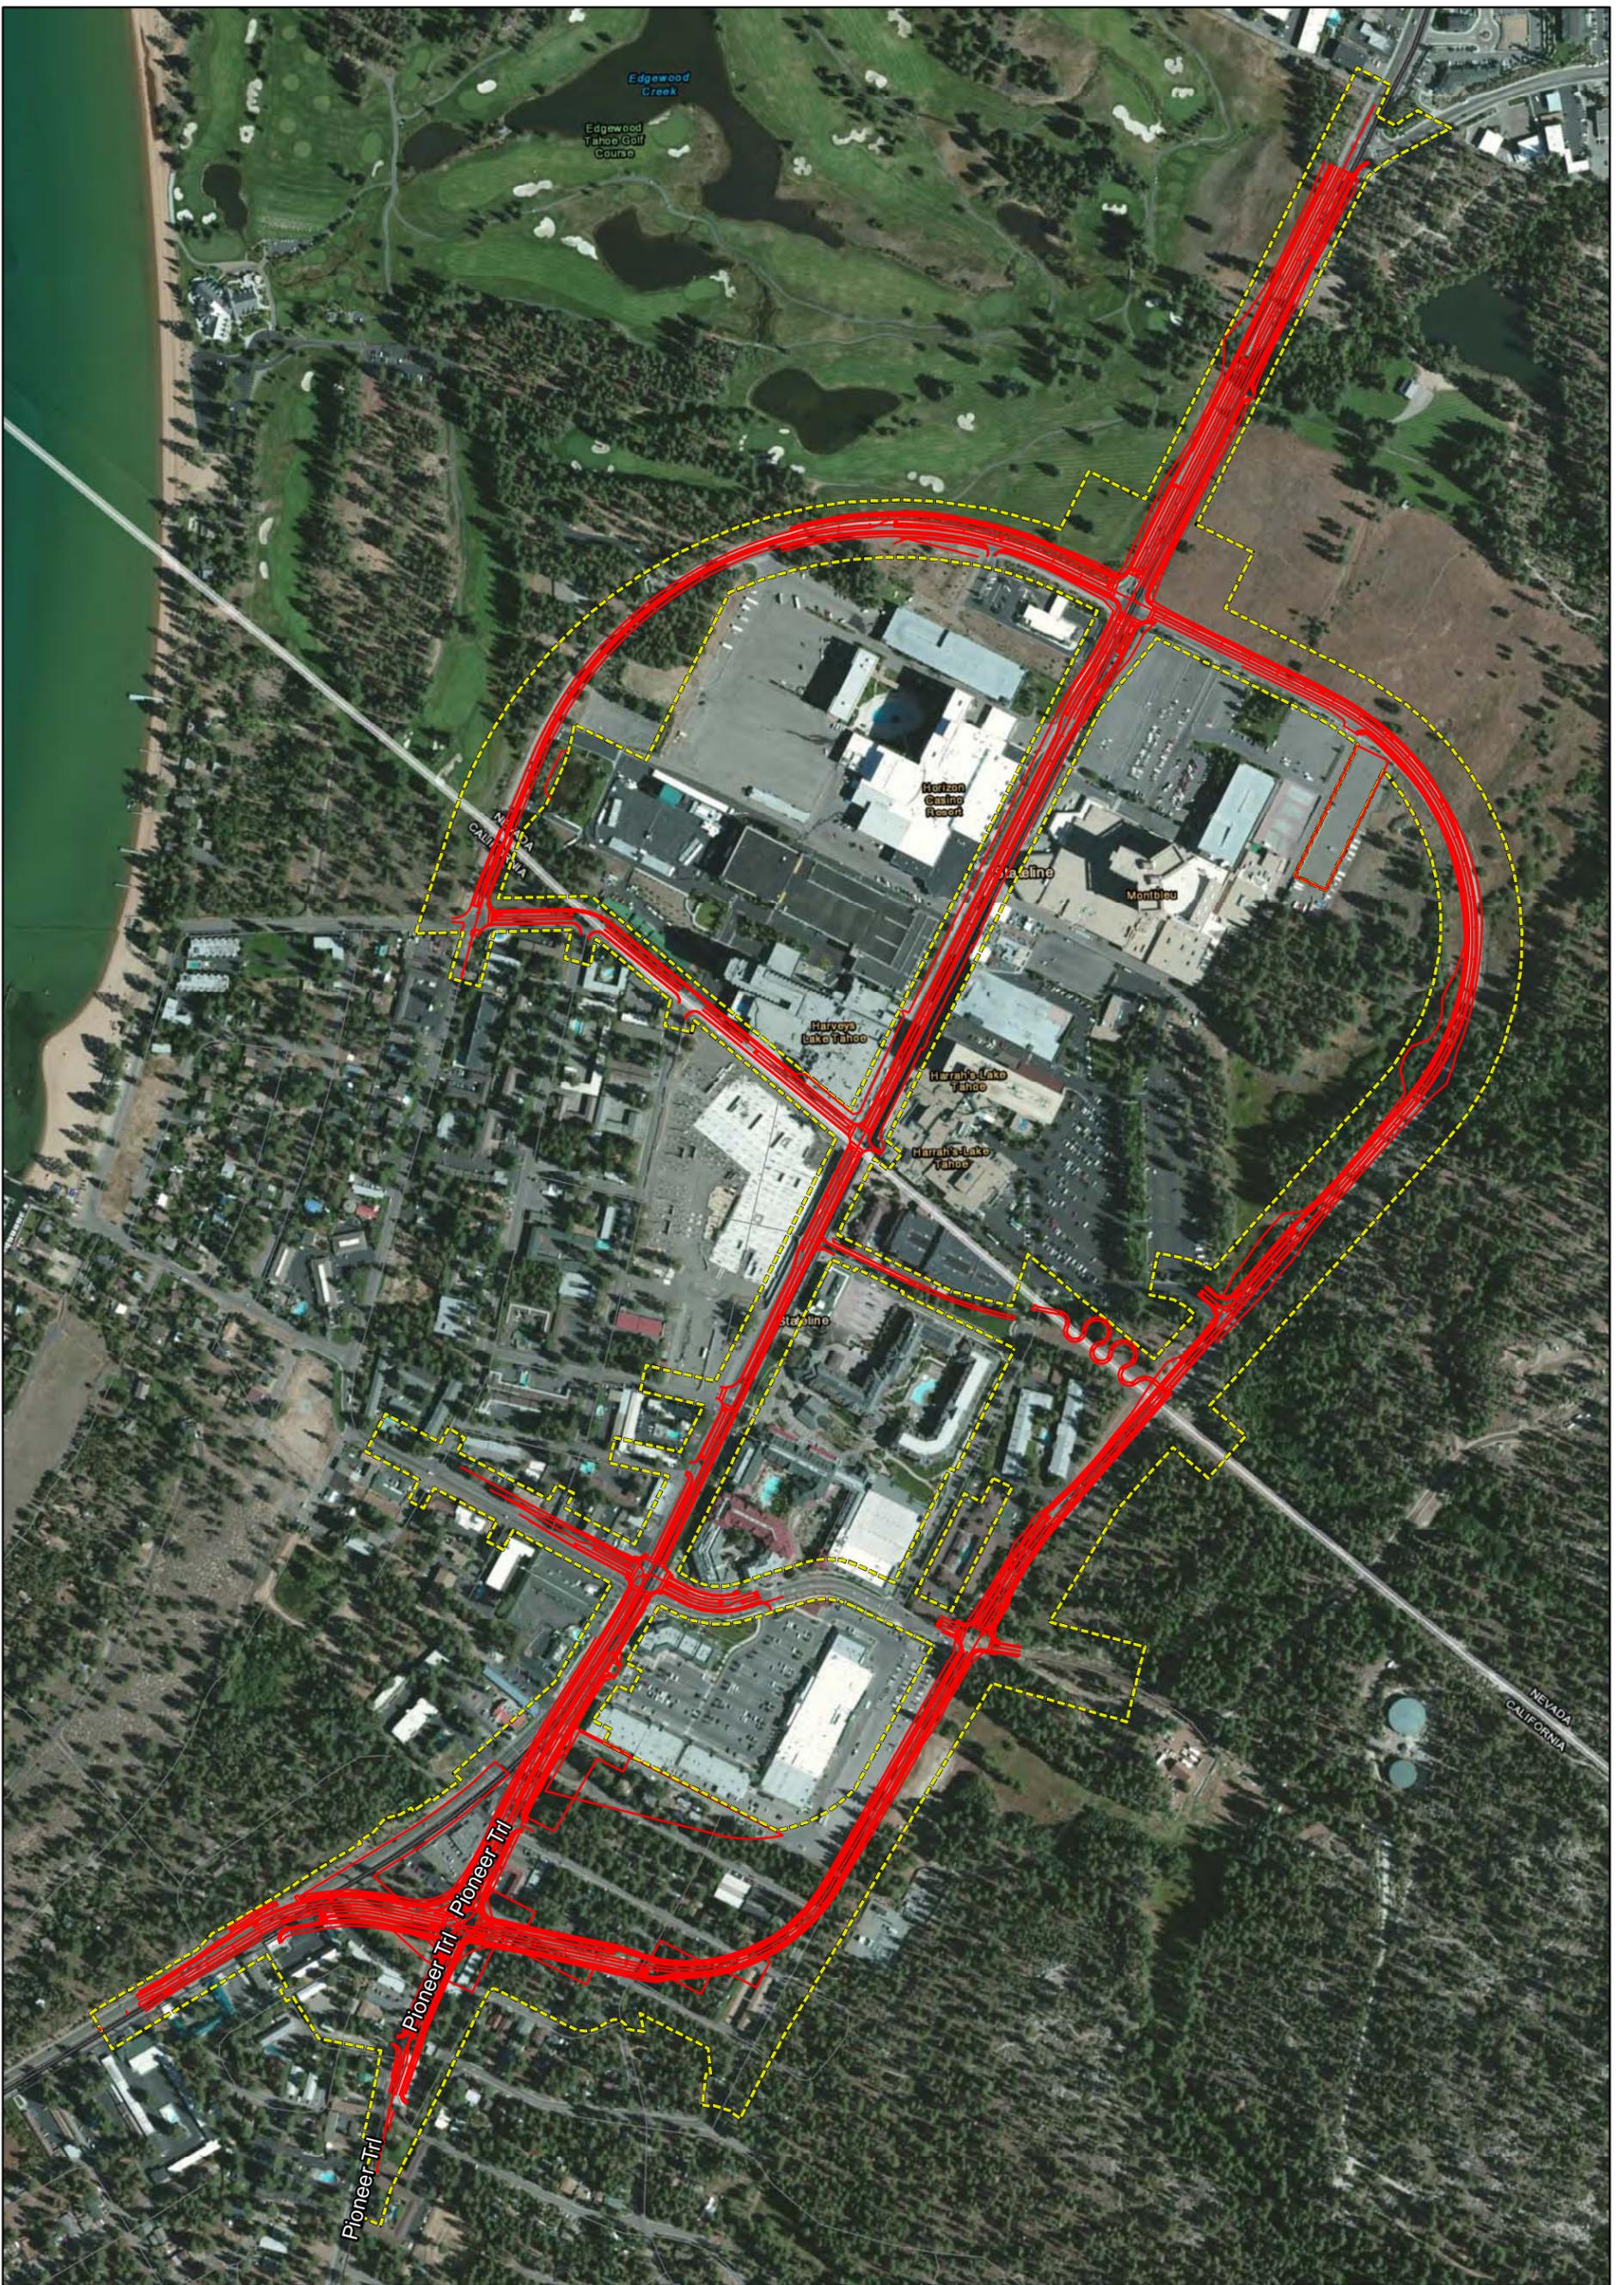
FIGURE 4

It should be noted that implementation of Alternative C would require partial and full parcel acquisition on the California side and partial parcel acquisition on the Nevada side of the Project footprint. Figure 4: Alternative C – Triangle One-Way Design shows the design of the proposed Project under Alternative C.

Alternative C - Triangle One-Way Design

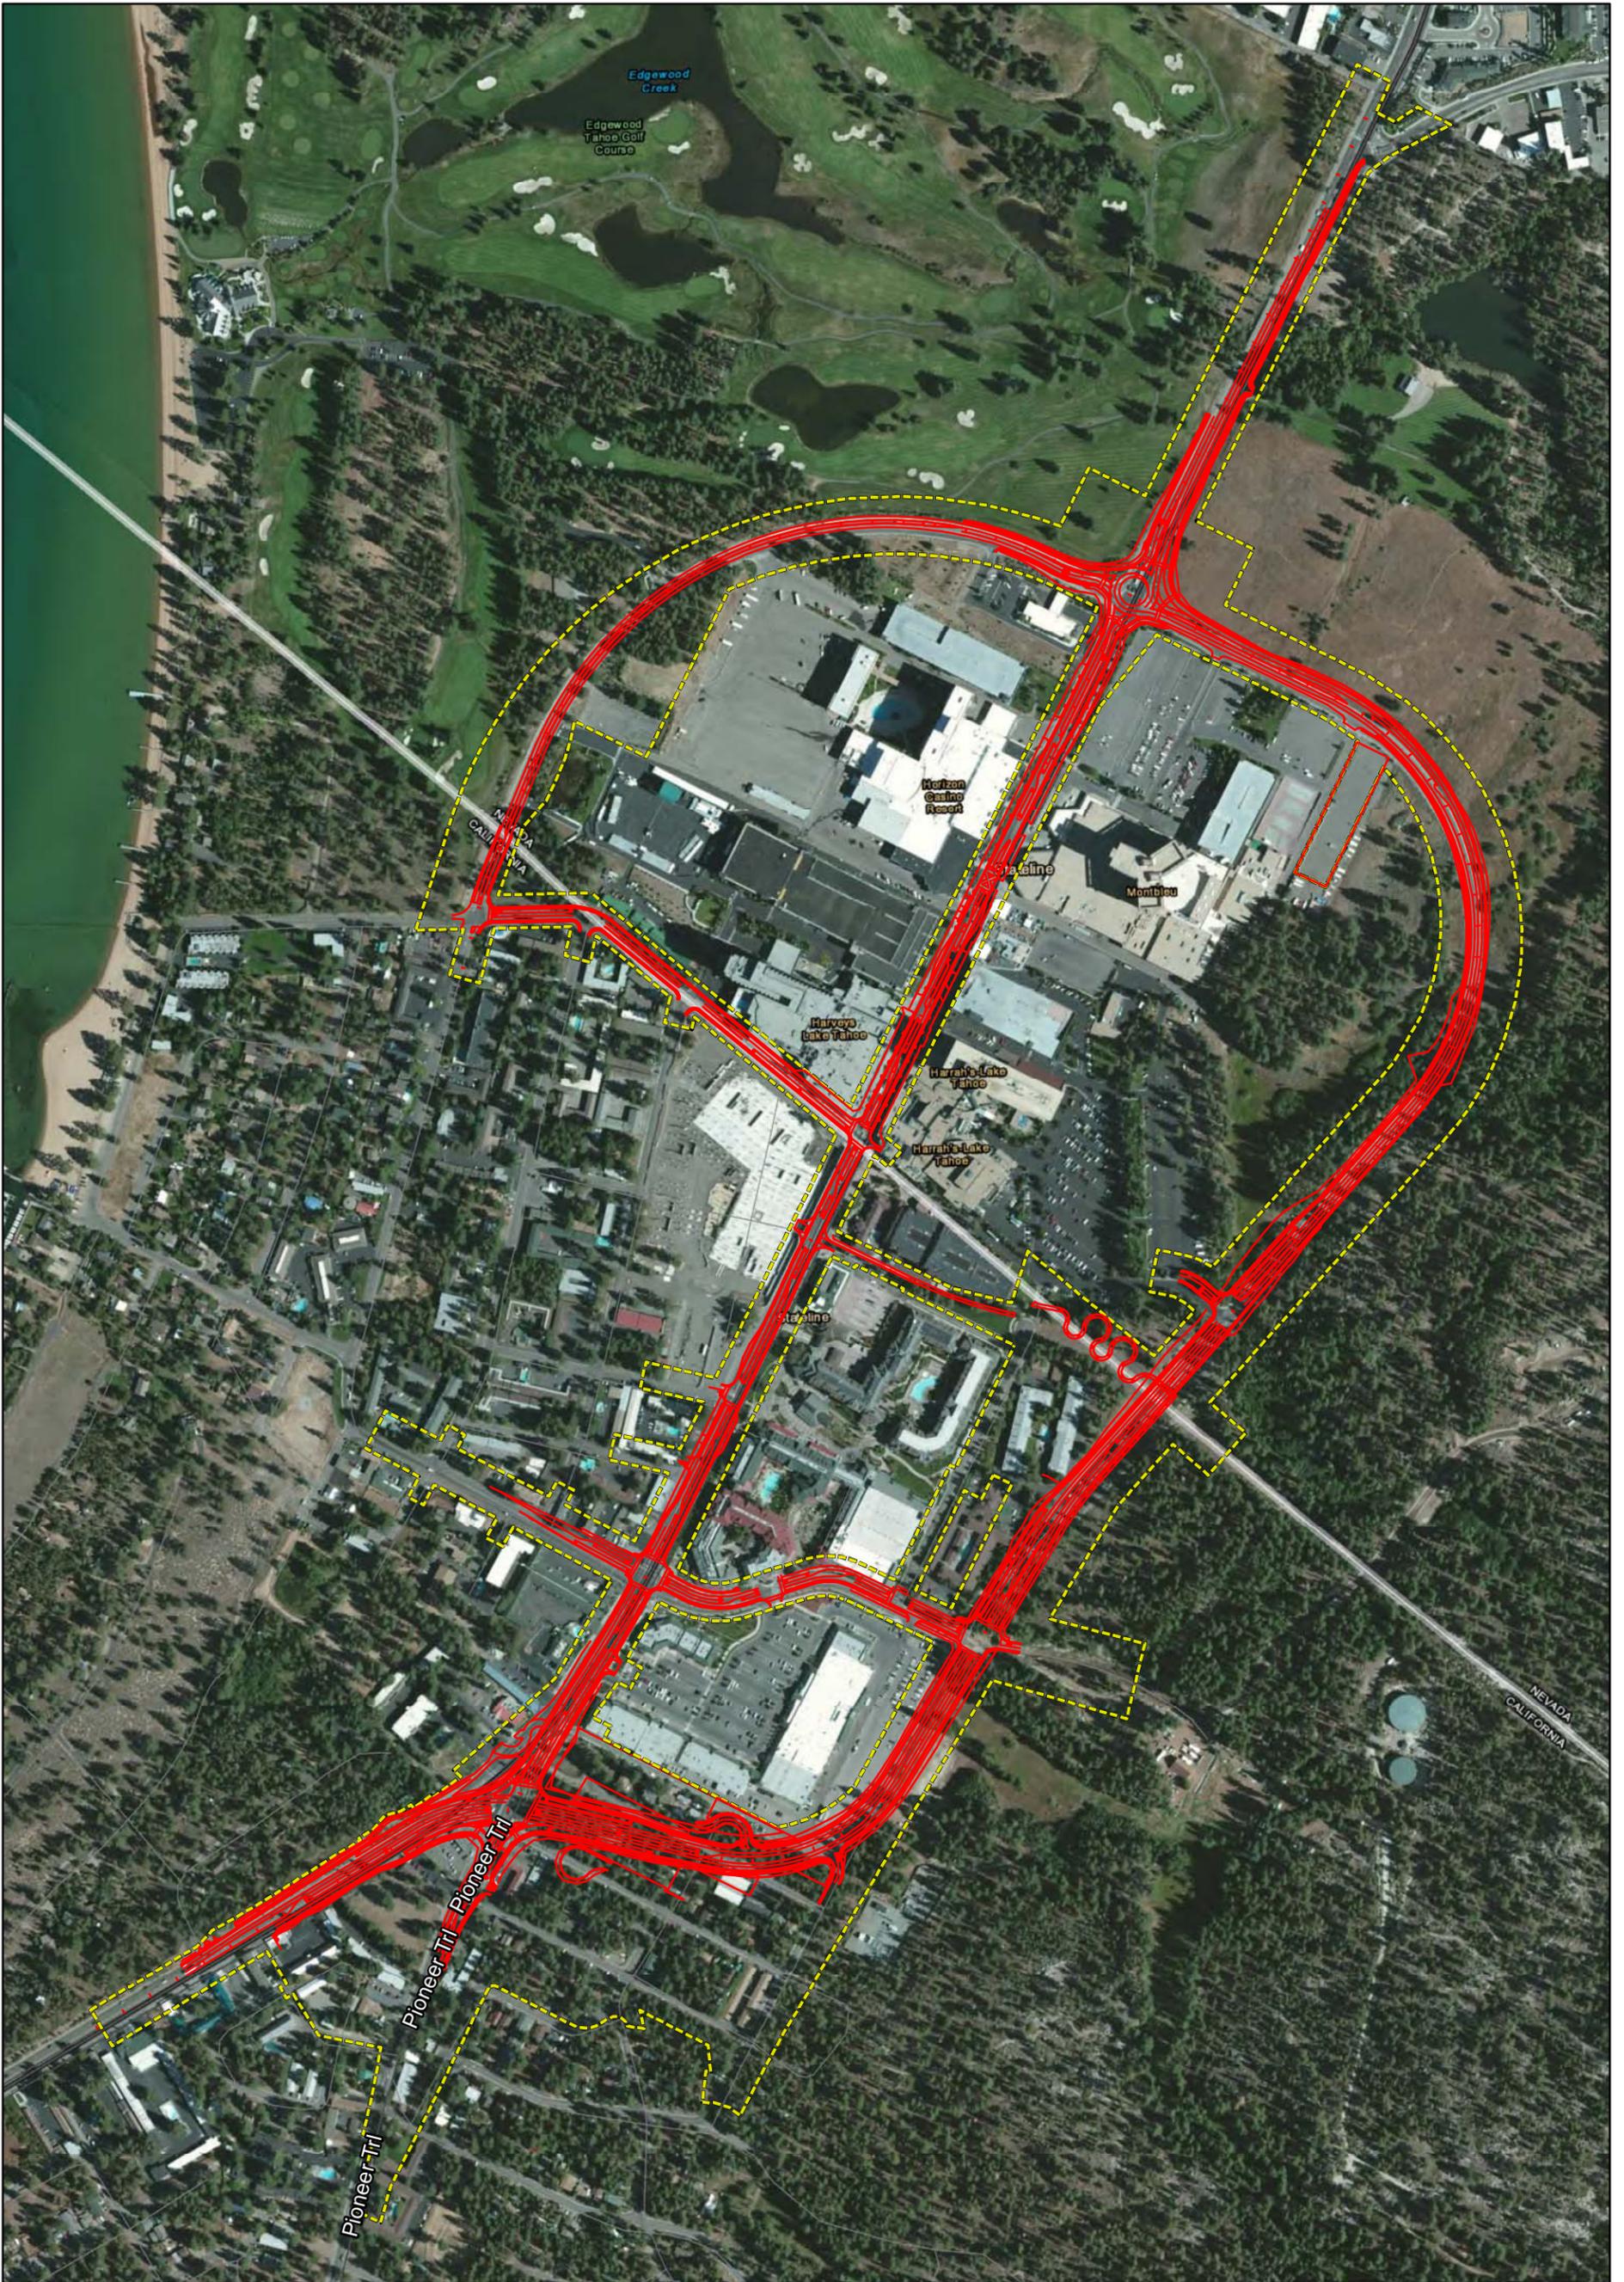
FIGURE 5

It should be noted that implementation of Alternative D would require partial and full parcel acquisition on the California side and partial parcel acquisition on the Nevada side of the Project footprint. Figure 5: Alternative D – PSR Alternative Design shows the design of the proposed Project under Alternative D.

Alternative D - PSR Alternative Design

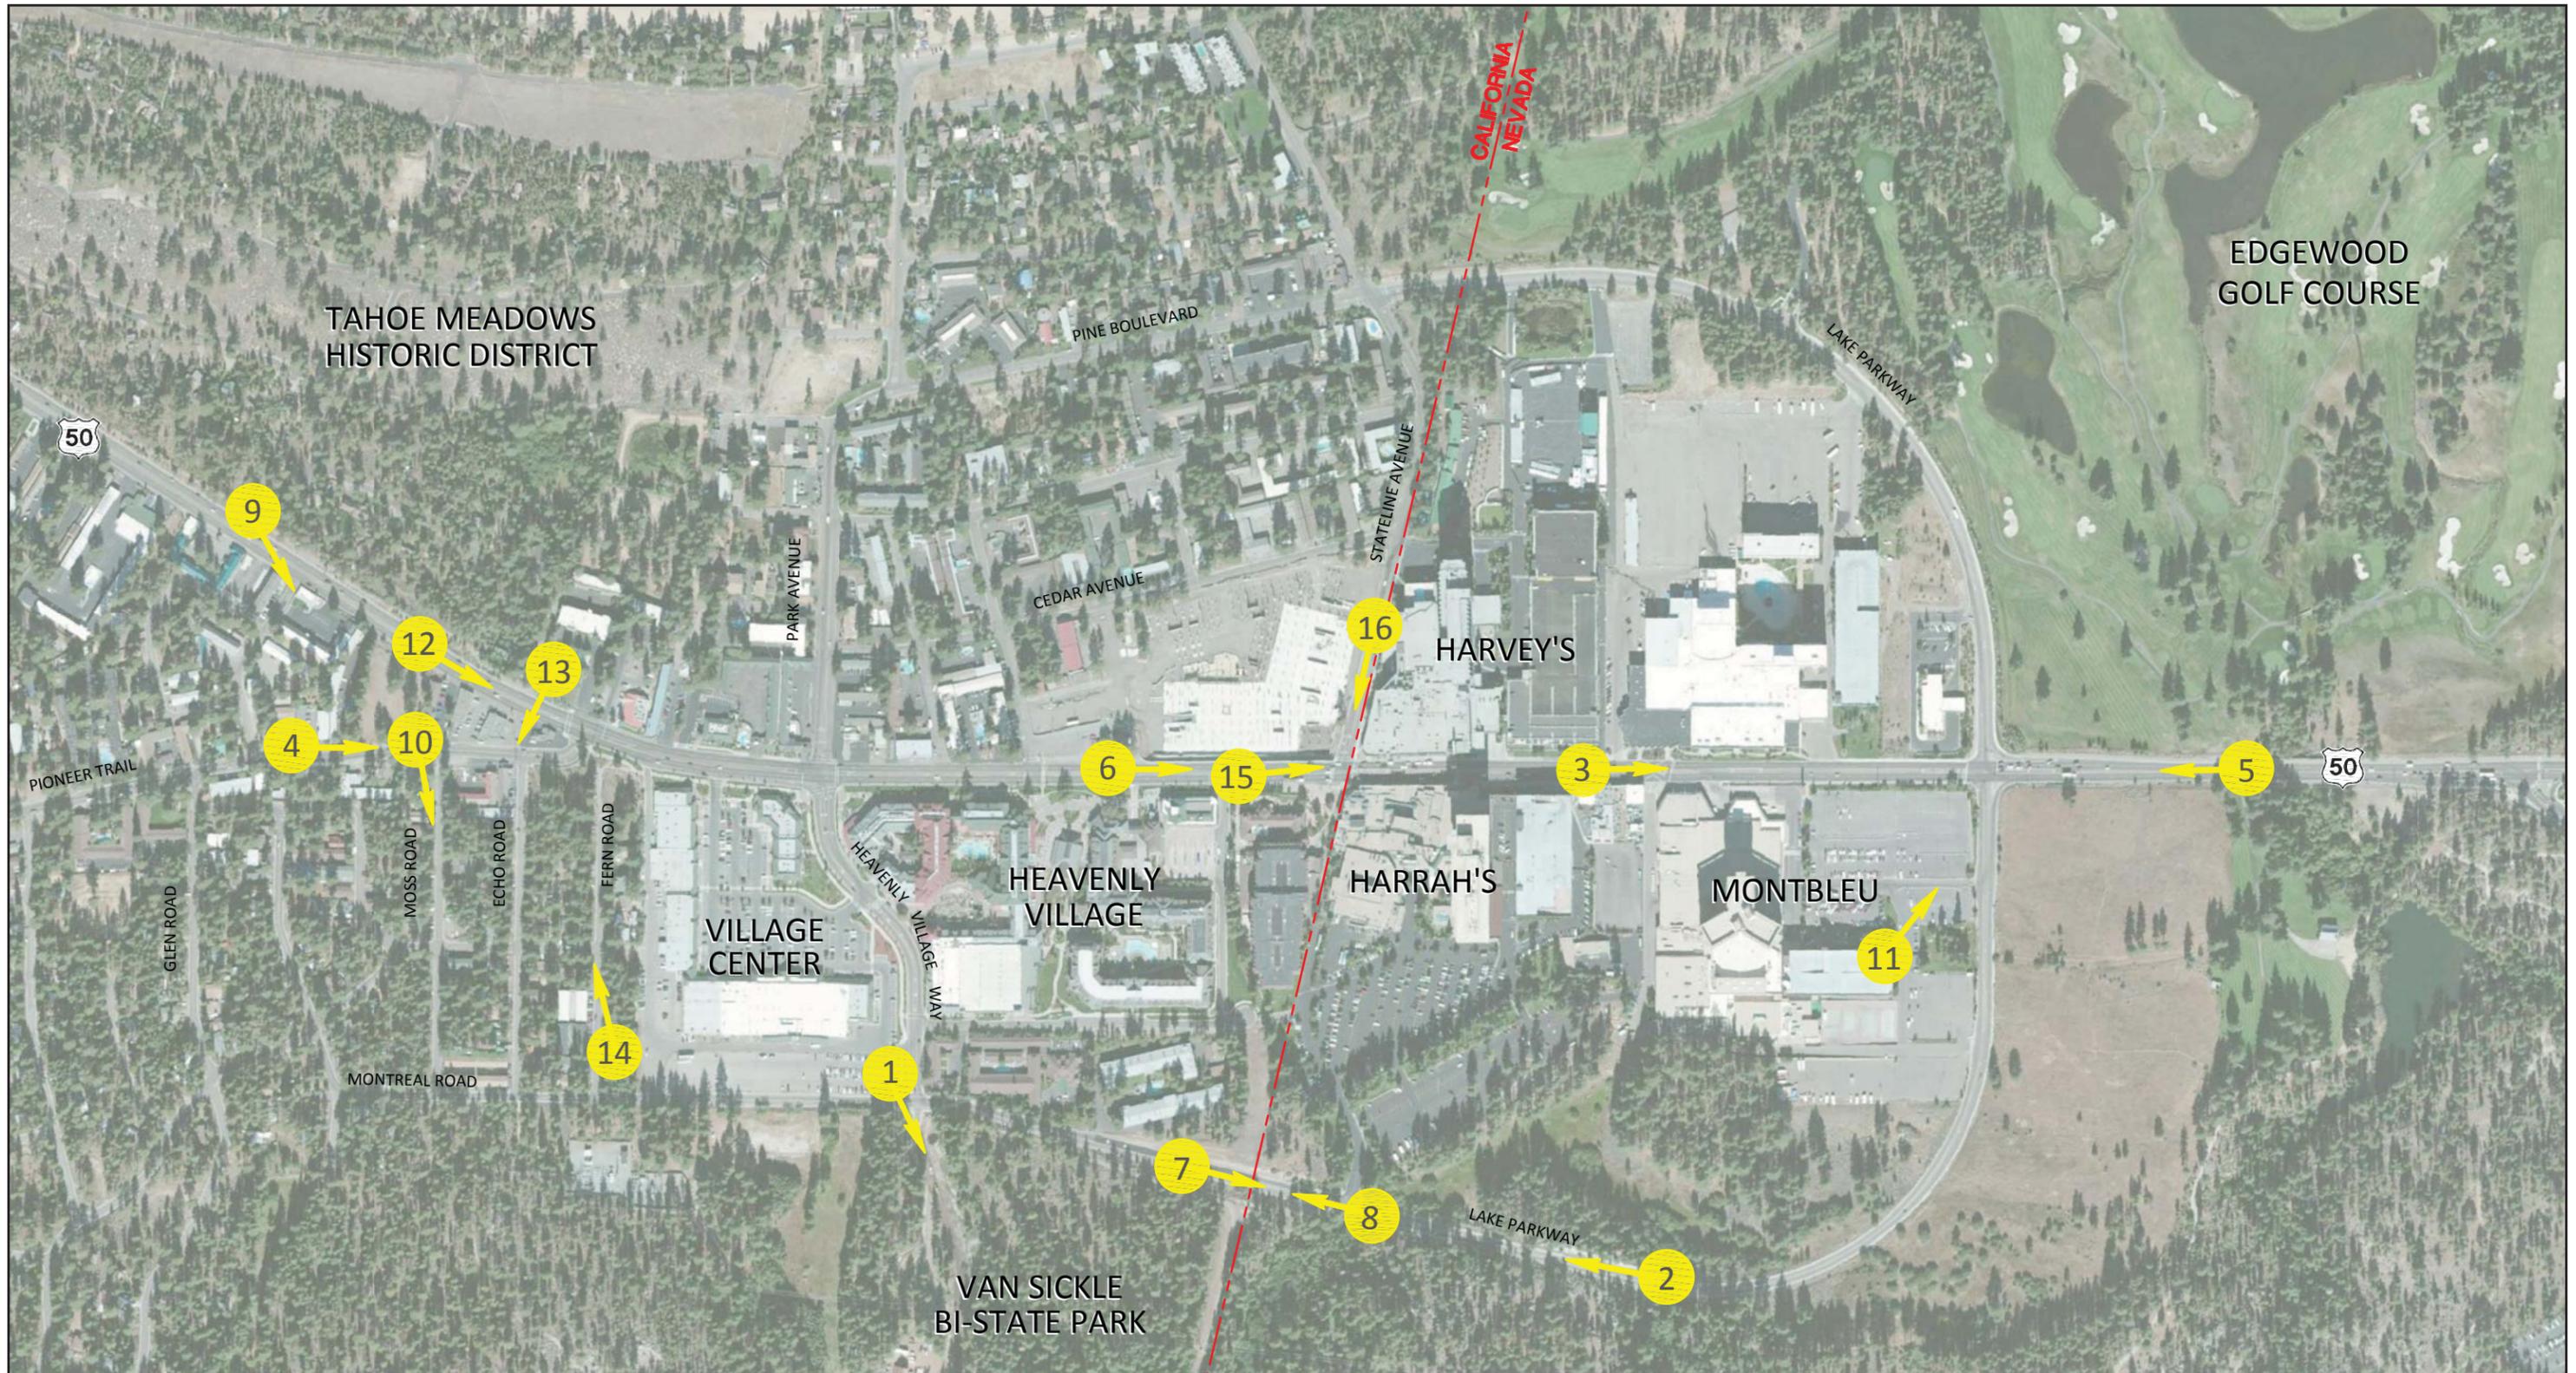
FIGURE 7

Observer viewpoints were established for each alternative to assist in describing the general visual quality of the Project corridor. Figure 7: Viewpoint Location Map shows the location of the sixteen viewpoints that will be analyzed for Alternatives A, B, C, D, and E in this document. The evaluation presents a weighted average of visual quality by observer viewpoints. These observer viewpoints are identified as those “views from the road” and “views of the road”.

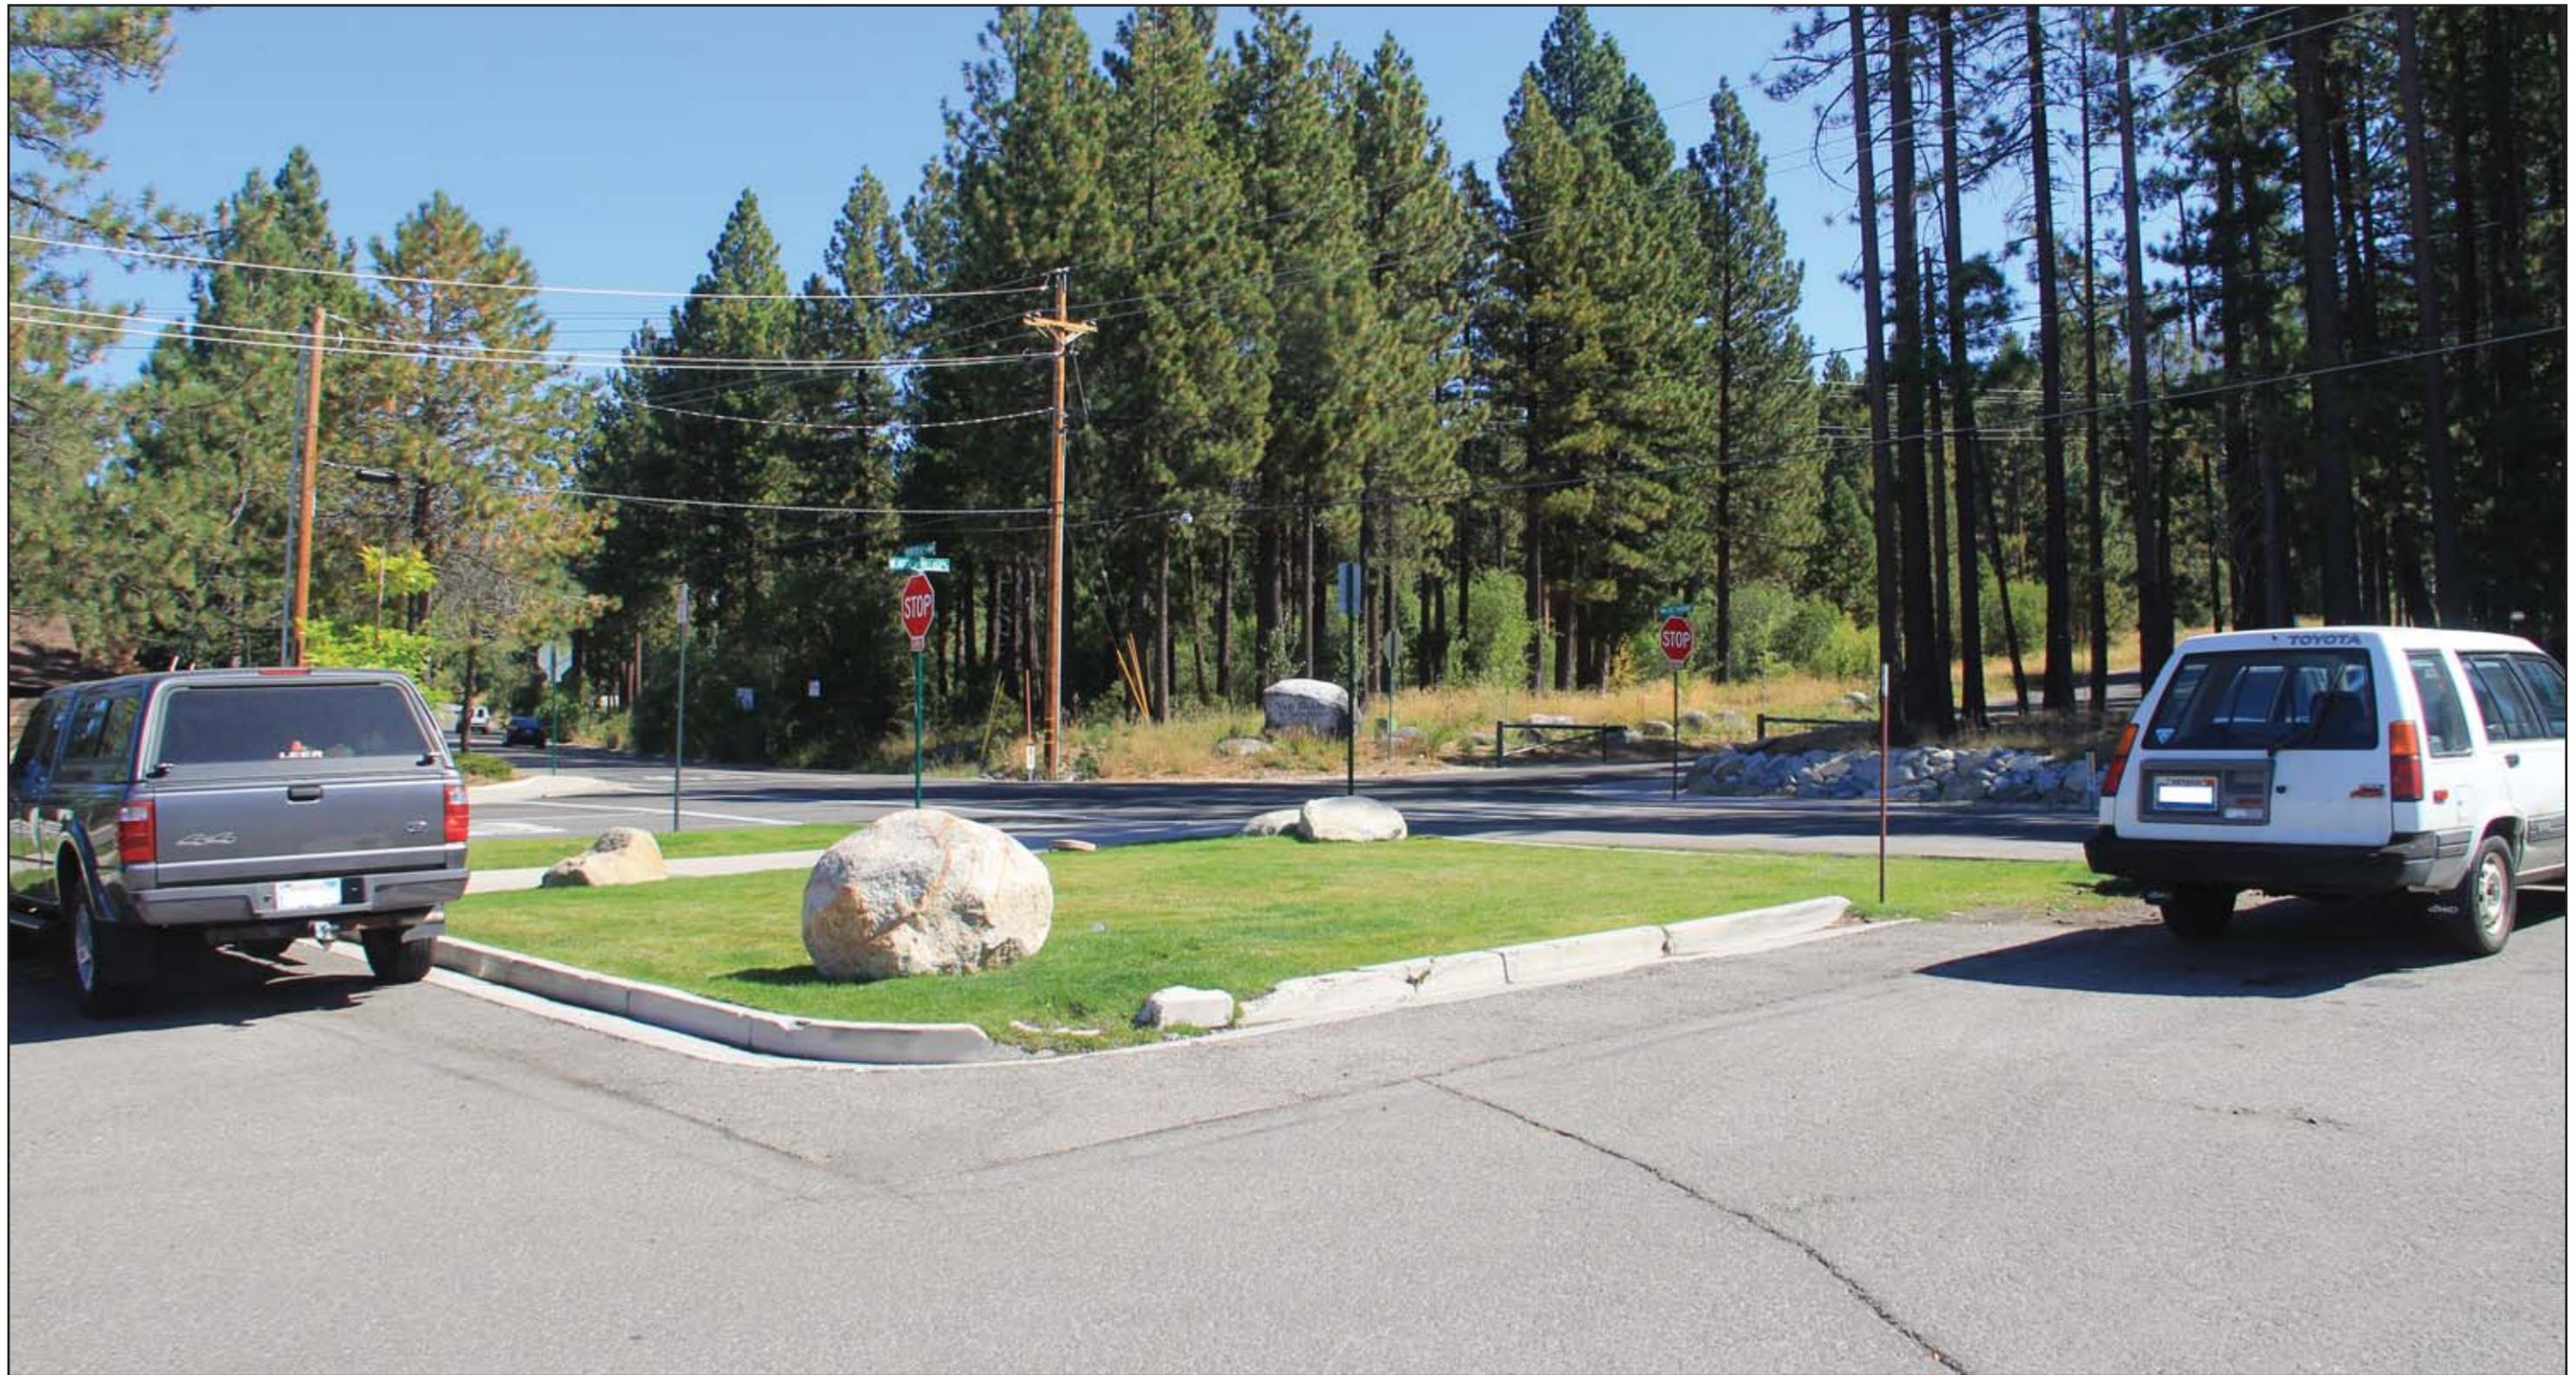
FIGURE 8

Viewpoint 1 is located in a parking lot looking eastward toward the intersection of Heavenly Village Way and Montreal Road/Lake Parkway. Figure 8: Viewpoint 1 Existing Conditions shows the existing visual conditions as seen by pedestrians, retail owners, and tourists from this viewpoint.

The foreground of this viewpoint offers views of manmade uses including a surface parking lot with vehicles and a vegetated area of the surface parking lot with decorative boulders. The middleground offers views of the Heavenly Village Way and Montreal Road/Lake Parkway intersection, utility poles/lines, street signs,

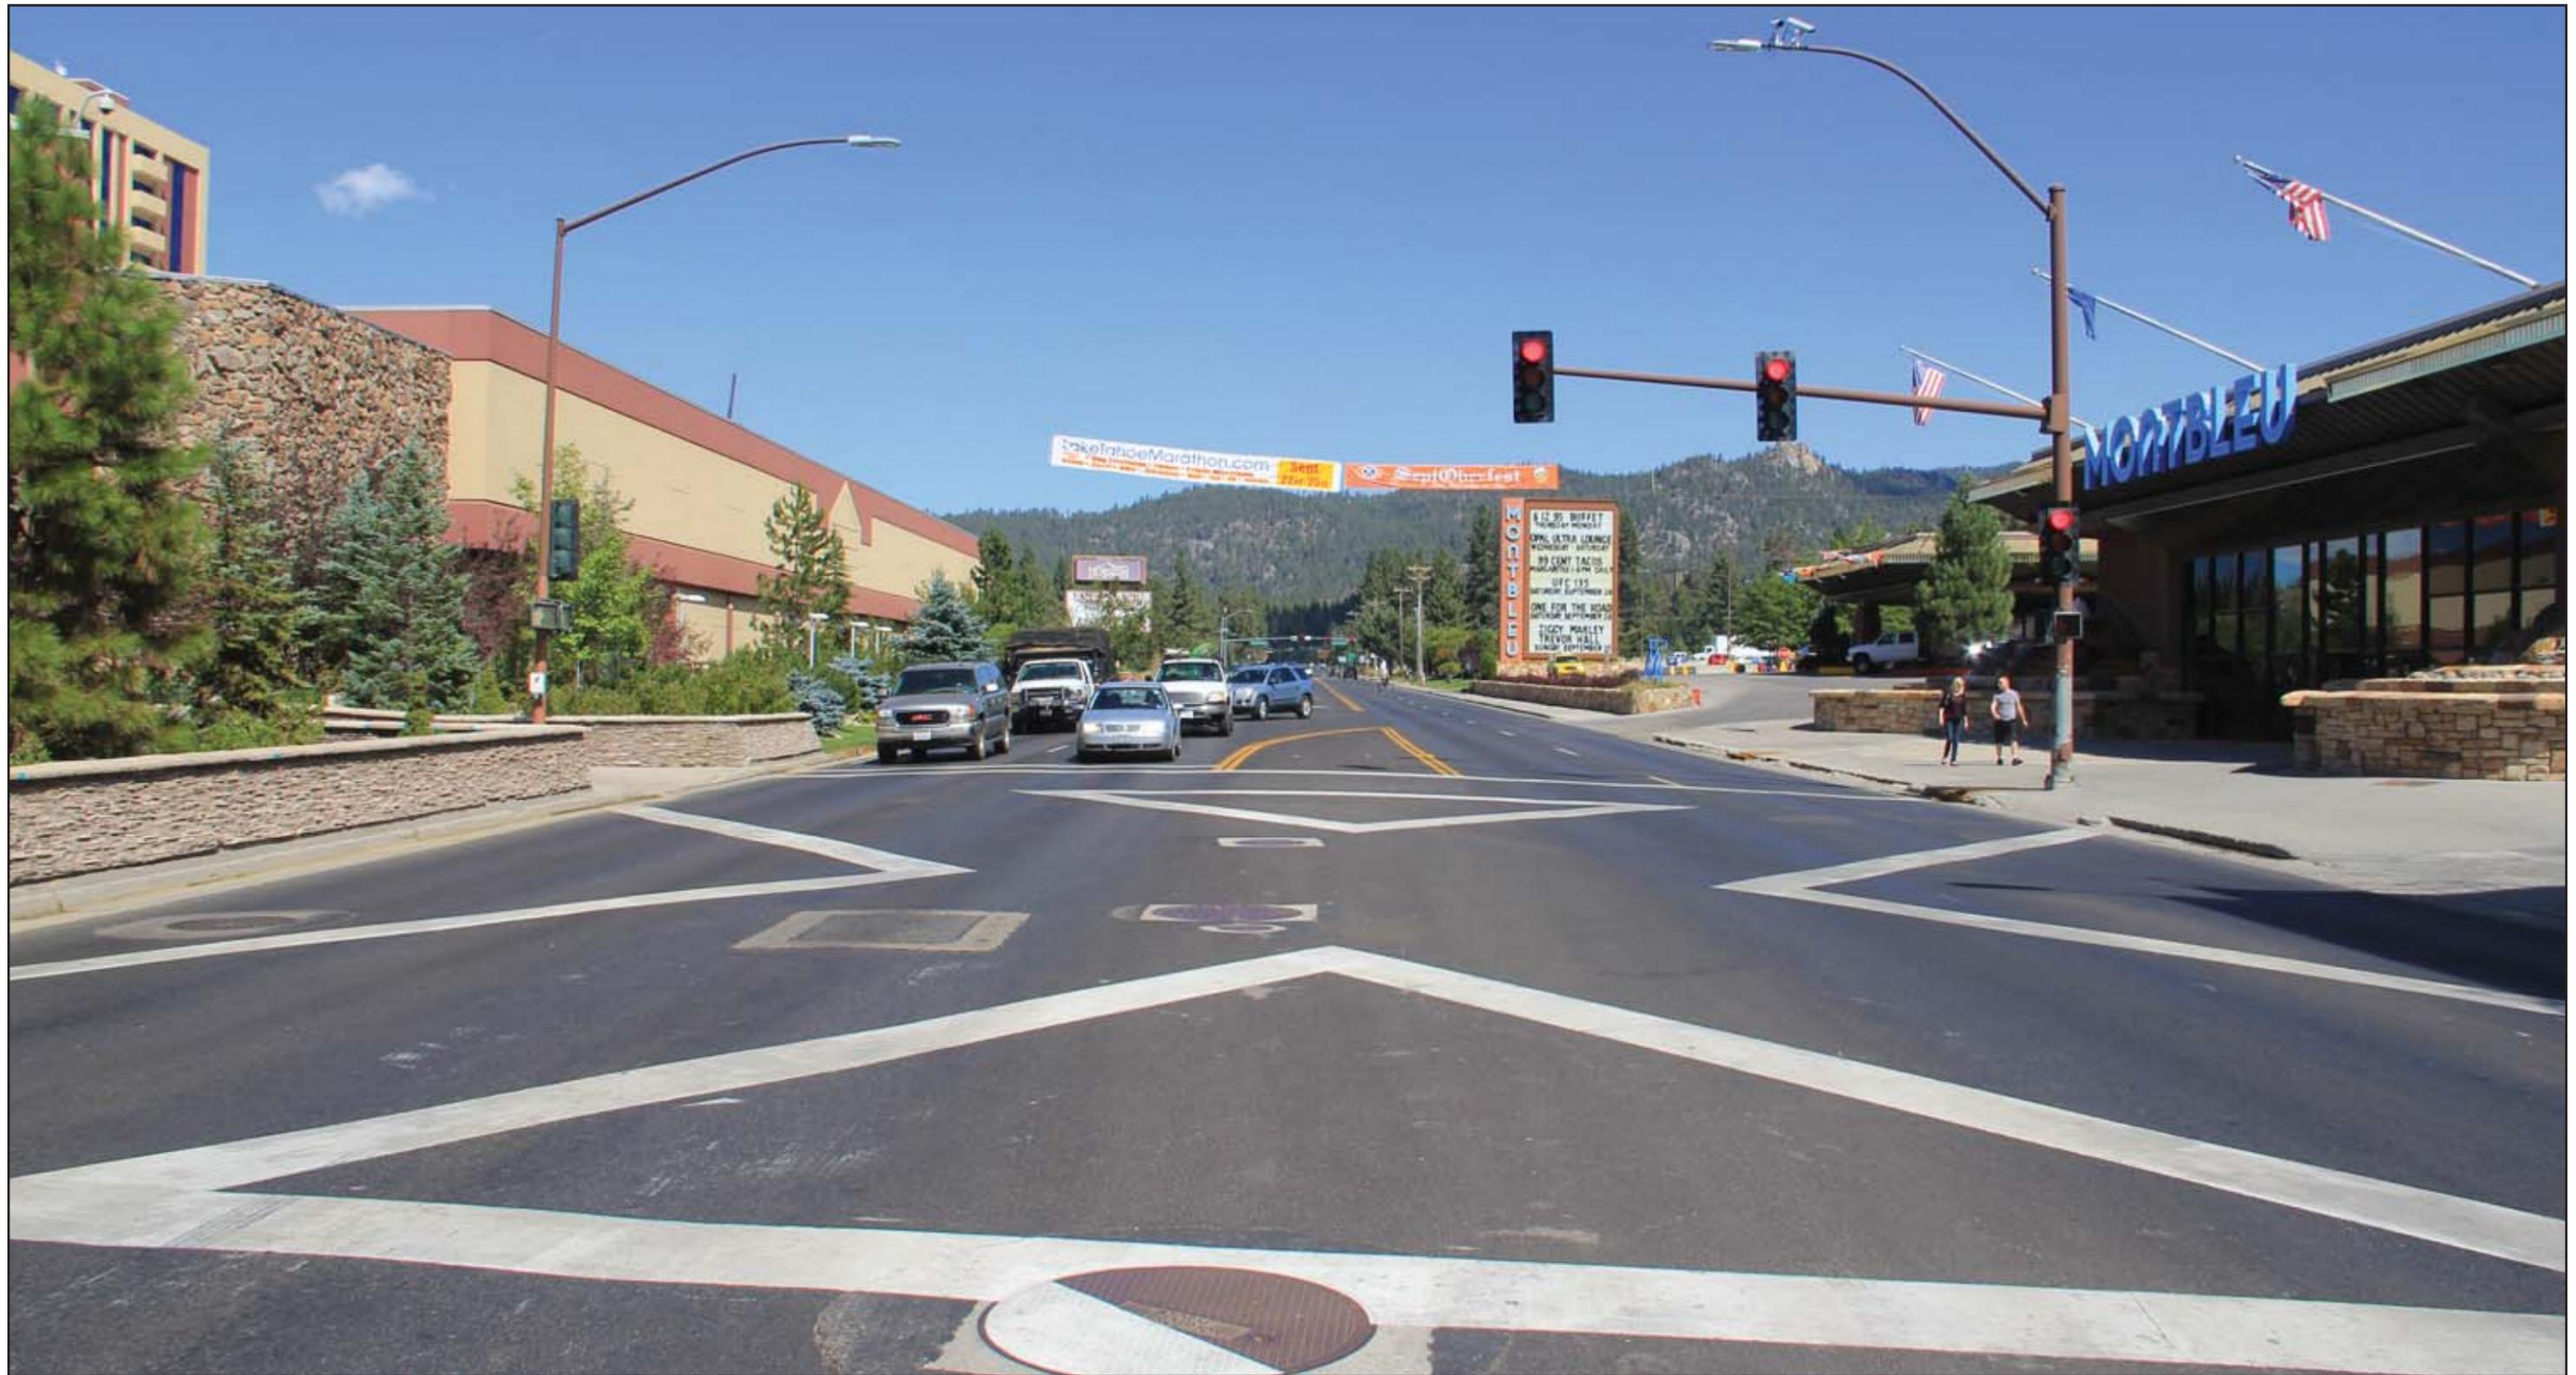
FIGURE 10

Viewpoint 3 is located on U.S. 50 adjacent to Montbleu Hotel/Casino looking northeast. Figure 10: Viewpoint 3 Existing Conditions shows the existing visual conditions as seen by motorists and bicyclists from this viewpoint.

The visual impression of this viewpoint is not memorable since it does not have any features (manmade or natural) that stand out. The landscape does not contain contrasting landscape elements as this viewpoint provides visuals of the urbanized Casino Corridor. Background mountains do not stand out compared to the manmade features seen from this viewpoint. Vividness for this viewpoint, under existing conditions, was rated at 3.00. The integrity of the visual order of the manmade features at this viewpoint is present. Some natural features such as ornamental vegetation and street trees conceal the façades of buildings at this viewpoint. Encroachment occurs in that some manmade features (buildings, marquee, etc.) obscure the mountains in the distance. Intactness of this viewpoint was rated 2.50. The manmade features at this viewpoint dominate the view and are of varying size. The manmade features, landscaped vegetation, and distant natural features (mountains, coniferous trees) do not form a coherent, harmonious visual pattern. Unity of this viewpoint was rated at 2.50. Based on the individual scores of vividness, intactness, and unity, the overall visual quality rating at this viewpoint under existing conditions is *Moderately Low* and rated **2.67**.
