**Draft Visual Impact Assessment – US
50/South Shore Community
Revitalization Project**

U.S. 50/South Shore Community Revitalization Project

South Lake Tahoe, California / Stateline, Nevada

**Draft Visual Impact Assessment (VIA) For
U.S. 50/South Shore Community Revitalization Project**

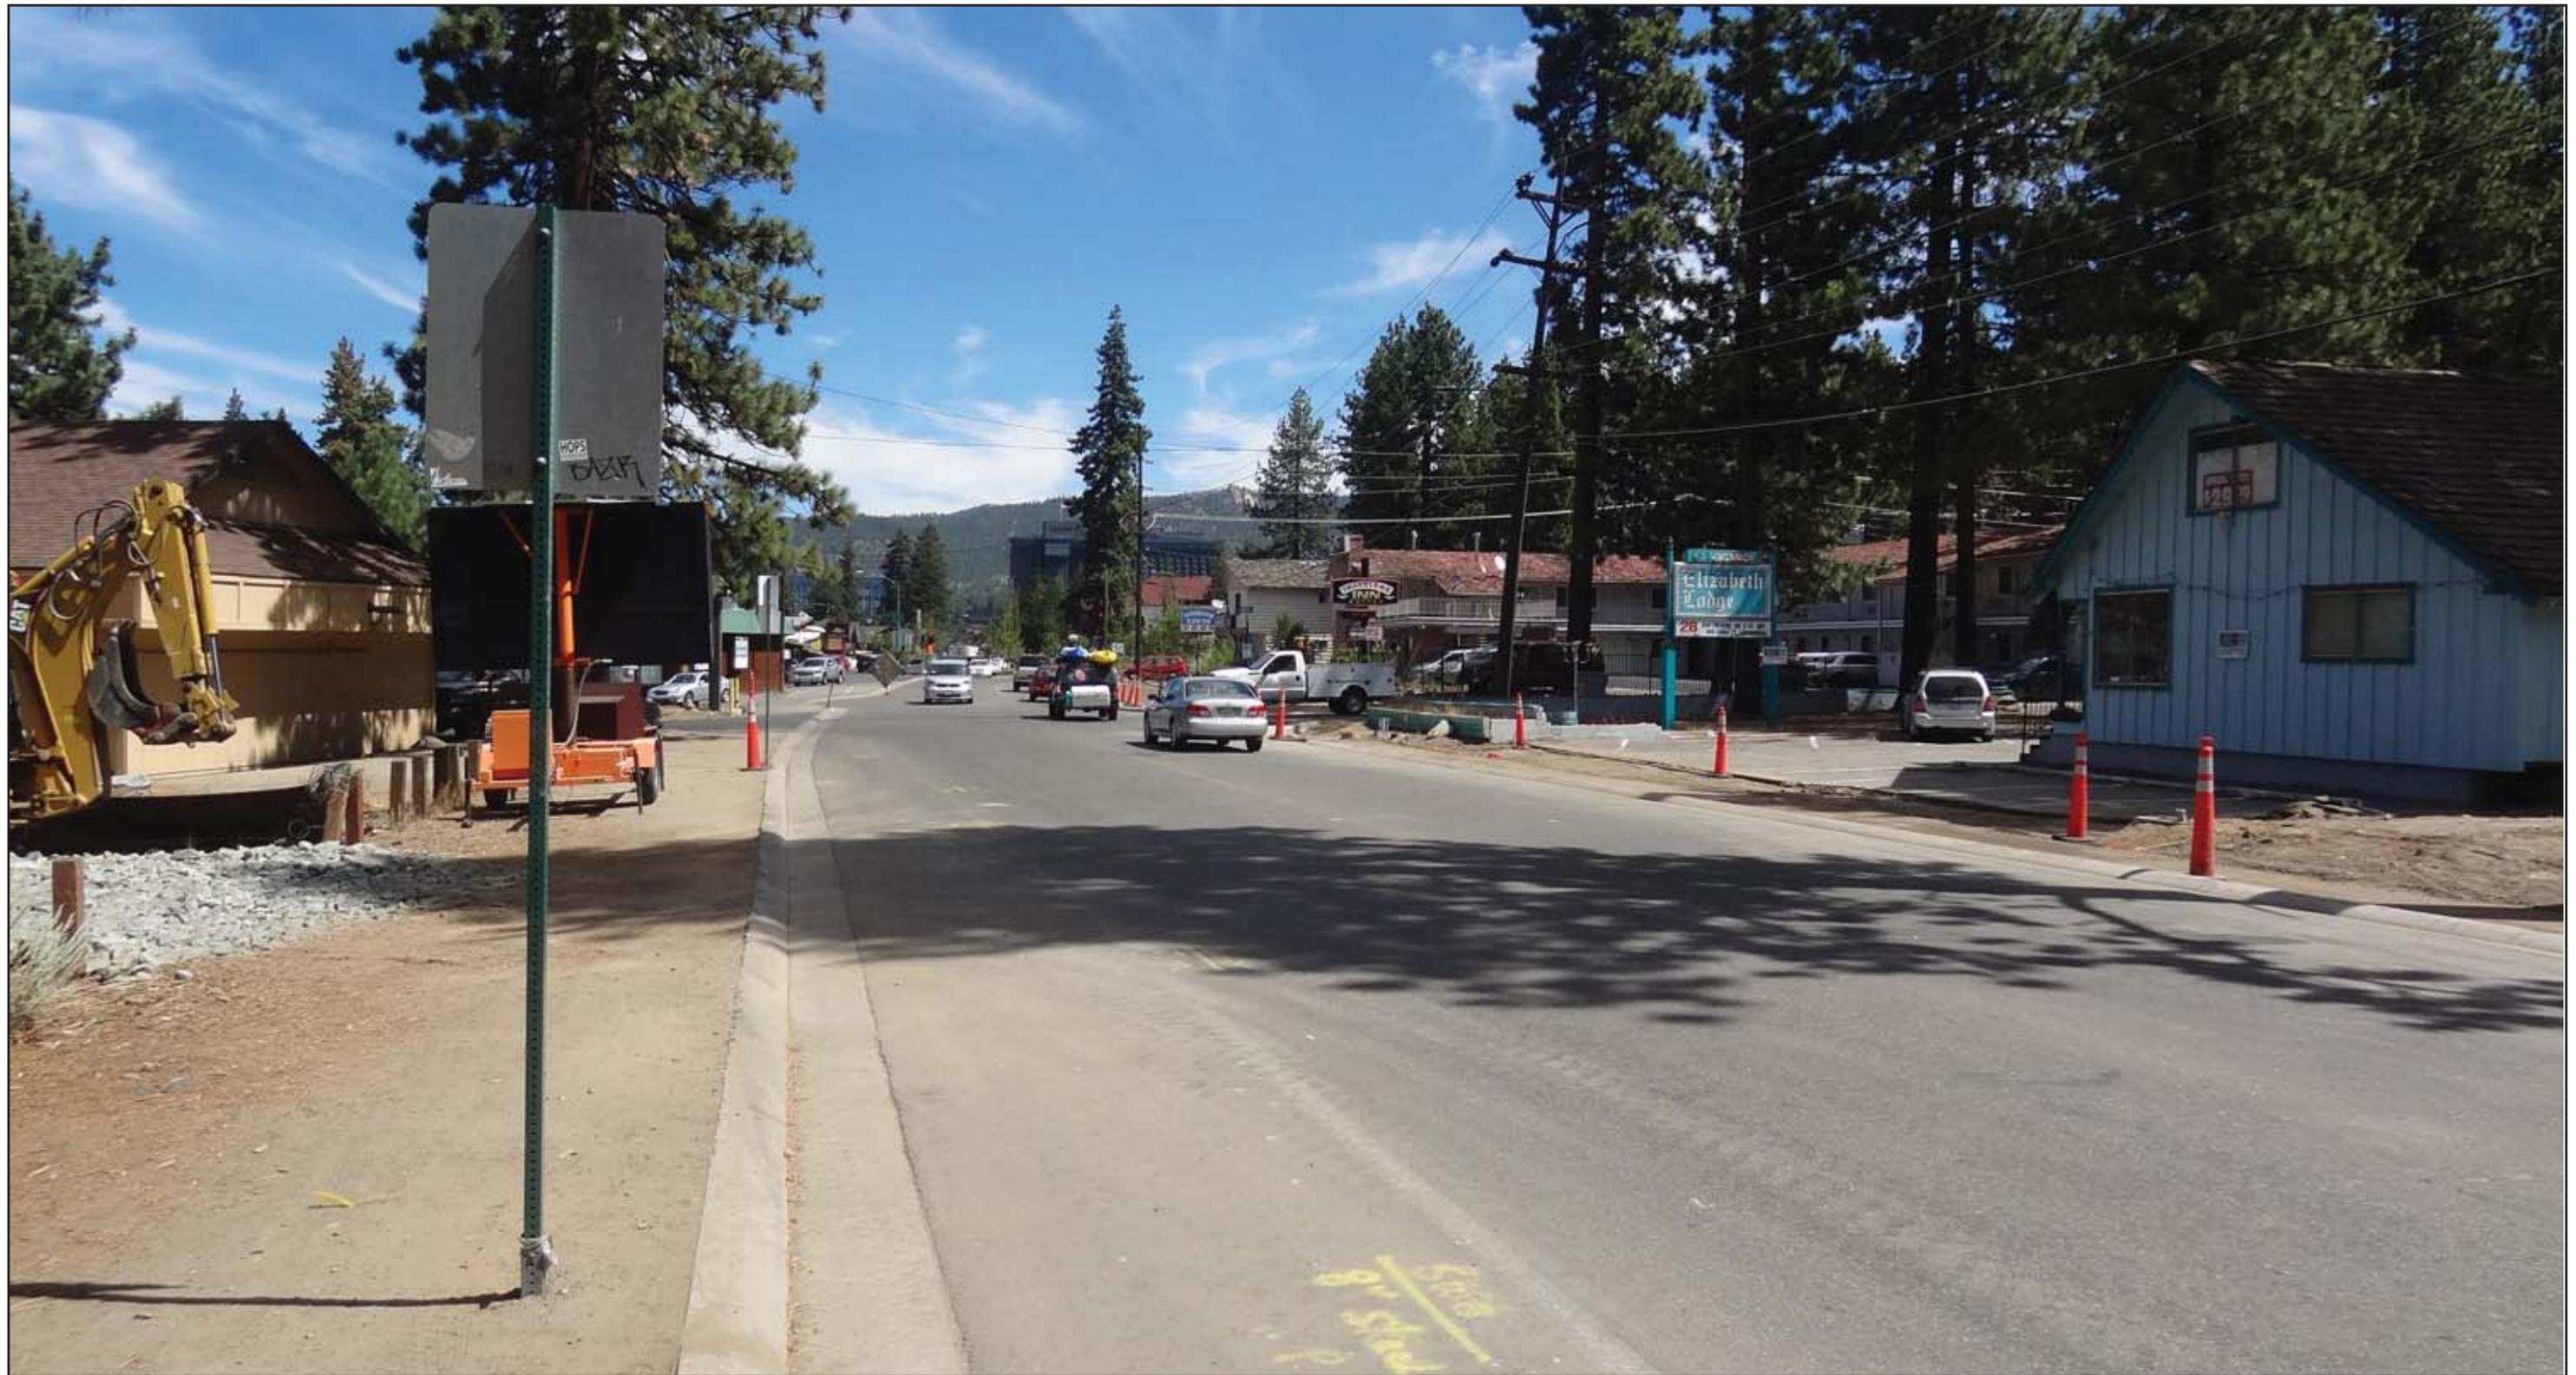
FIGURE 11

Viewpoint 4 is located along Pioneer Trail looking northeast towards Moss Road. Figure 11: Viewpoint 4 Existing Conditions shows the existing visual conditions as seen by motorists and bicyclists at this viewpoint.

Viewpoint 4 Existing Conditions

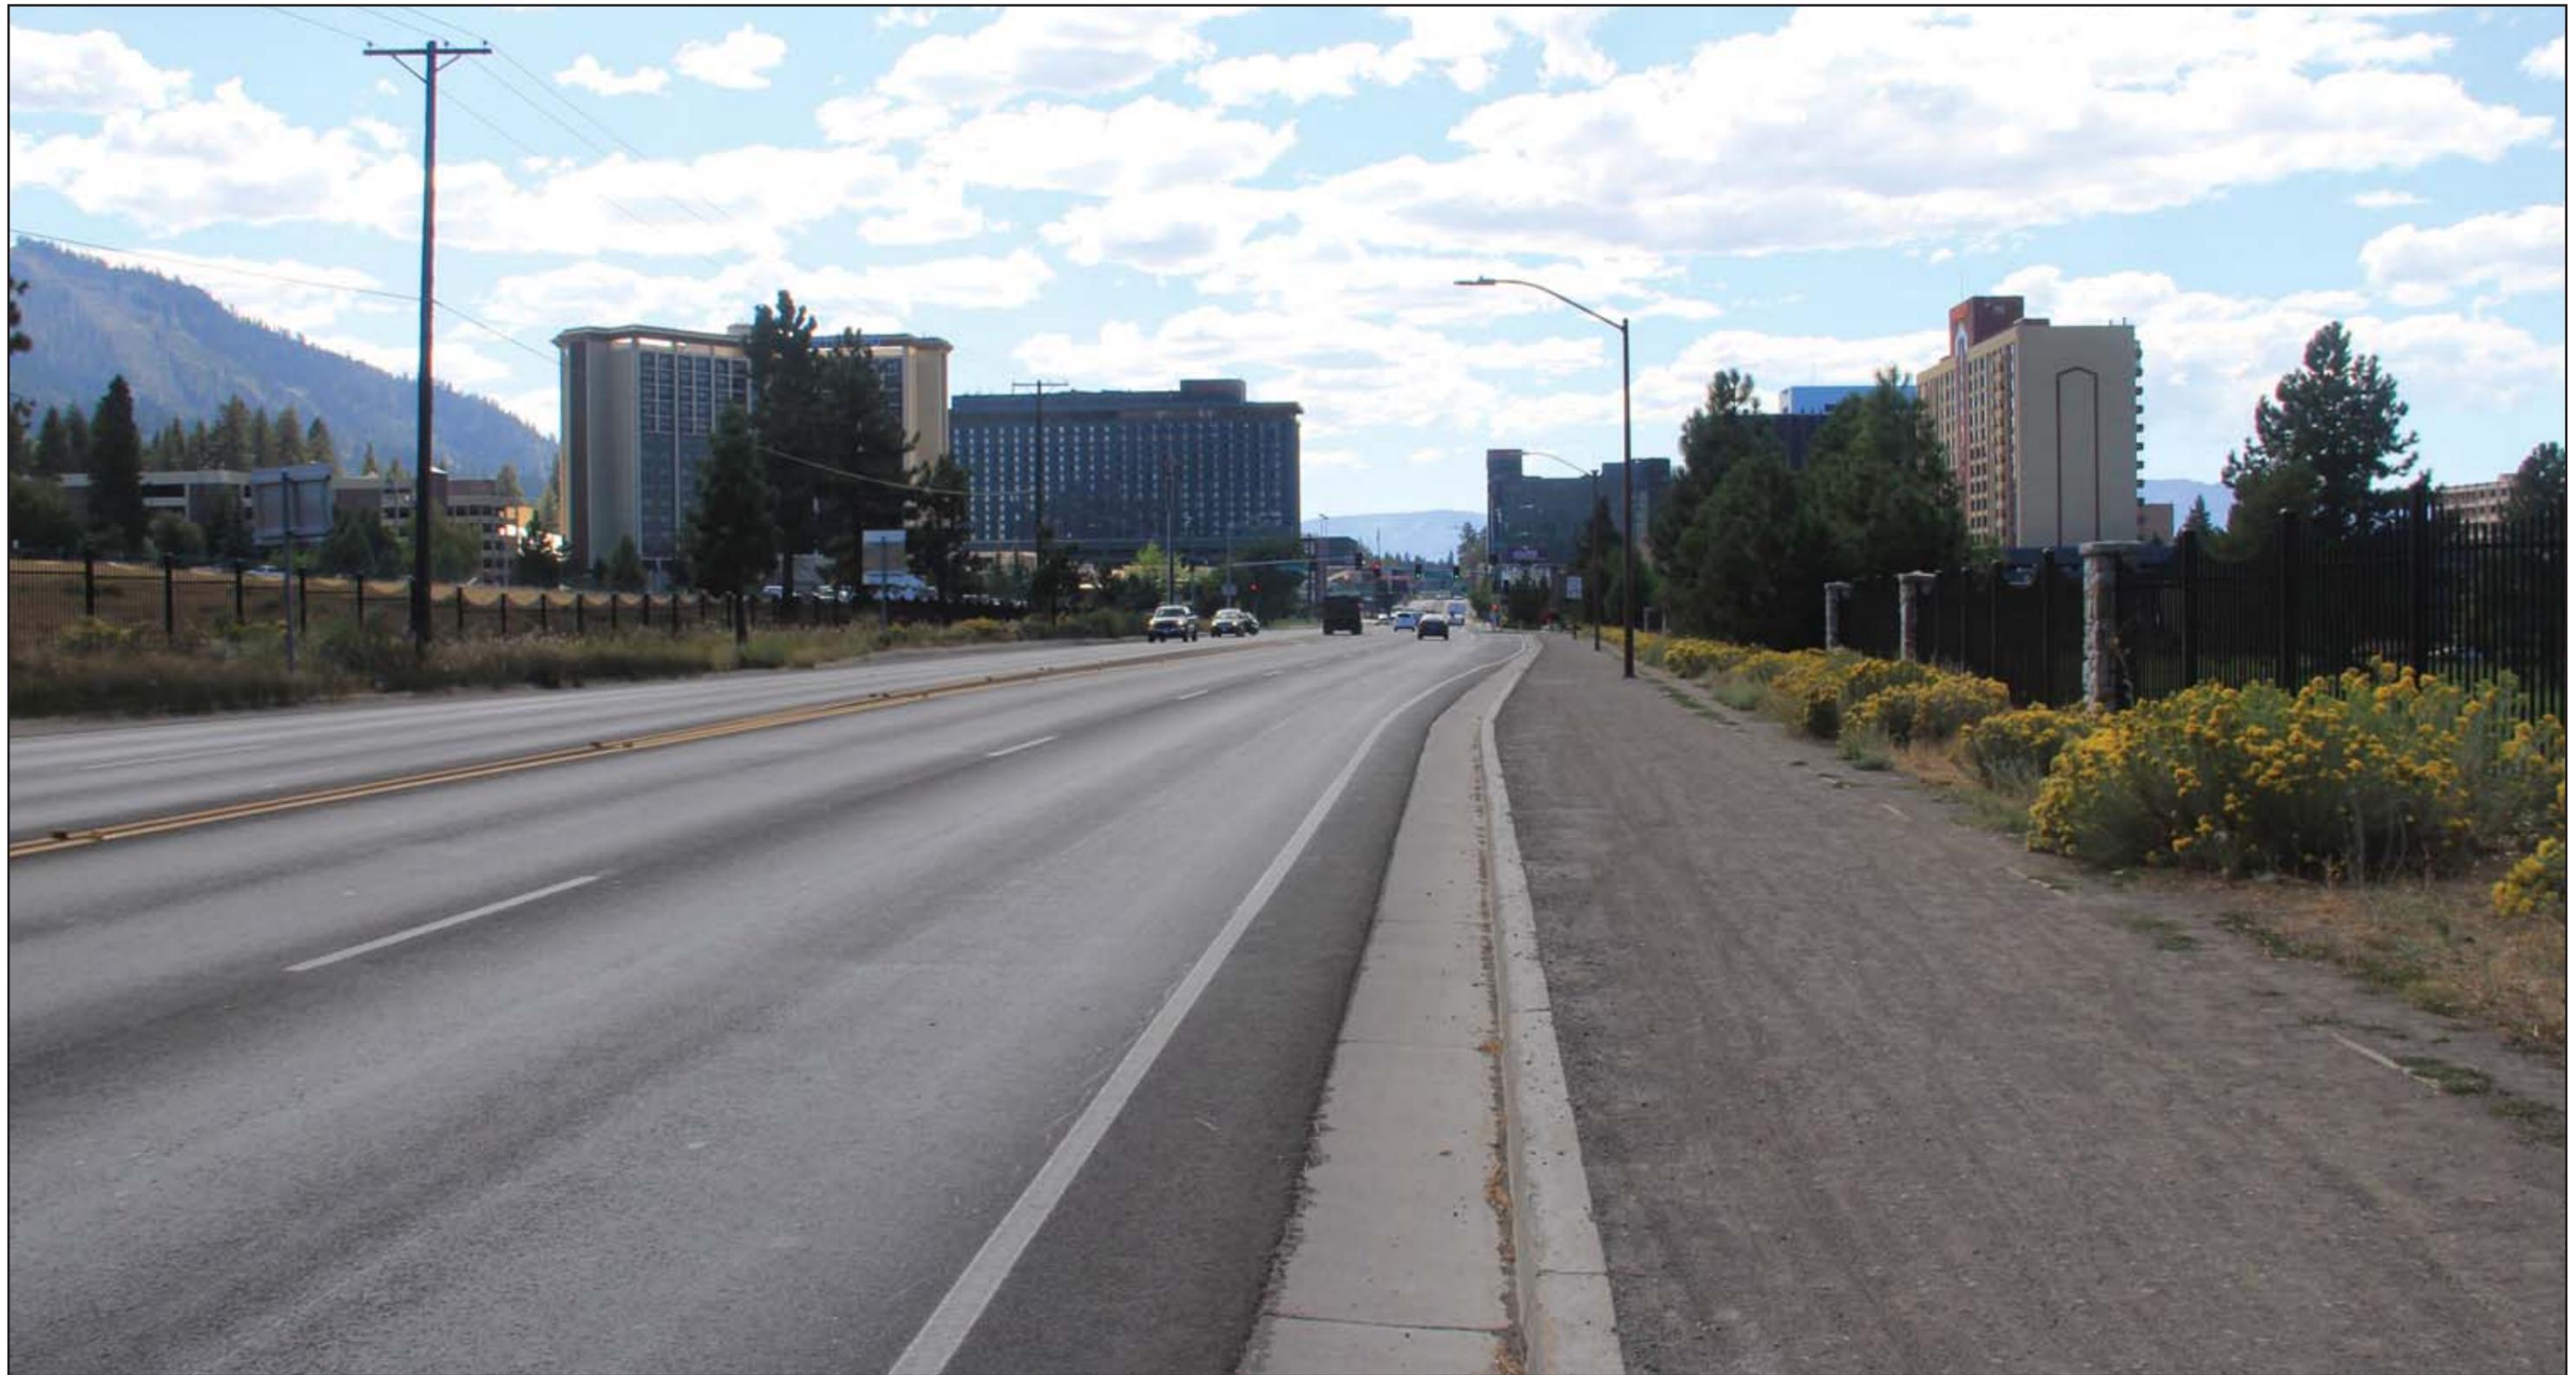
FIGURE 12

Viewpoint 5 is located in the northern portion of the Project area on U.S. 50 north of Lake Parkway, looking south towards the Casino Corridor. Figure 12: Viewpoint 5 Existing Conditions shows the existing visual condition as seen by motorists and bicyclists at this viewpoint.

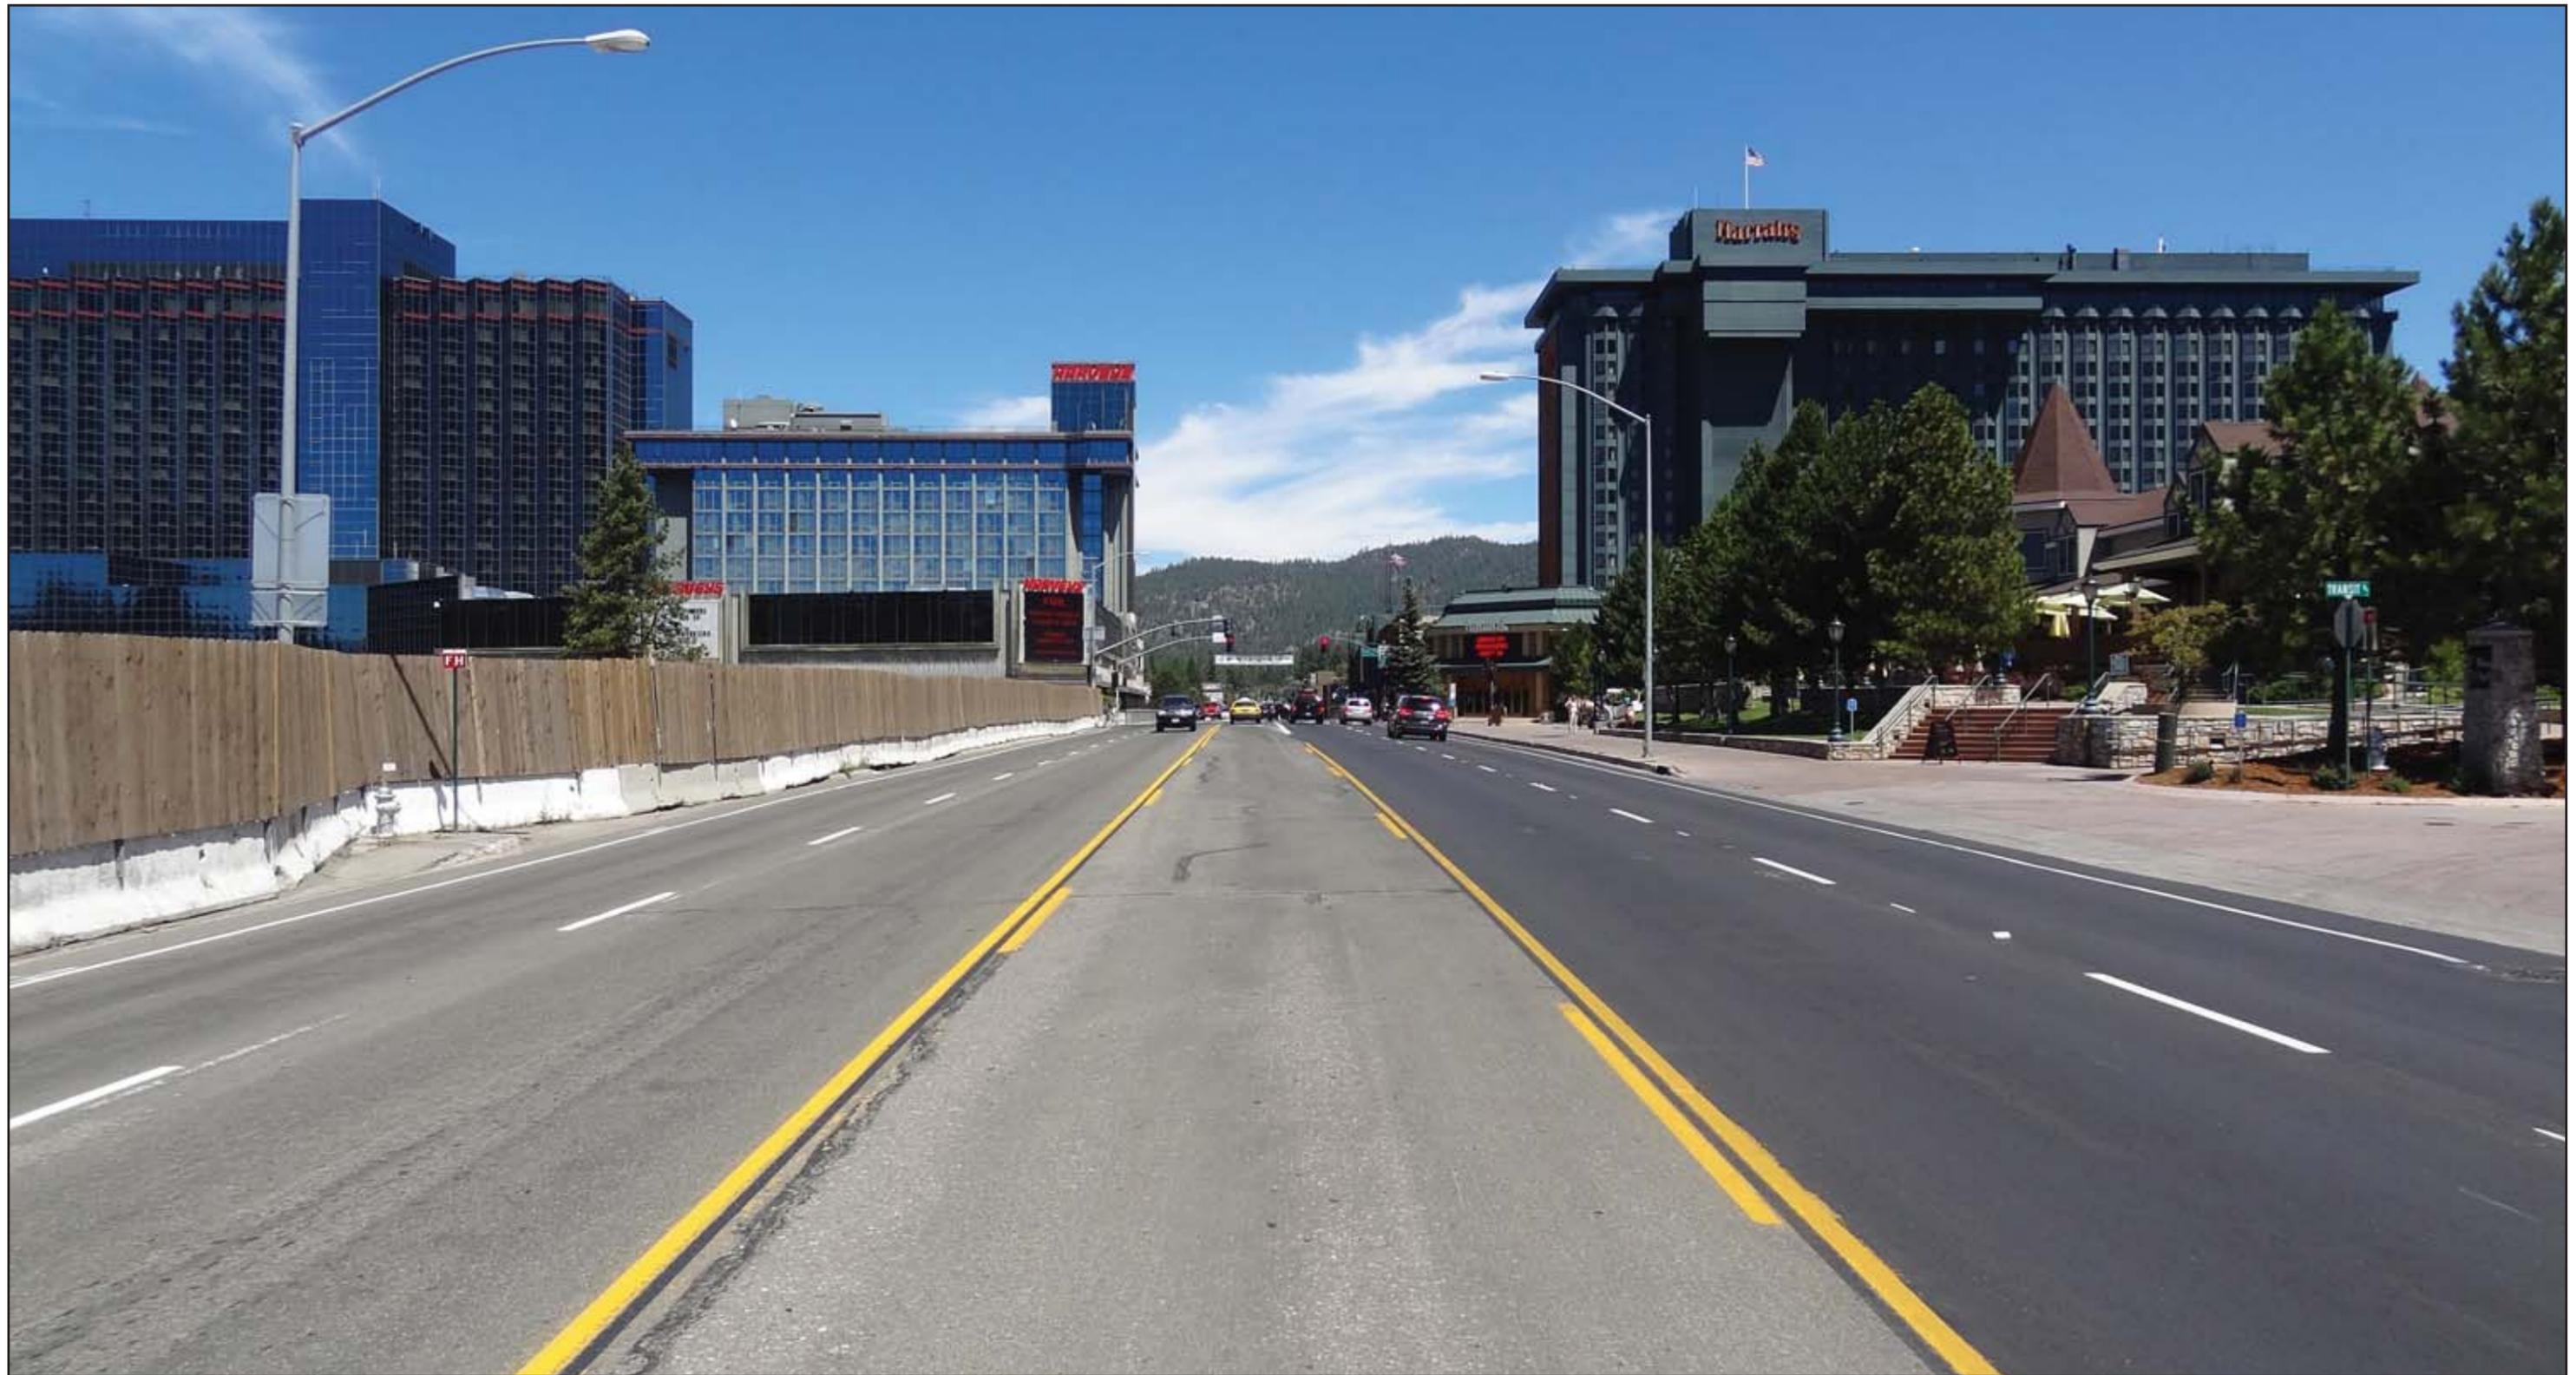
FIGURE 13

Viewpoint 6 is located along U.S. 50 in the Casino Corridor looking to the northeast. Figure 13: Viewpoint 6 Existing Conditions shows the existing visual conditions as seen by motorists and bicyclists as they approach the California/Nevada boundary from the southwest along U.S. 50.

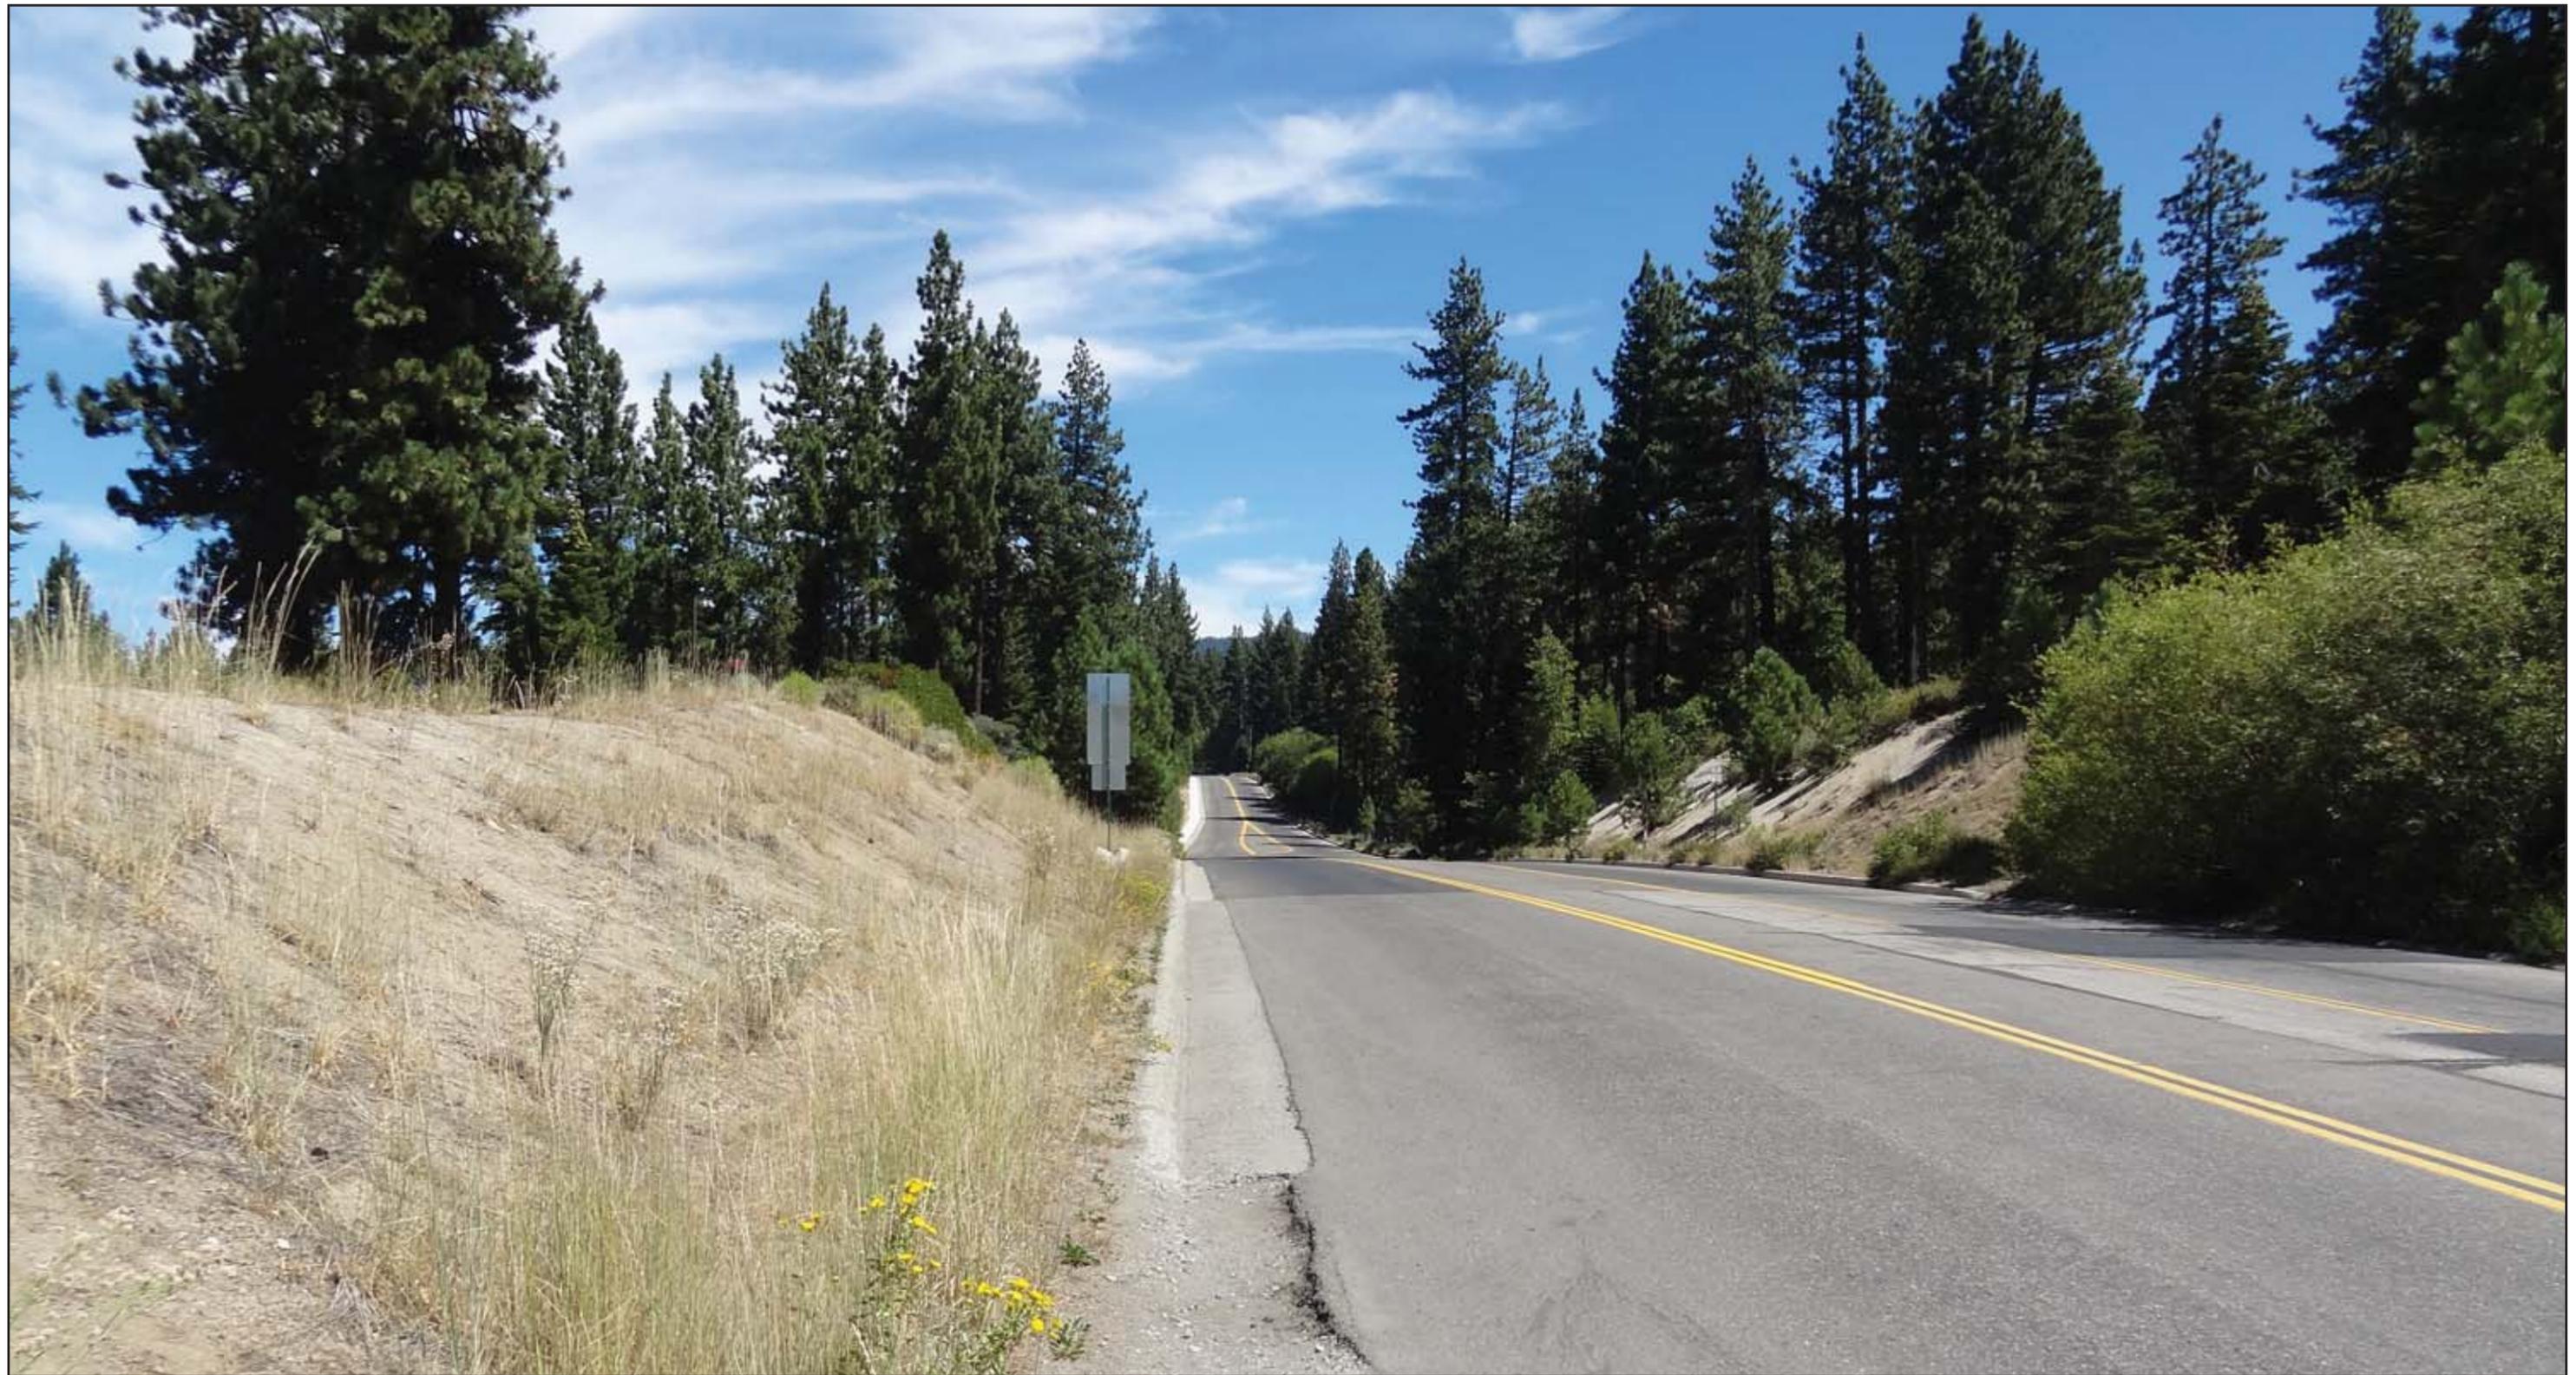
FIGURE 14

Viewpoint 7 is located along Lake Parkway at the California/Nevada State Line looking northeast. Figure 14: Viewpoint 7 Existing Conditions shows the existing vantage point as seen by motorists and bicyclists as they travel along Lake Parkway.

This viewpoint shows a two-lane road bisecting a natural landscape. Foreground and middleground provides views of Lake Parkway with scrub and forested areas paralleling the roadway.

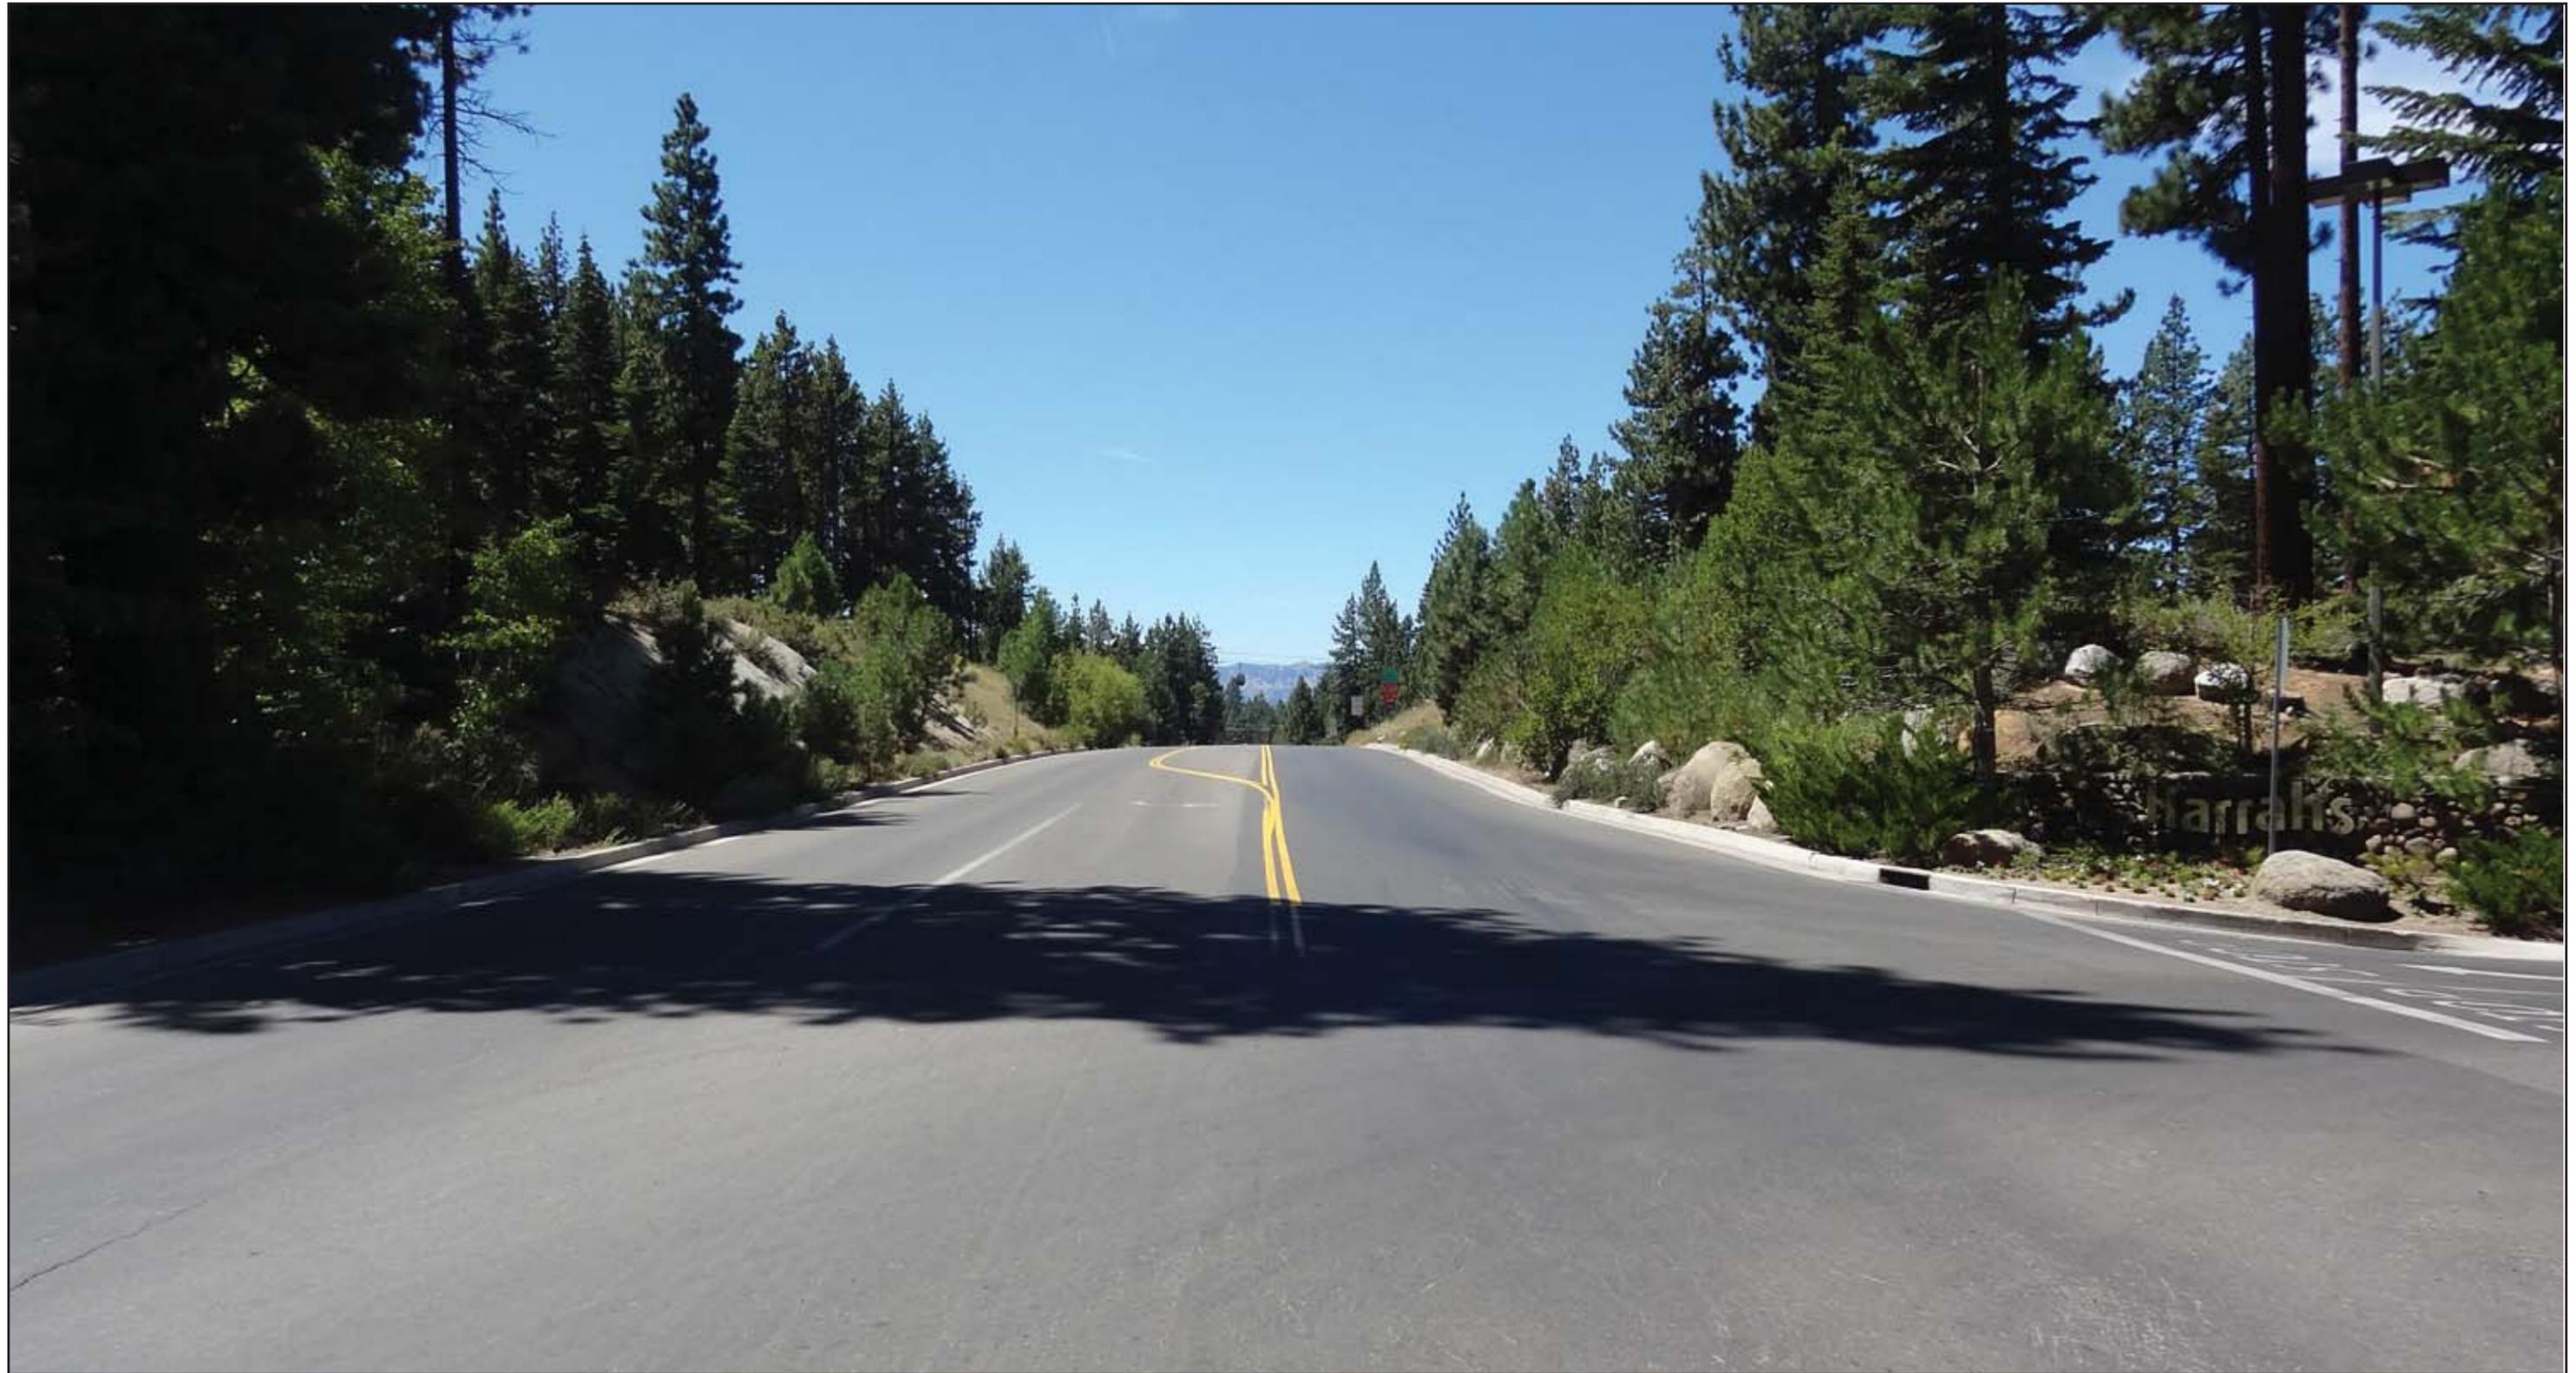
FIGURE 15

Viewpoint 8 is located along Lake Parkway at the Harrah's entrance looking southwest. Figure 15: Viewpoint 8 Existing Conditions shows the existing visual conditions as seen by motorists and bicyclists as they travel along Lake Parkway.

The forested area paralleling the roadway at this viewpoint provides the primary element of vividness. The roadway and coniferous trees provide color and texture and contrast against the sky and mountain backdrop. Vividness at this viewpoint is rated 3.67.

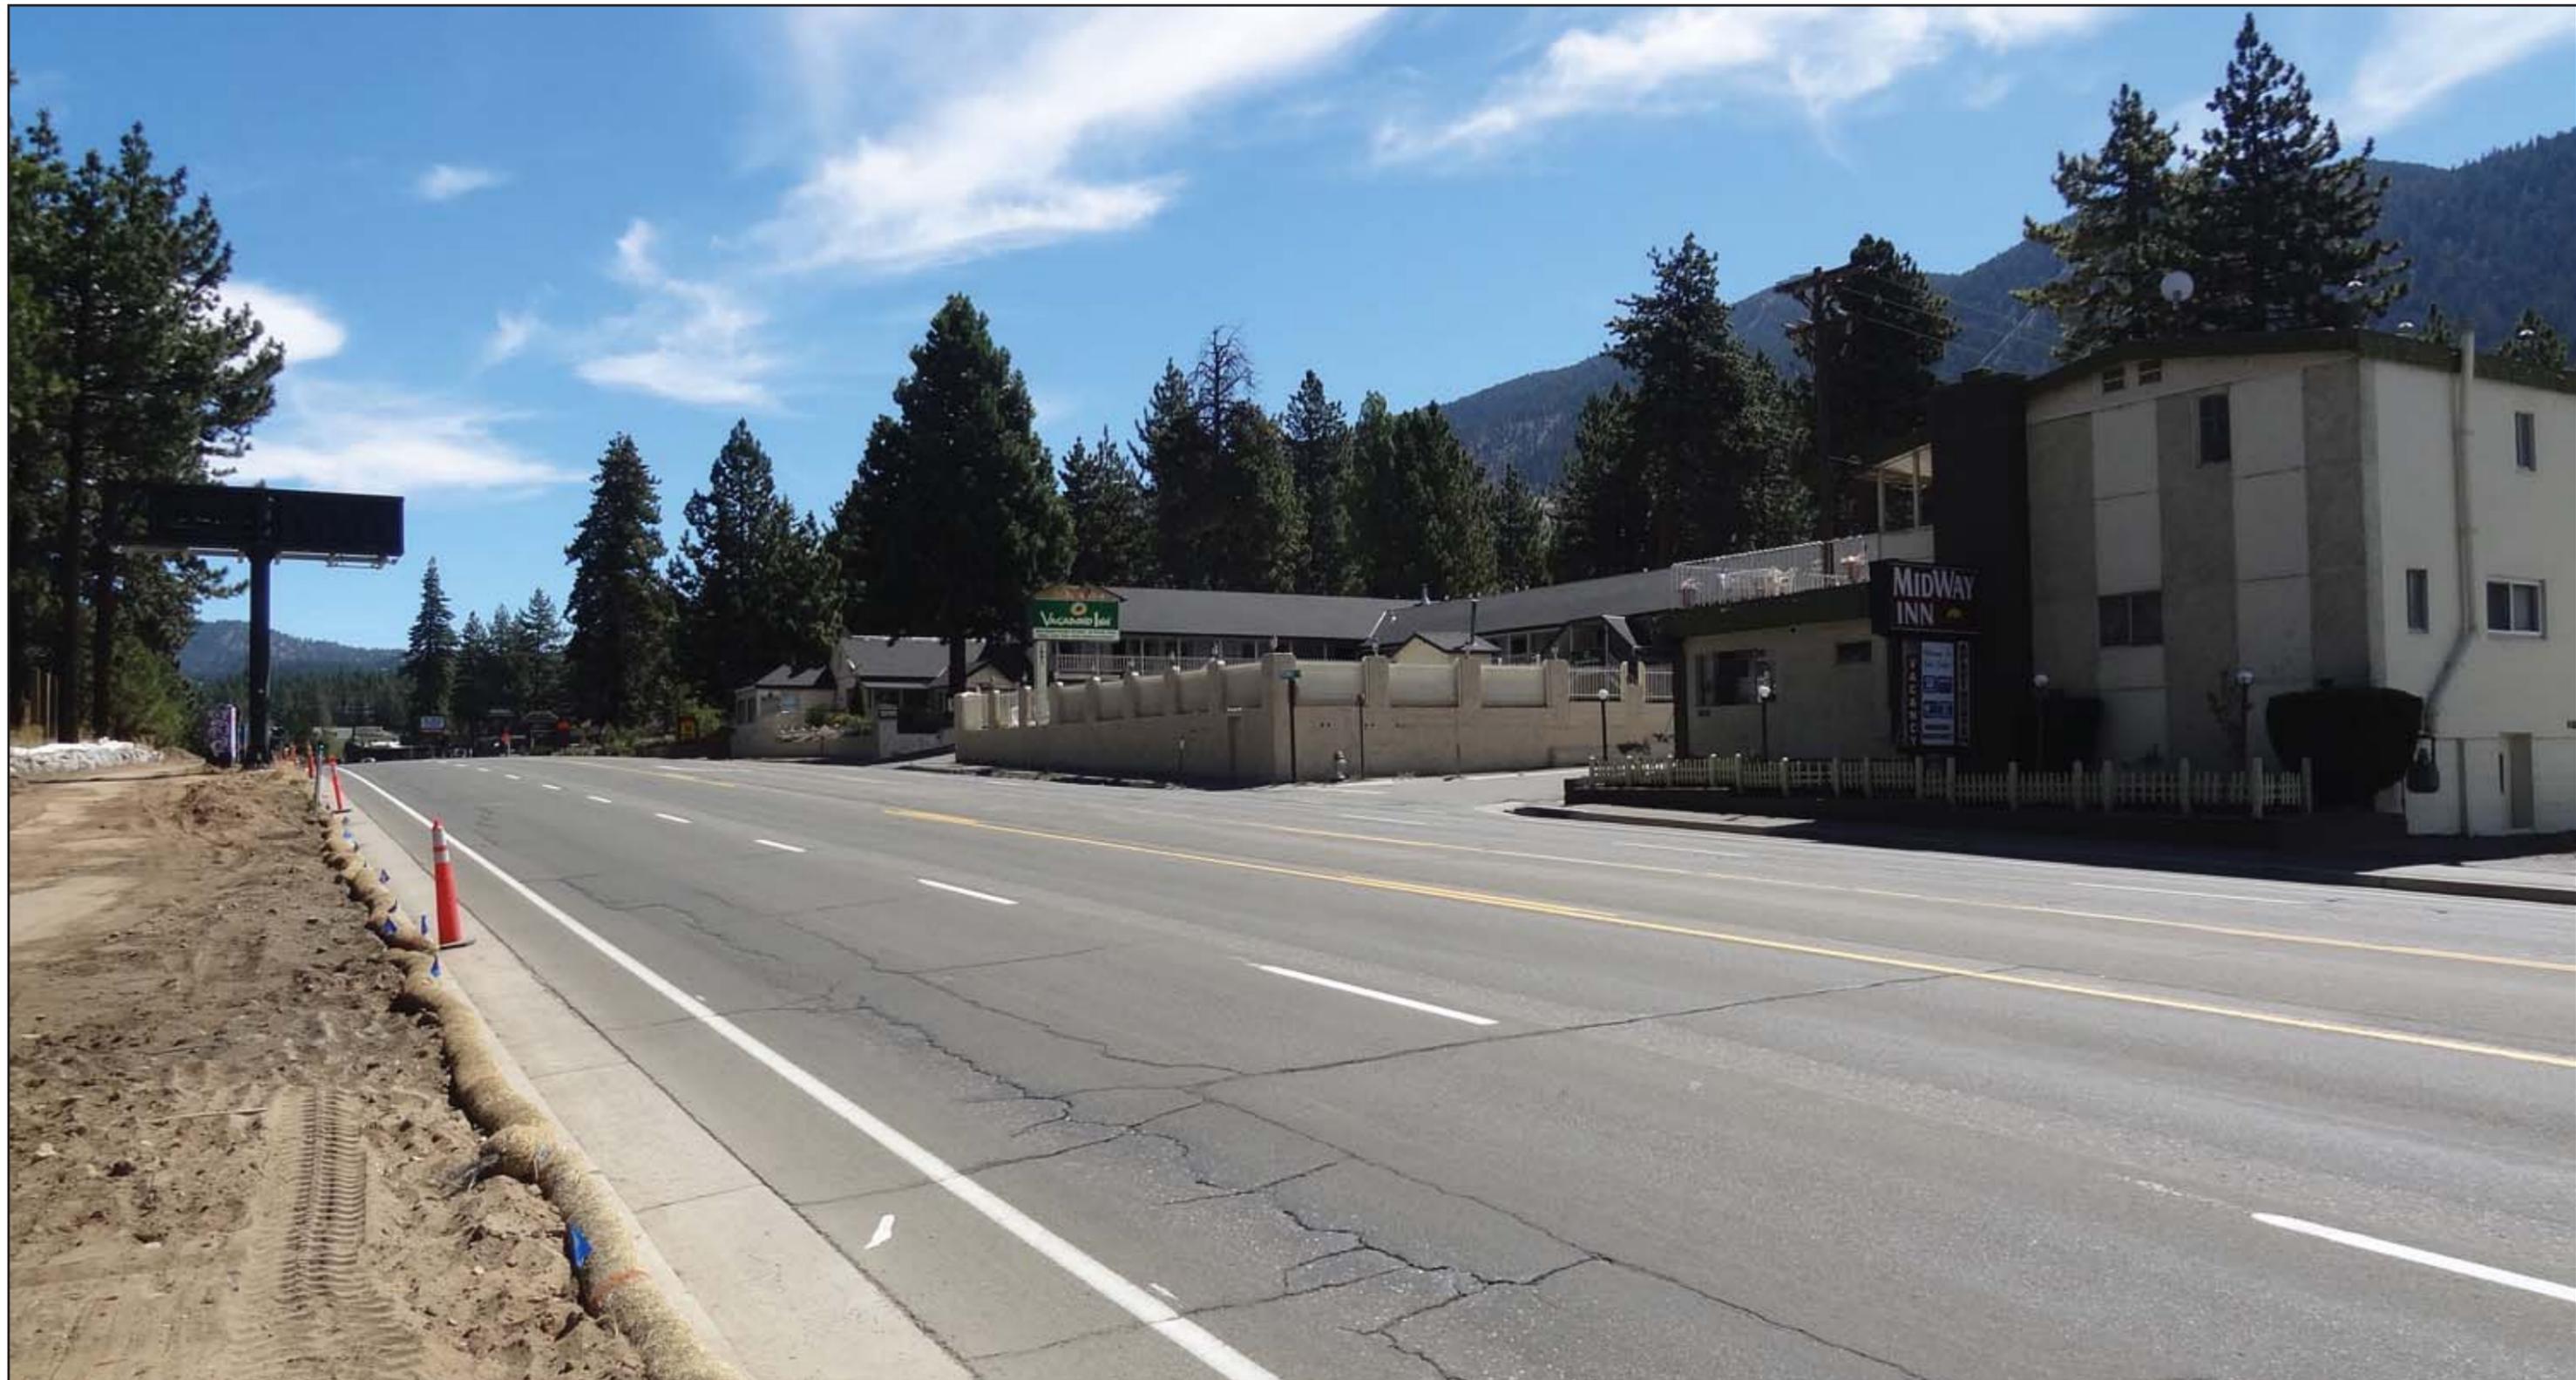
FIGURE 16

Viewpoint 9 is located along U.S. 50 south of Midway Road looking northeast. Figure 16: Viewpoint 9 Existing Conditions shows the existing visual conditions of the area along U.S. 50 as seen by motorists and bicyclists on the southern end of the Project footprint.

This viewpoint does not provide any features with dominant vividness. Colors and texture of the manmade features are duller than the coniferous trees and mountains in the backdrop of this viewpoint. Vividness at this viewpoint is rated 3.00. The manmade and natural features are for the most part visually intact. Some visual encroachment of the coniferous trees and mountains in the background occur due to the height and mass of the existing lodging structures at this viewpoint. Intactness at this viewpoint is rated at 3.00. The scale and form of the manmade features at this viewpoint blend with the scale and form of the coniferous trees and mountains in the background. Unity at this viewpoint is rated 3.00.
