**Draft Visual Impact Assessment – US
50/South Shore Community
Revitalization Project**

U.S. 50/South Shore Community Revitalization Project

South Lake Tahoe, California / Stateline, Nevada

**Draft Visual Impact Assessment (VIA) For
U.S. 50/South Shore Community Revitalization Project**

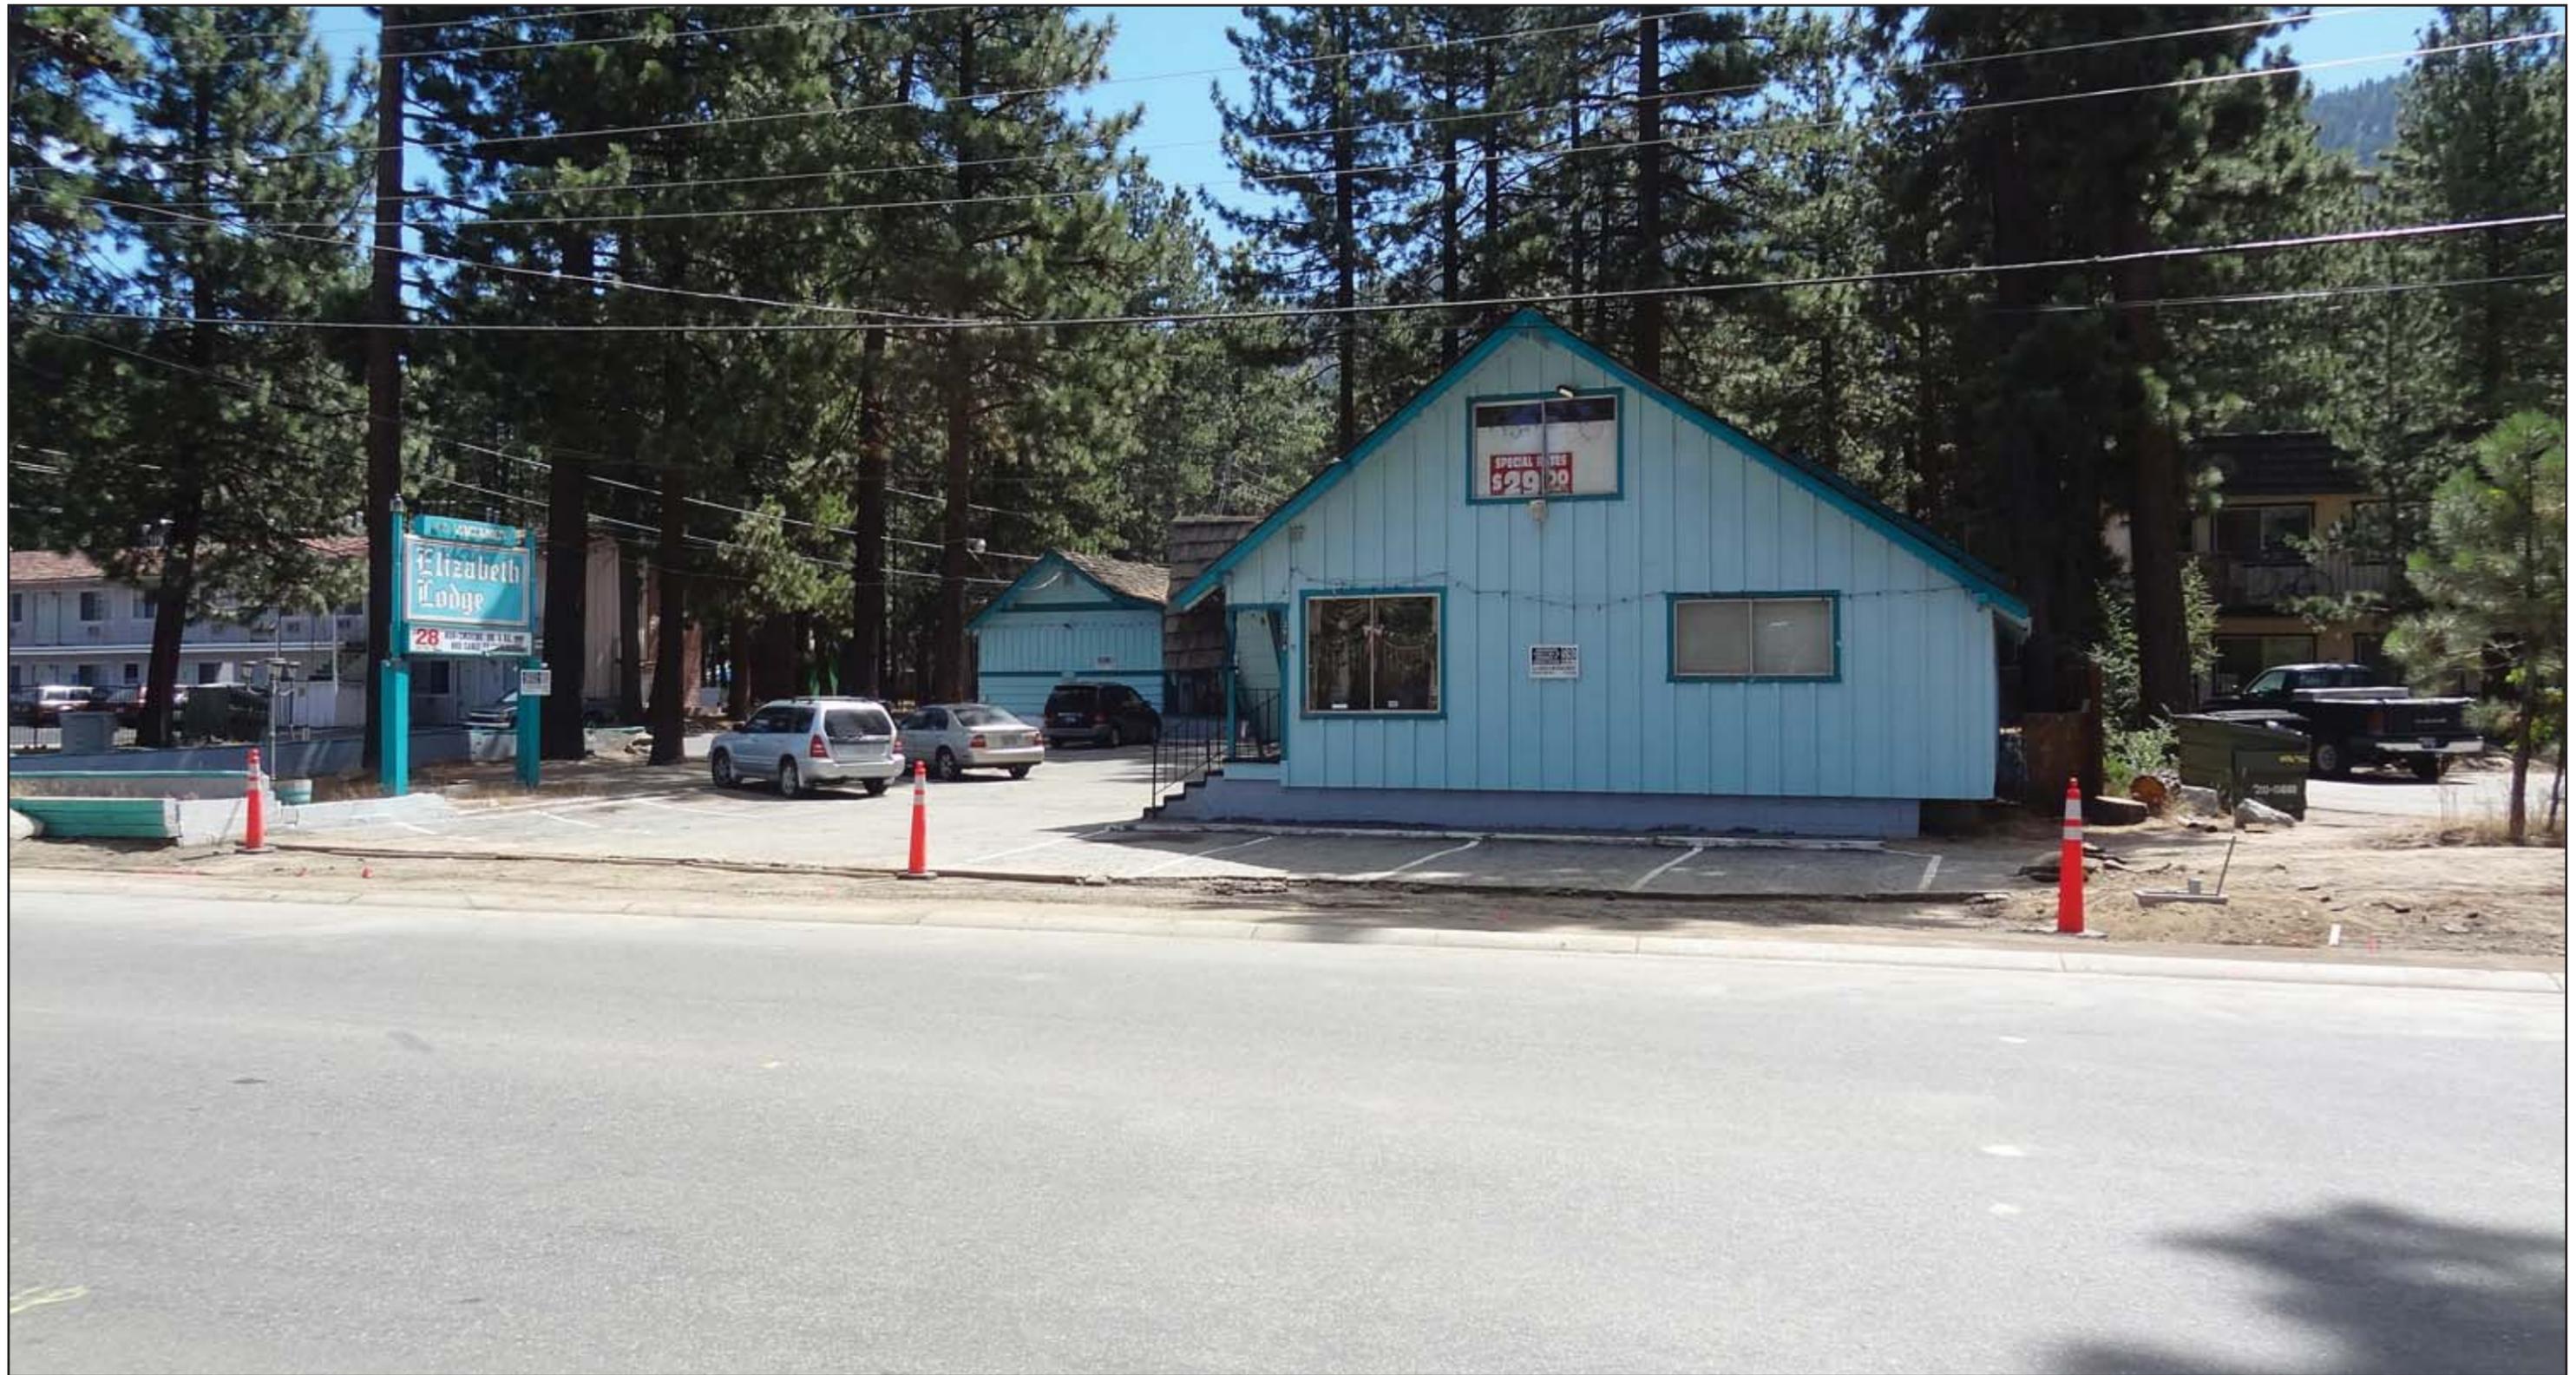
FIGURE 17

Viewpoint 10 is located just south of the intersection of Pioneer Trail and Moss Road looking northeast. Figure 17: Viewpoint 10 Existing Conditions shows the existing visual conditions at this viewpoint as seen by motorists and bicyclists.

With the exception of the lodging building at the center of this viewpoint, most of the manmade features at this viewpoint are painted colors that blend with the coniferous trees and, therefore, none of the visual elements stand out to the viewer. This viewpoint lacks true vivid landforms as the topography is flat. The lodging building at the center of this viewpoint provides the most vivid element due to its sky blue color. Vividness of this viewpoint is rated 1.33. This viewpoint contains a mix of manmade and natural features and a visual pattern is not readily identifiable. The coniferous trees intermingled between the manmade uses encroach on views of the distant mountains in the background. Intactness for this viewpoint is rated 3.00. The manmade buildings are intermingled among coniferous trees; however, this viewpoint is chaotic, jumbled, and confusing and has a moderately low visual unity. Unity for this viewpoint is rated 2.00. Based on the individual scores of vividness, intactness, and unity, the overall visual quality rating at this viewpoint under existing conditions is *Moderately Low* and rated **2.11**.

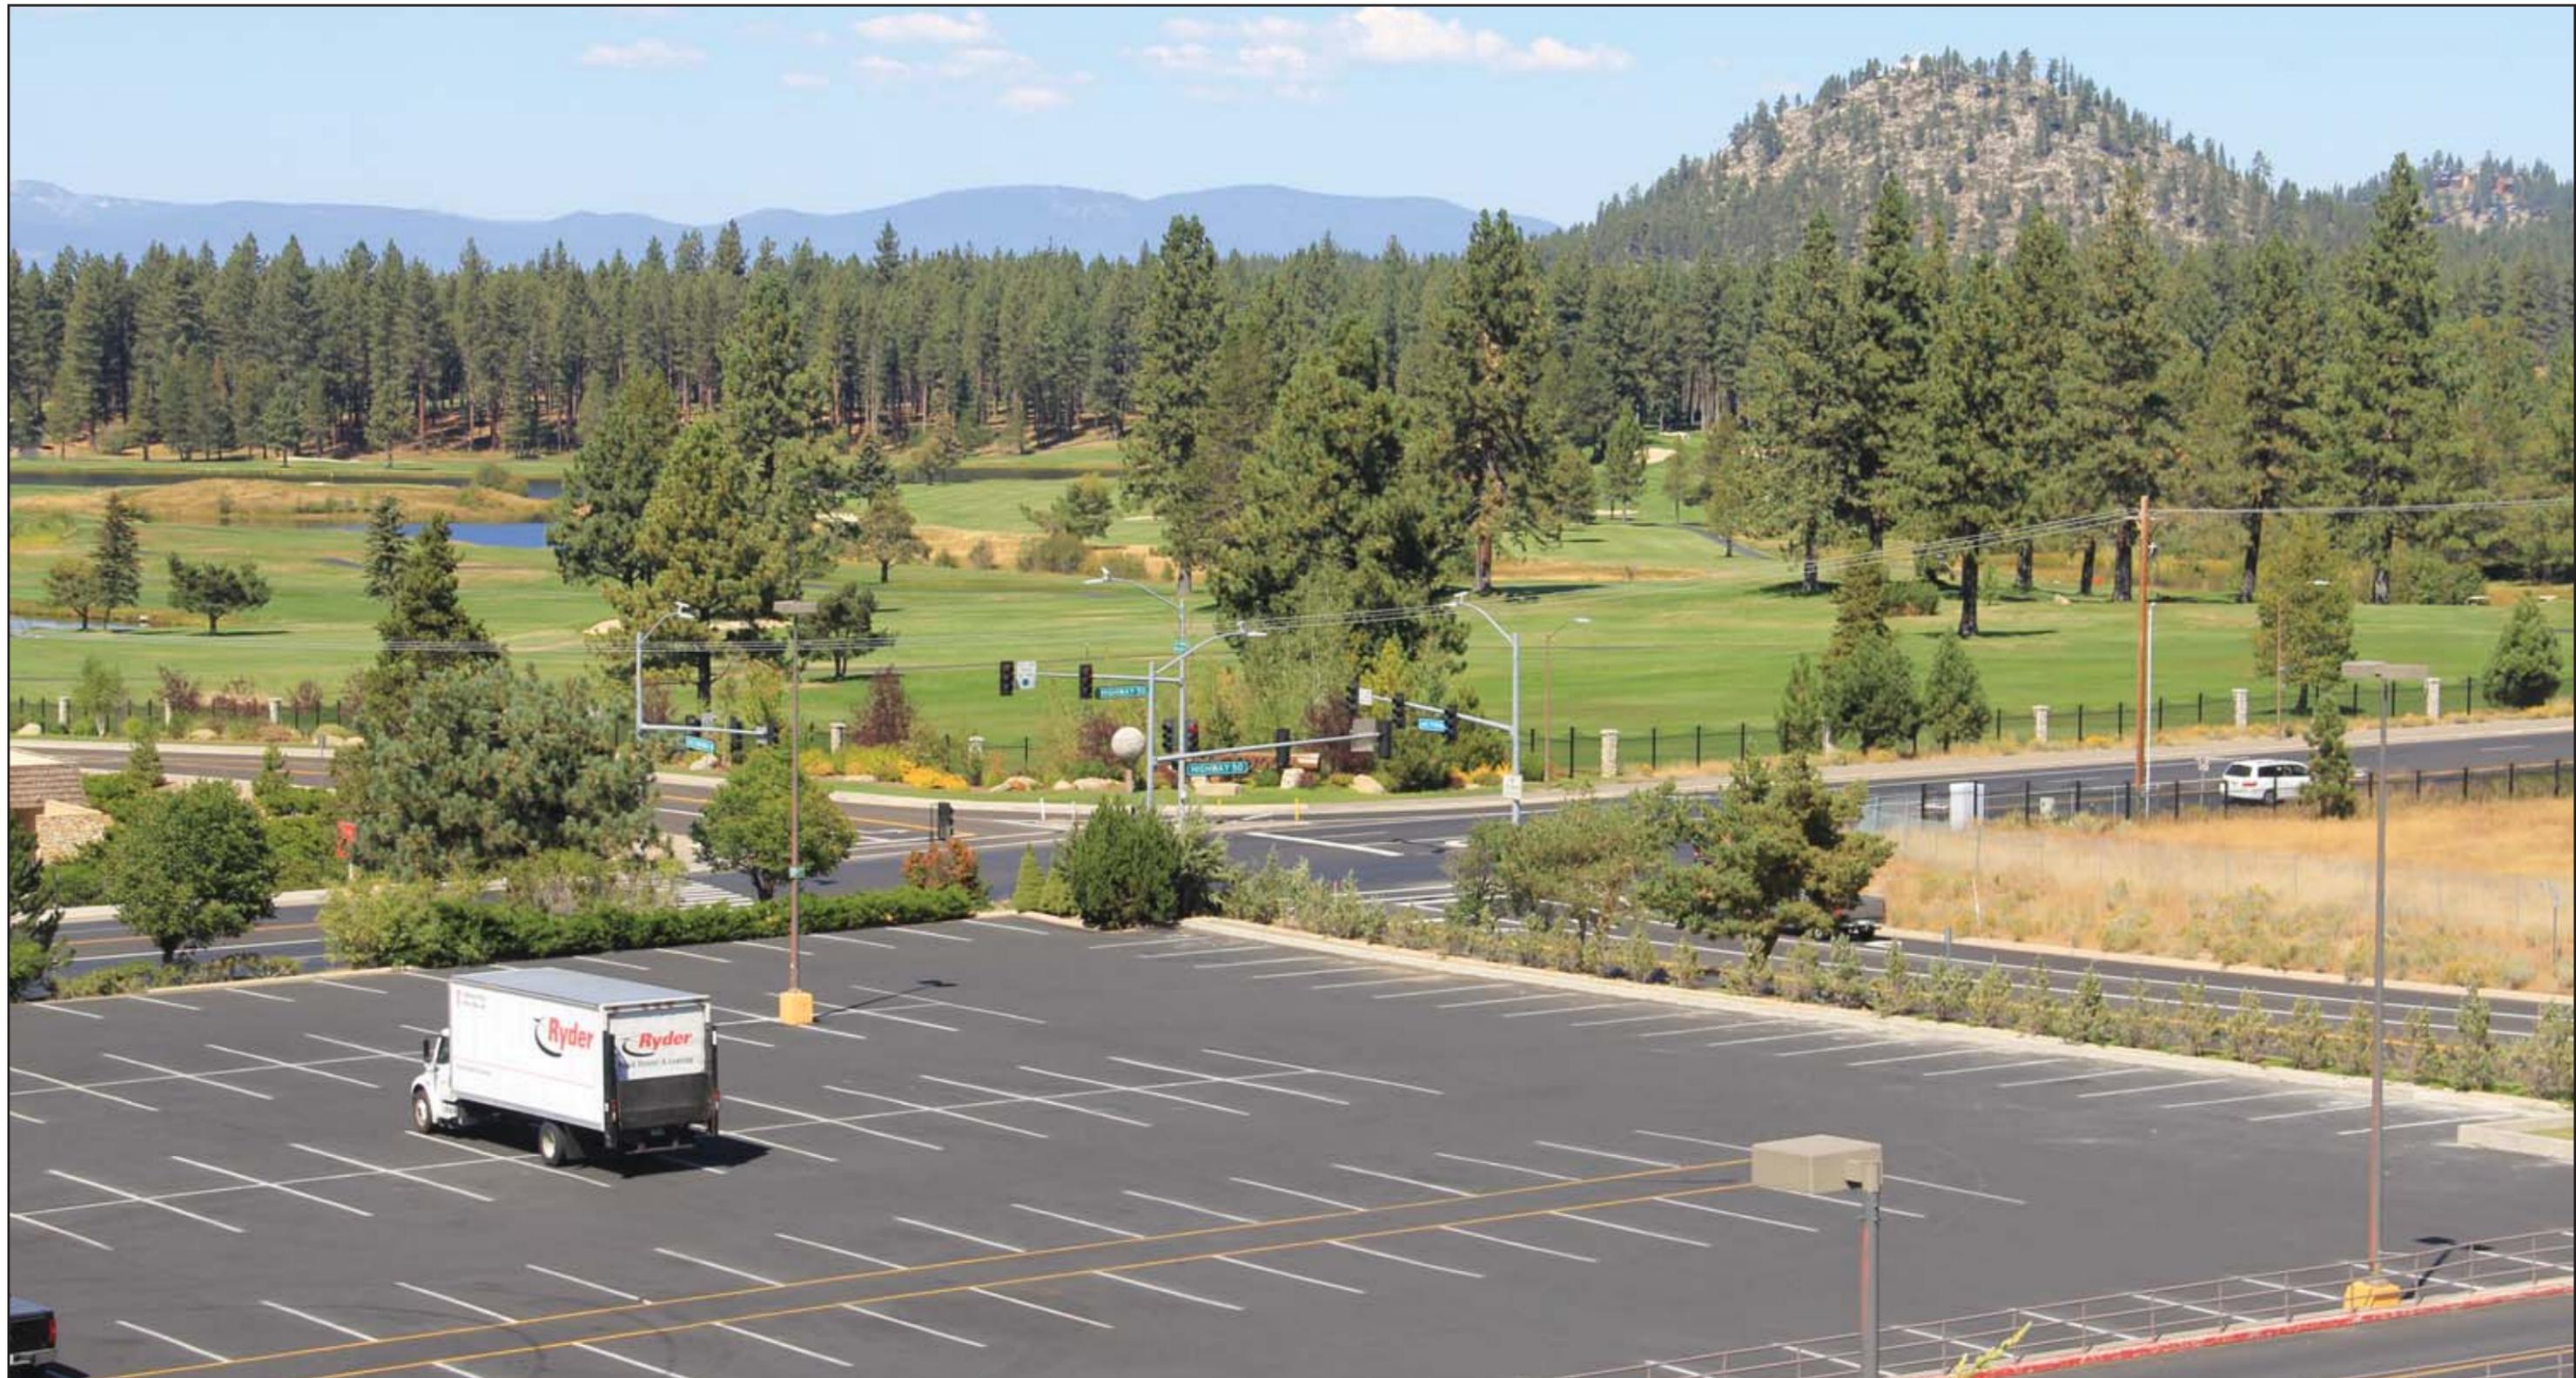
FIGURE 18

Viewpoint 11 is located toward the northern end of the Project area on the Montbleu Hotel/Casino parking structure adjacent to Lake Parkway looking toward the northwest. Figure 18: Viewpoint 11 Existing Conditions shows the existing visual conditions as seen by pedestrians and tourists at this viewpoint.

The natural features are the major elements of vividness at this viewpoint. The grass of the golf course, ponds, natural grasses, and coniferous trees provide a memorable visual impression of the natural landscape at this viewpoint. The coniferous forest, mountains, and tree/rock outcropping covered hills add to the vividness of this viewpoint. Vividness at this viewpoint under existing conditions was rated at 4.00. This viewpoint provides views of manmade and natural features. There is a distinct line of where the manmade features end and where the natural features begin. The manmade features (such as light poles from the surface parking lot, signals at the U.S. 50/Lake Parkway intersection, and utility/poles lines) do not encroach on the natural landscape in the middle- and background at this viewpoint. Intactness for this viewpoint is rated at 5.50. The visual resources of the manmade features do not impede on the visual resources of the natural features. The manmade and natural features form a moderately high coherent, harmonious visual pattern. Unity at this viewpoint is rated at 5.50. Based on the individual scores of vividness, intactness, and unity, the overall visual quality rating at this viewpoint under existing conditions is ***Moderately High*** and rated **5.00**.

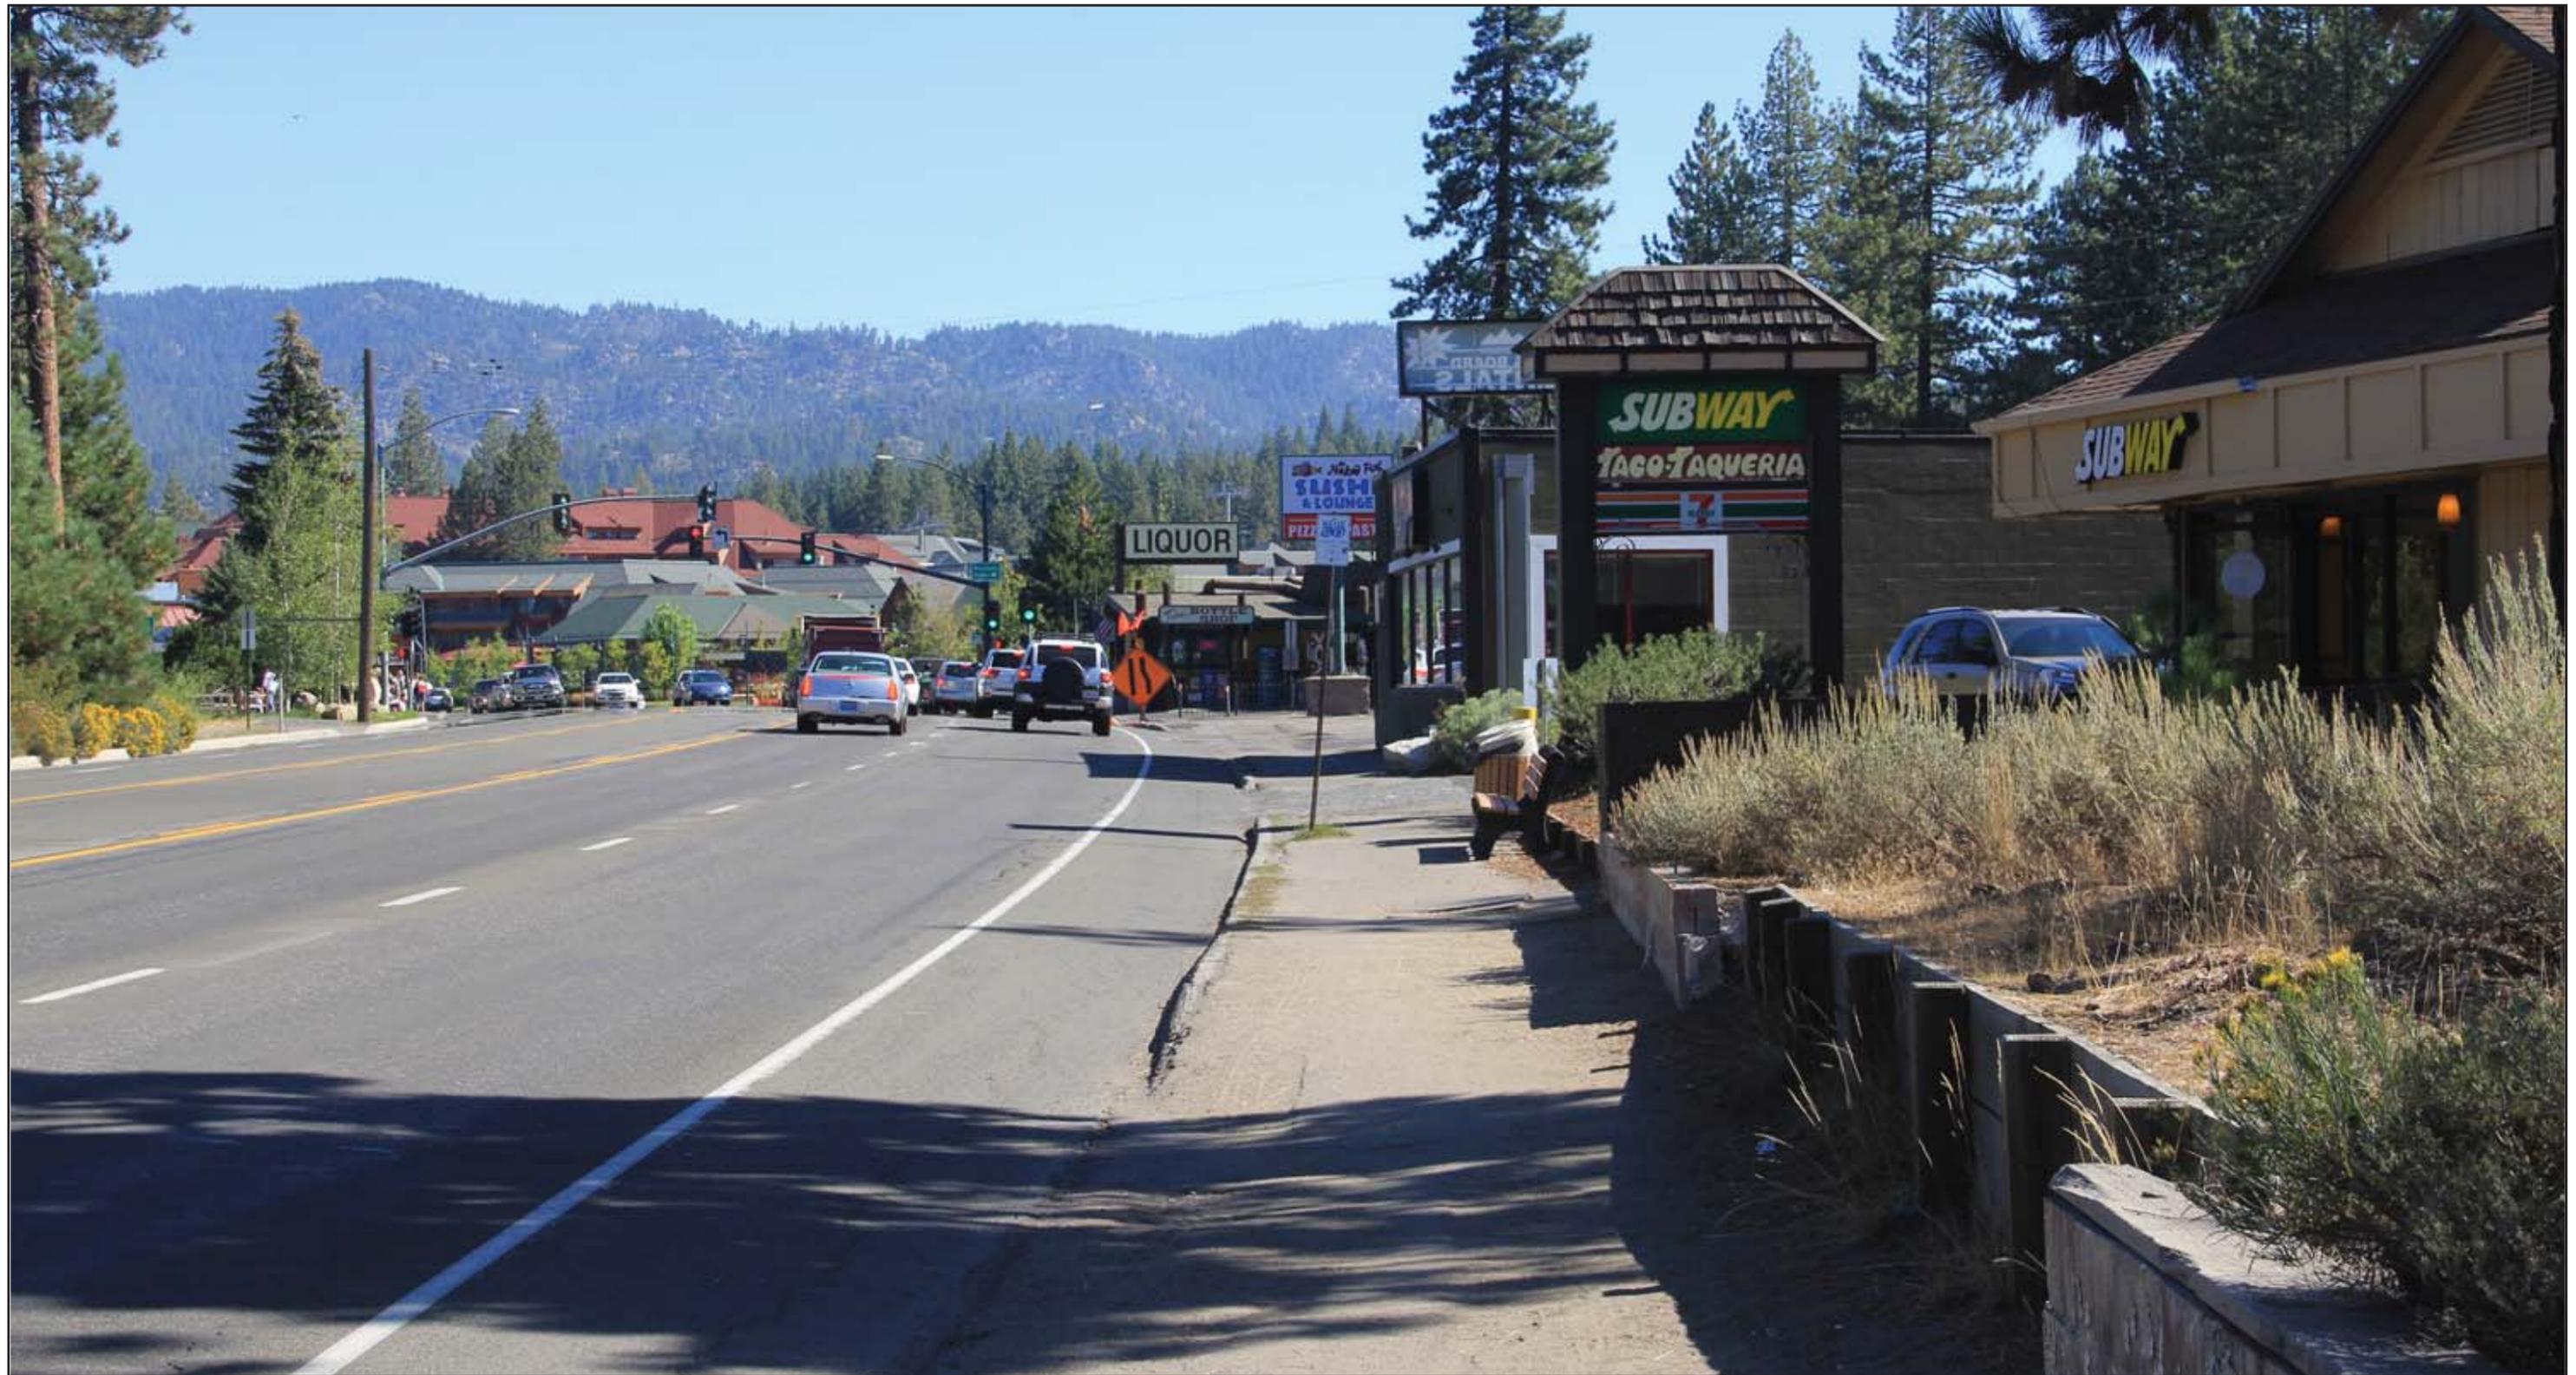
FIGURE 19

Viewpoint 12 is located along U.S. 50 between Pioneer Trail and Midway Road looking northeast. Figure 19: Viewpoint 12 Existing Conditions shows the existing visual conditions as seen by motorists and bicyclists from this viewpoint.

A visual quality assessment was performed for the existing conditions at this viewpoint. The visual impression of this viewpoint is not memorable as views are of an urbanized area backdropped by coniferous trees and mountains covered in vegetation. The landscape elements do not combine to form a striking and distinctive visual pattern; therefore, vividness of this viewpoint was rated at 3.67. This viewpoint has some visual order between the urbanized and natural landscape. The background provides a distinct line of where the urbanized uses stop and the natural landscape begins. Visual encroachment of the urbanized uses into the natural setting is nearly absent as views of the mountains and coniferous forest are visible in the background. Intactness of the natural and manmade landscape at this viewpoint is present; therefore, intactness of this viewpoint was rated at 2.50. The manmade landscape at this viewpoint includes natural landscape elements intermingled between buildings and along the sides of the roadway. The inter-compatibility between the manmade and natural landscape is present; therefore, the unity of this viewpoint was rated at 3.50. Based on the individual scores of vividness, intactness, and unity, the overall visual quality rating at this viewpoint under existing conditions is ***Moderate*** and rated **3.22**.

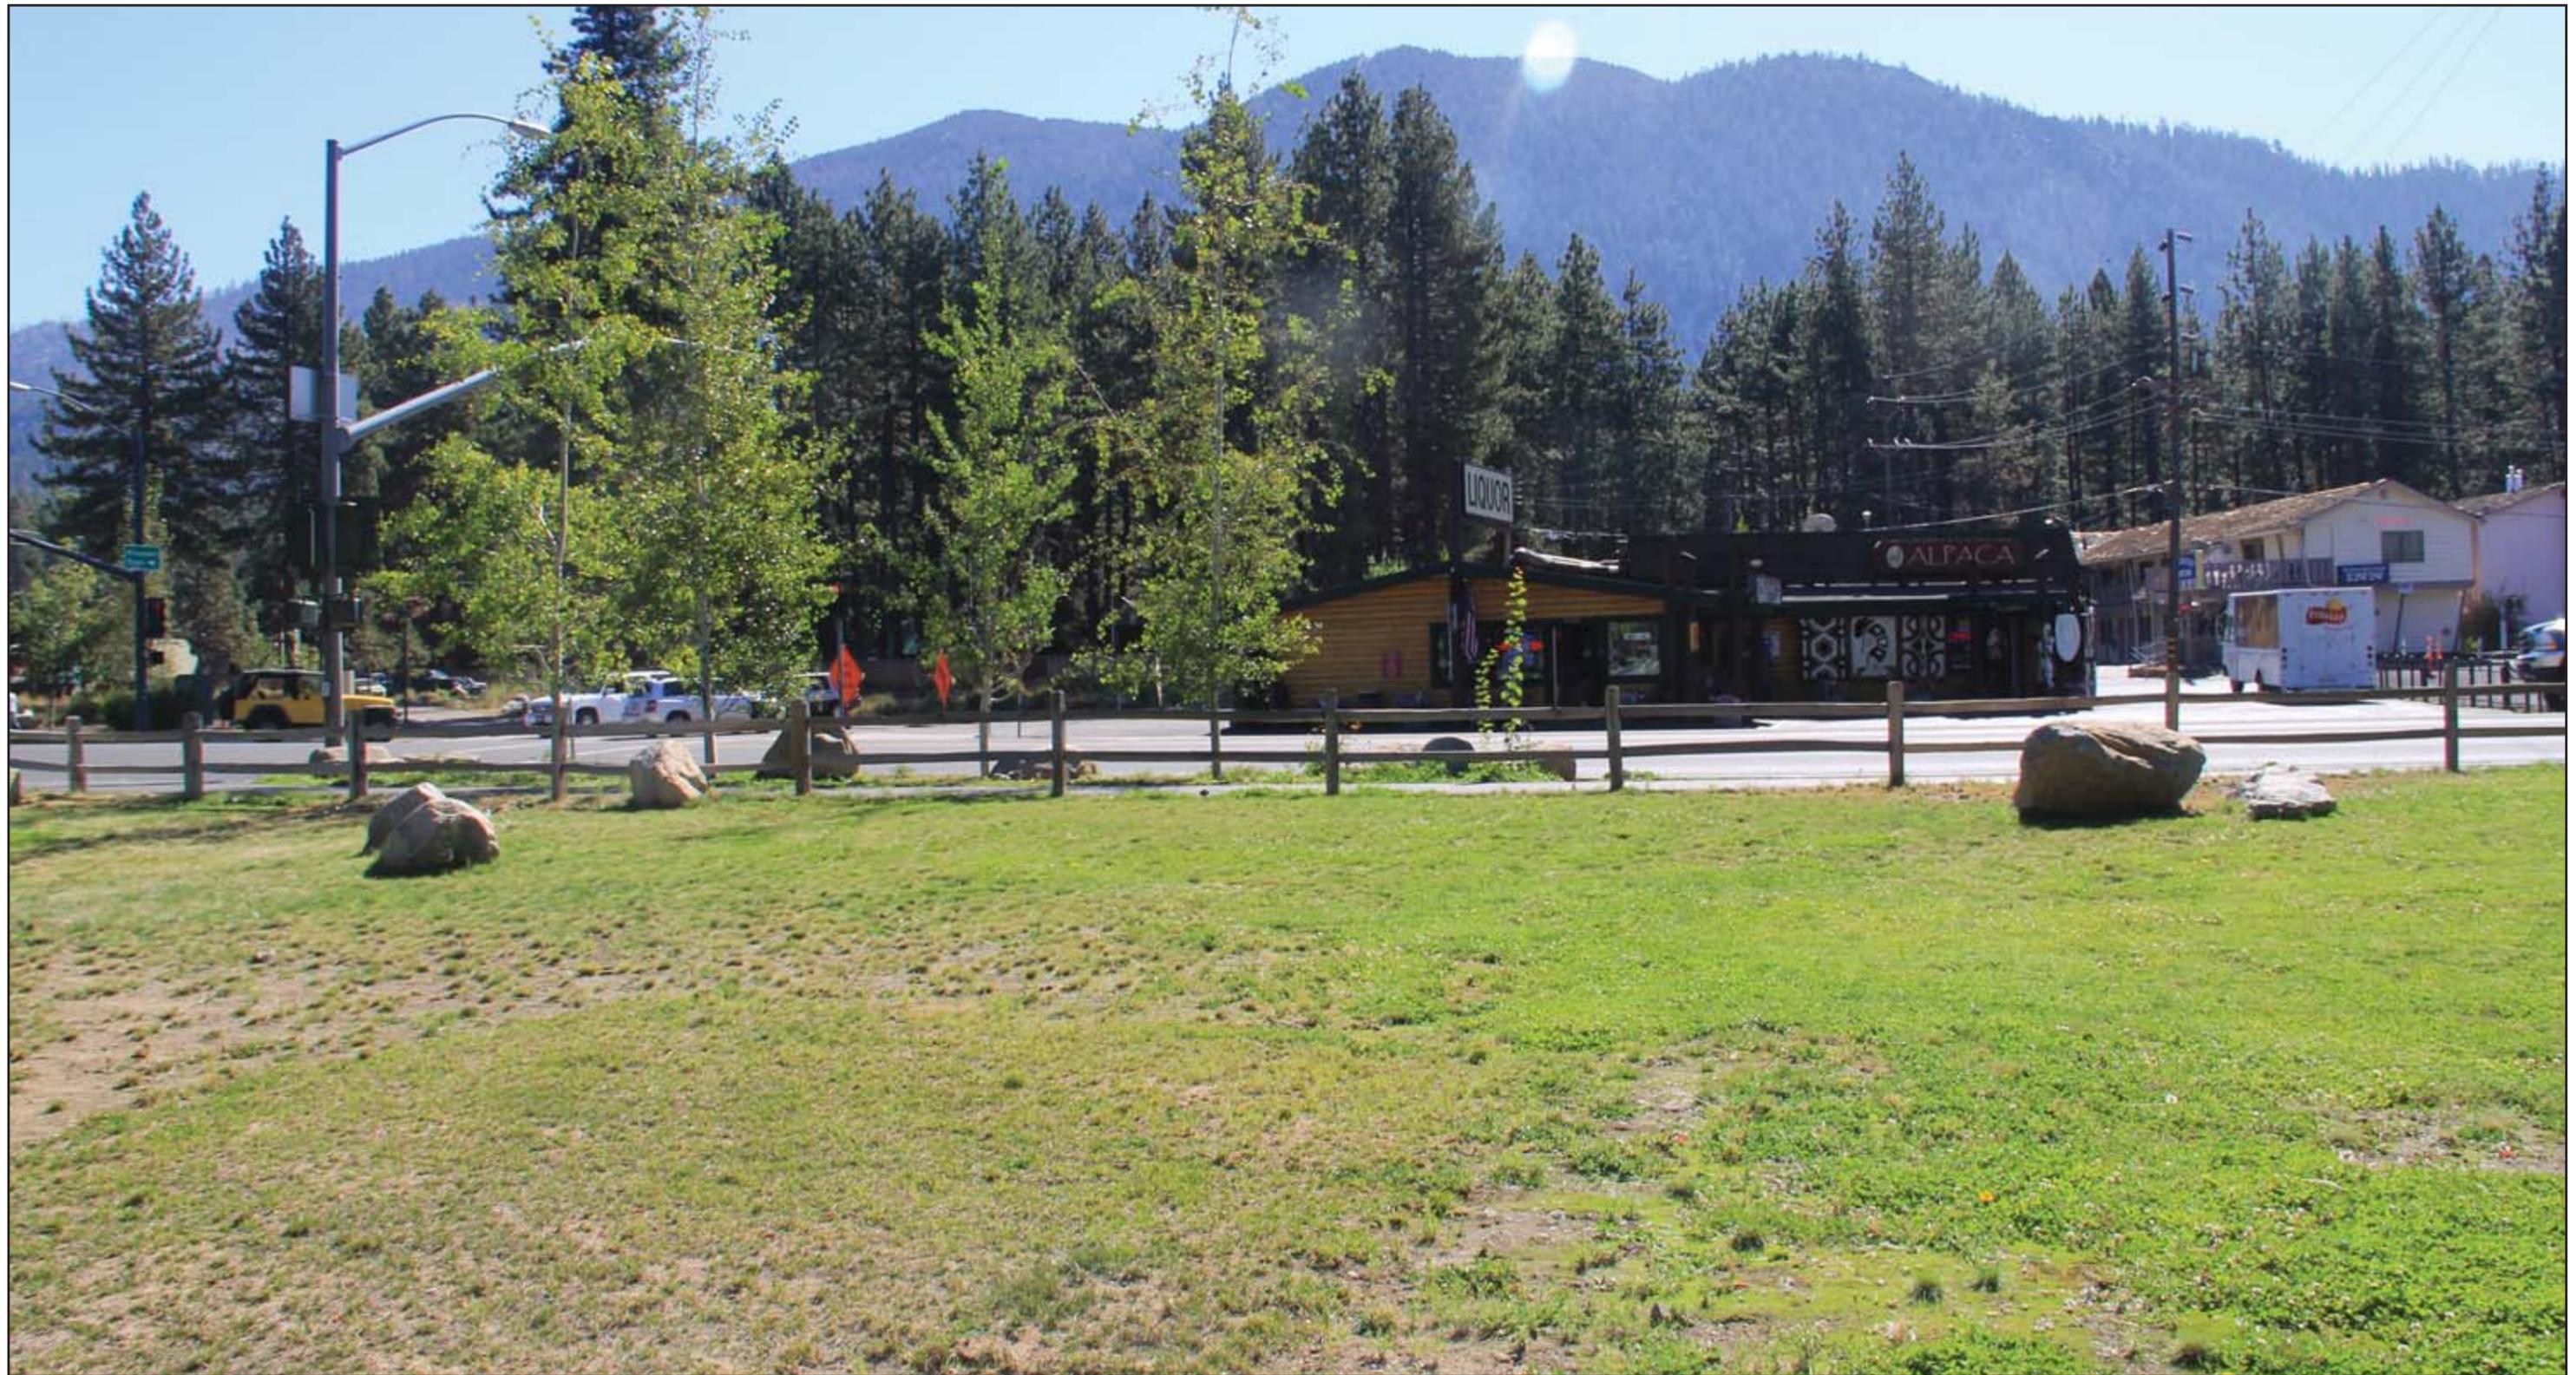
FIGURE 20

Viewpoint 13 is located in a vacant area looking east toward the Pioneer Trail/U.S. 50 intersection. Figure 20: Viewpoint 13 Existing Conditions shows the existing visual conditions as seen by pedestrians and tourists from this viewpoint.

Viewpoint 13 Existing Conditions

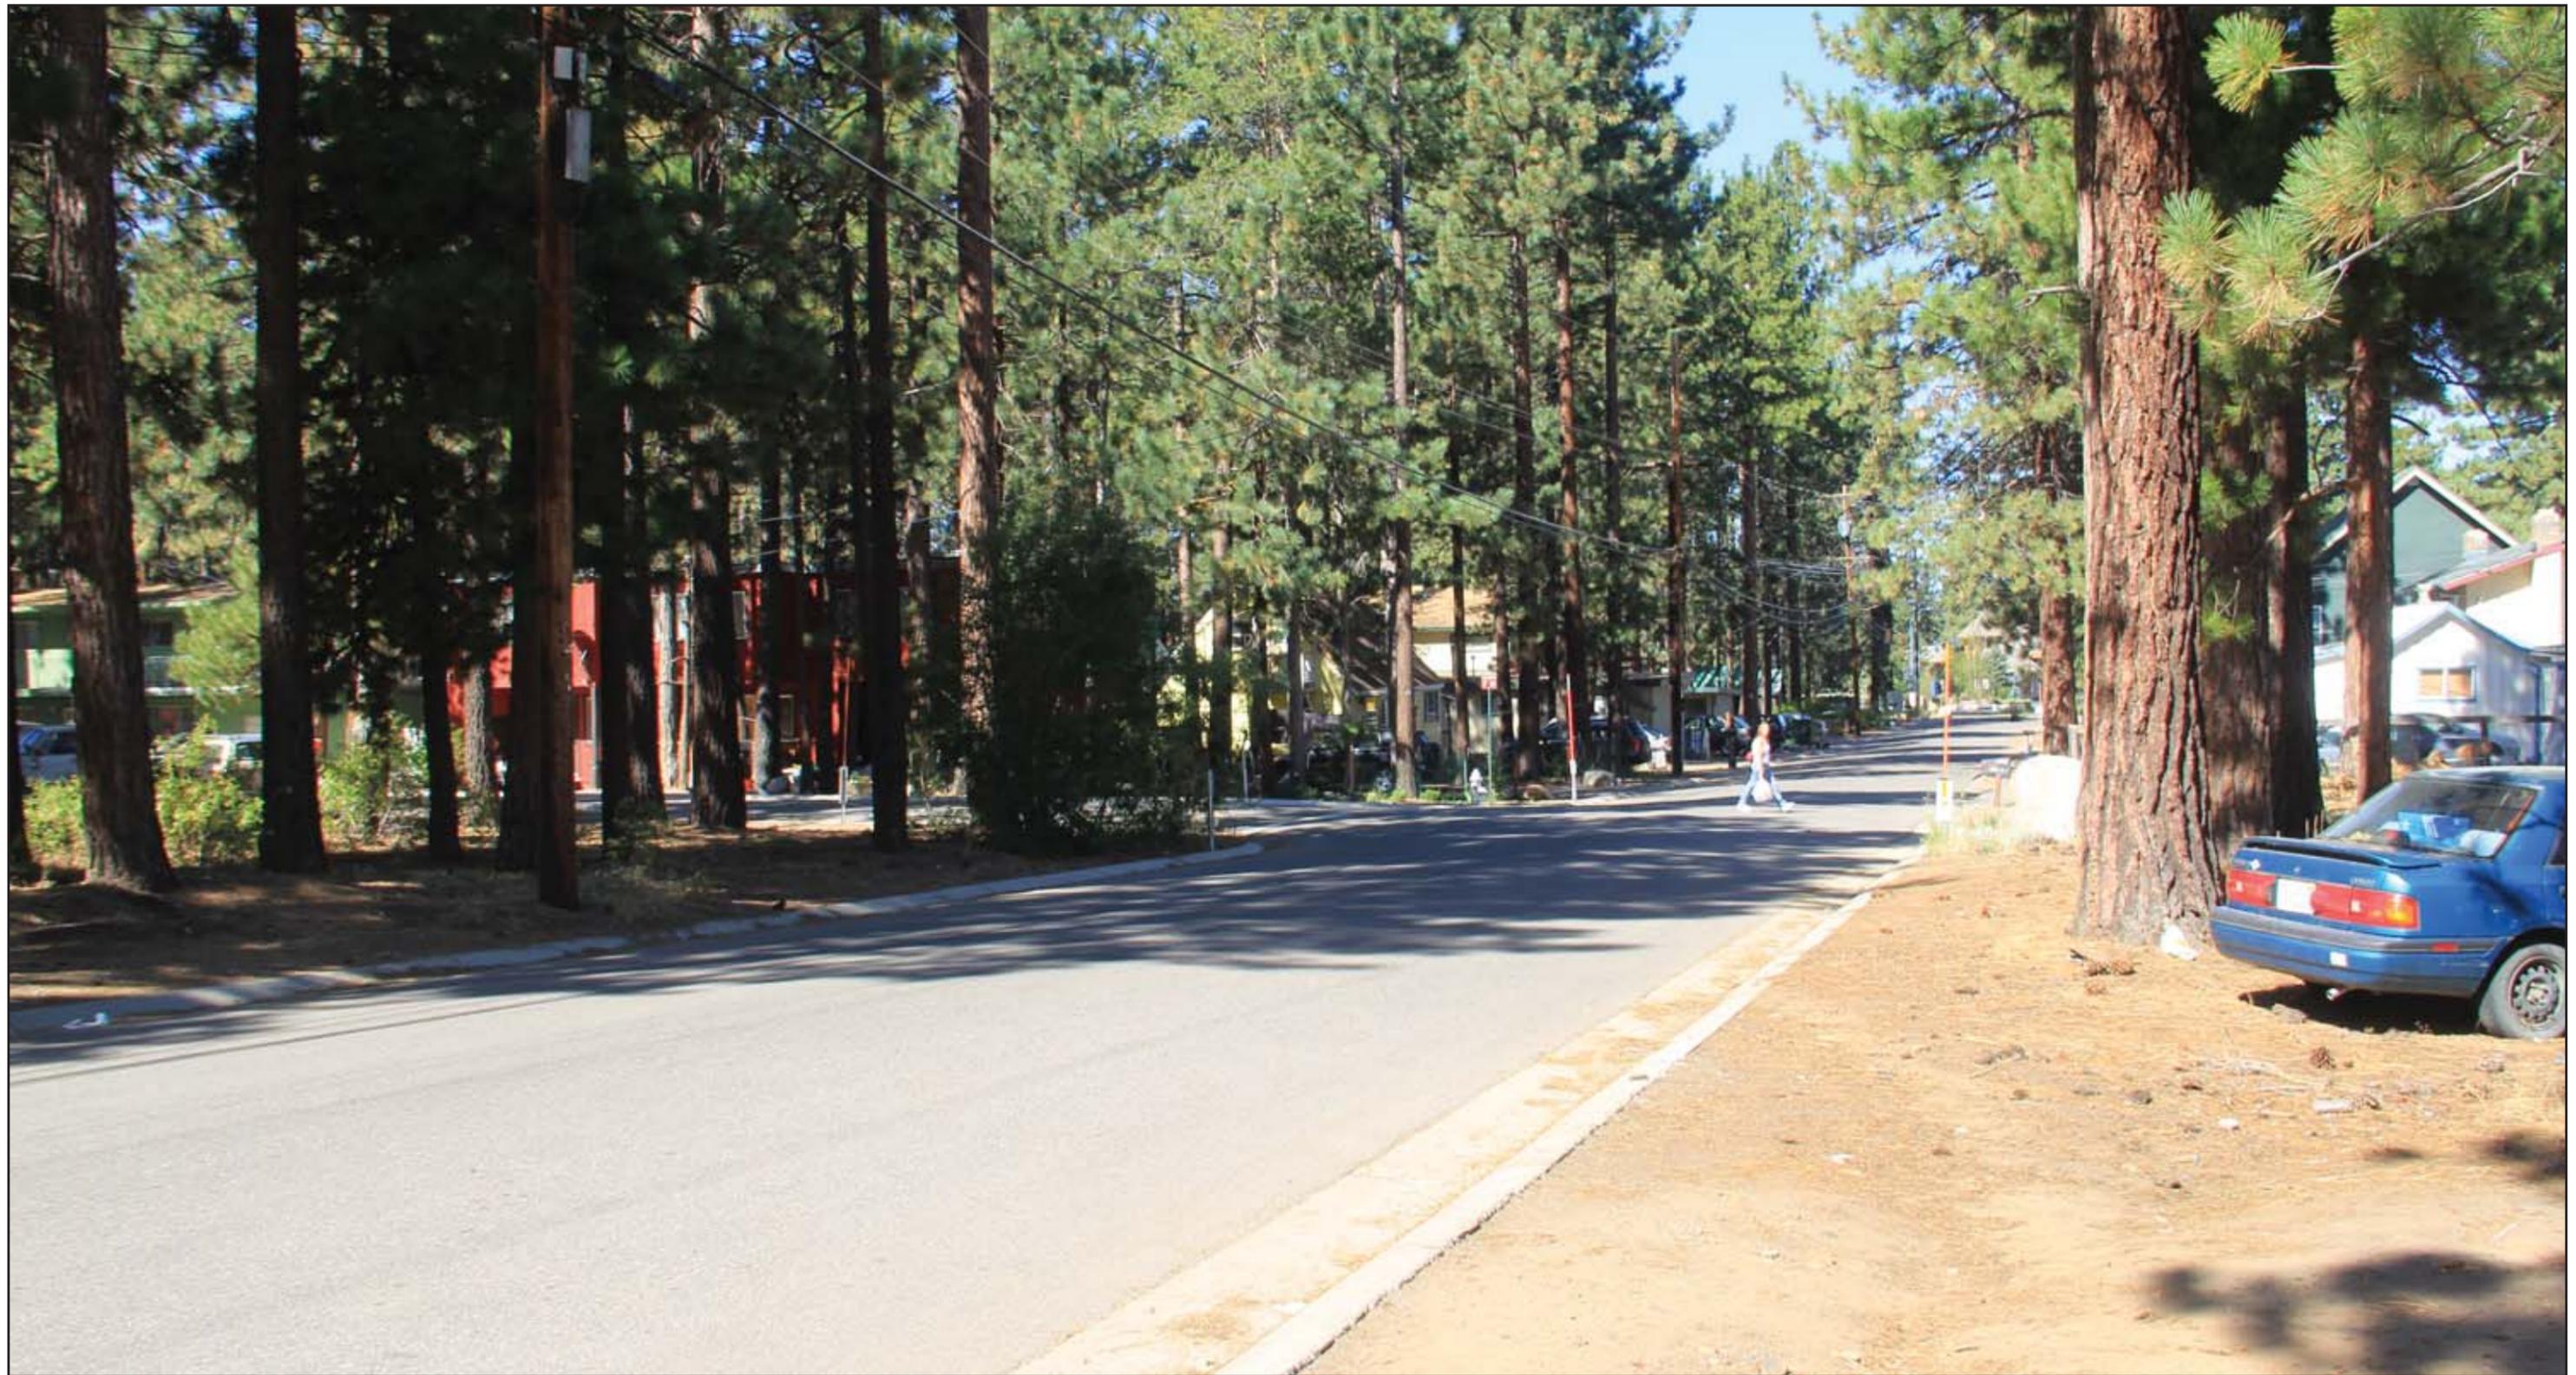
FIGURE 21

Viewpoint 14 is located along Fern Road looking northwest. Figure 21: Viewpoint 14 Existing Conditions shows the existing visual conditions as seen by motorists and bicyclists from this viewpoint.

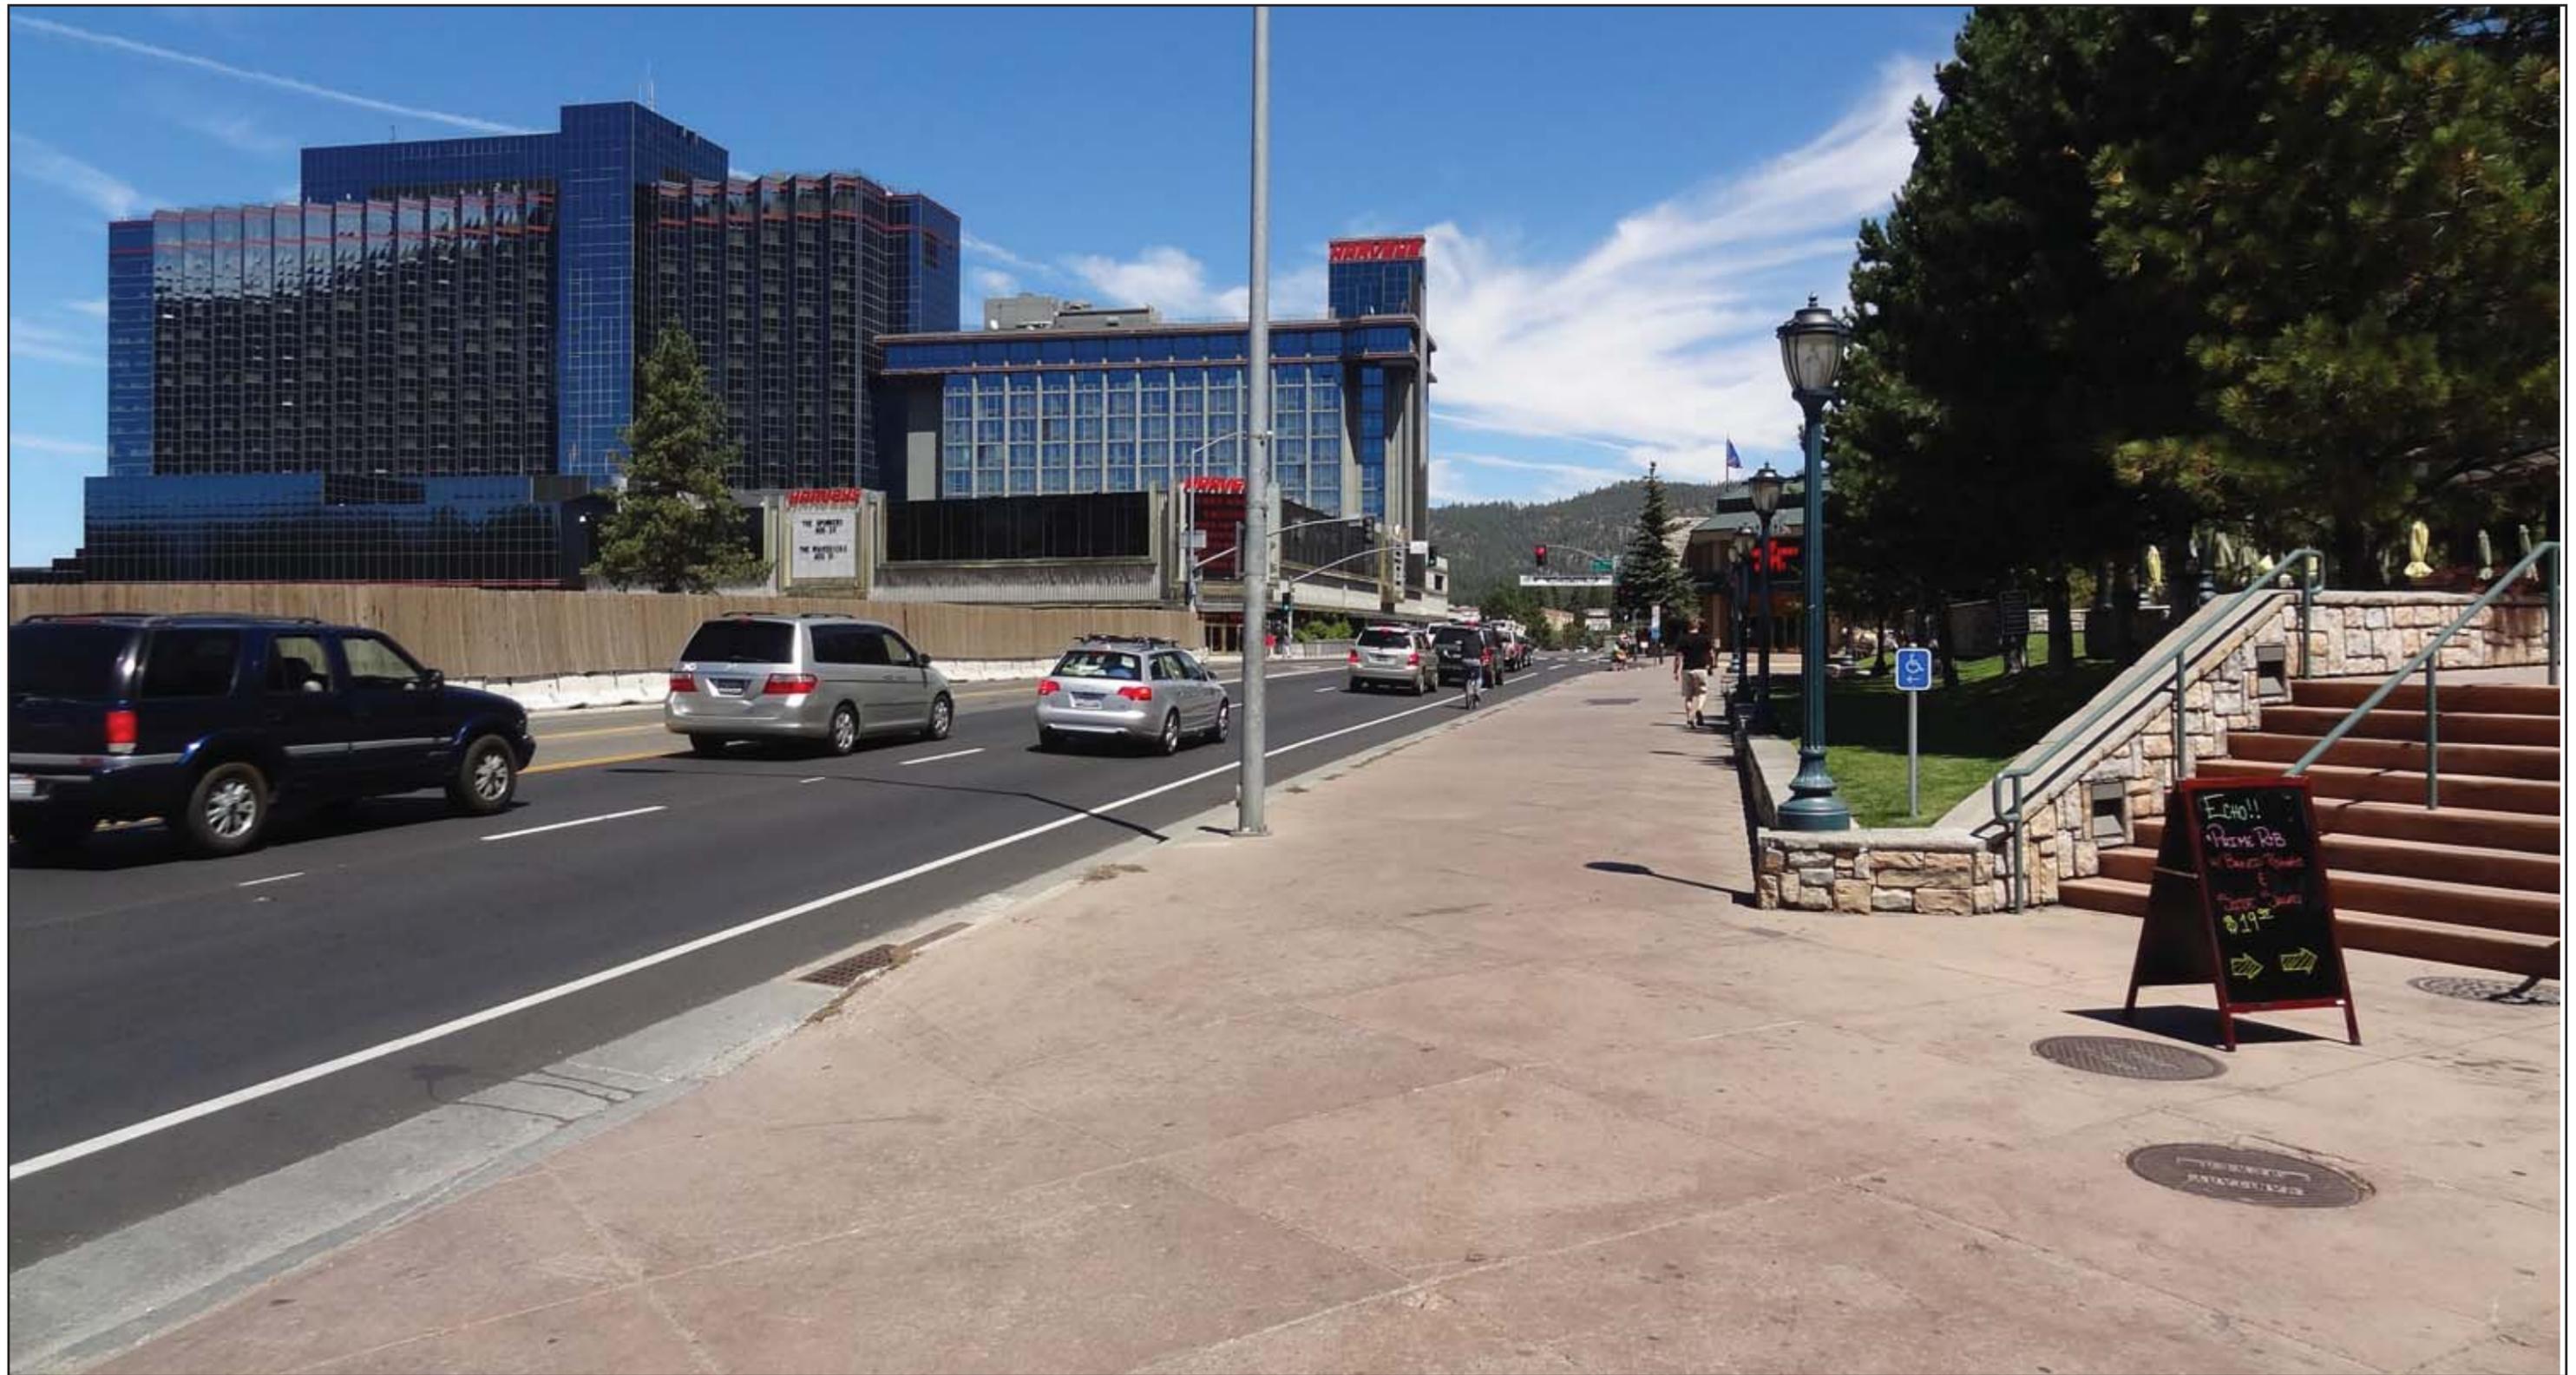
FIGURE 22

Viewpoint 15 is located at the intersection of Transit Way and U.S. 50 looking northeast toward the center of the Casino Corridor of Stateline. Figure 22: Viewpoint 15 Existing Conditions shows the existing visual conditions as seen by motorists and bicyclists at this viewpoint.

This viewpoint is characterized by urbanized uses. The foreground offers views of U.S. 50, a wide sidewalk (on the eastern side of U.S. 50), street lights, decorative light standards, decorative walls, ornamental vegetation (grass and trees). The middleground of Viewpoint 15 provides views of the continuation of U.S. 50, mid-rise buildings associated with the hotels/casinos of the Casino Corridor in Stateline. The colors of the buildings are blue, white, and red and blend in with the skyline in the background.
