**Draft Visual Impact Assessment – US
50/South Shore Community
Revitalization Project**

U.S. 50/South Shore Community Revitalization Project

South Lake Tahoe, California / Stateline, Nevada

**Draft Visual Impact Assessment (VIA) For
U.S. 50/South Shore Community Revitalization Project**

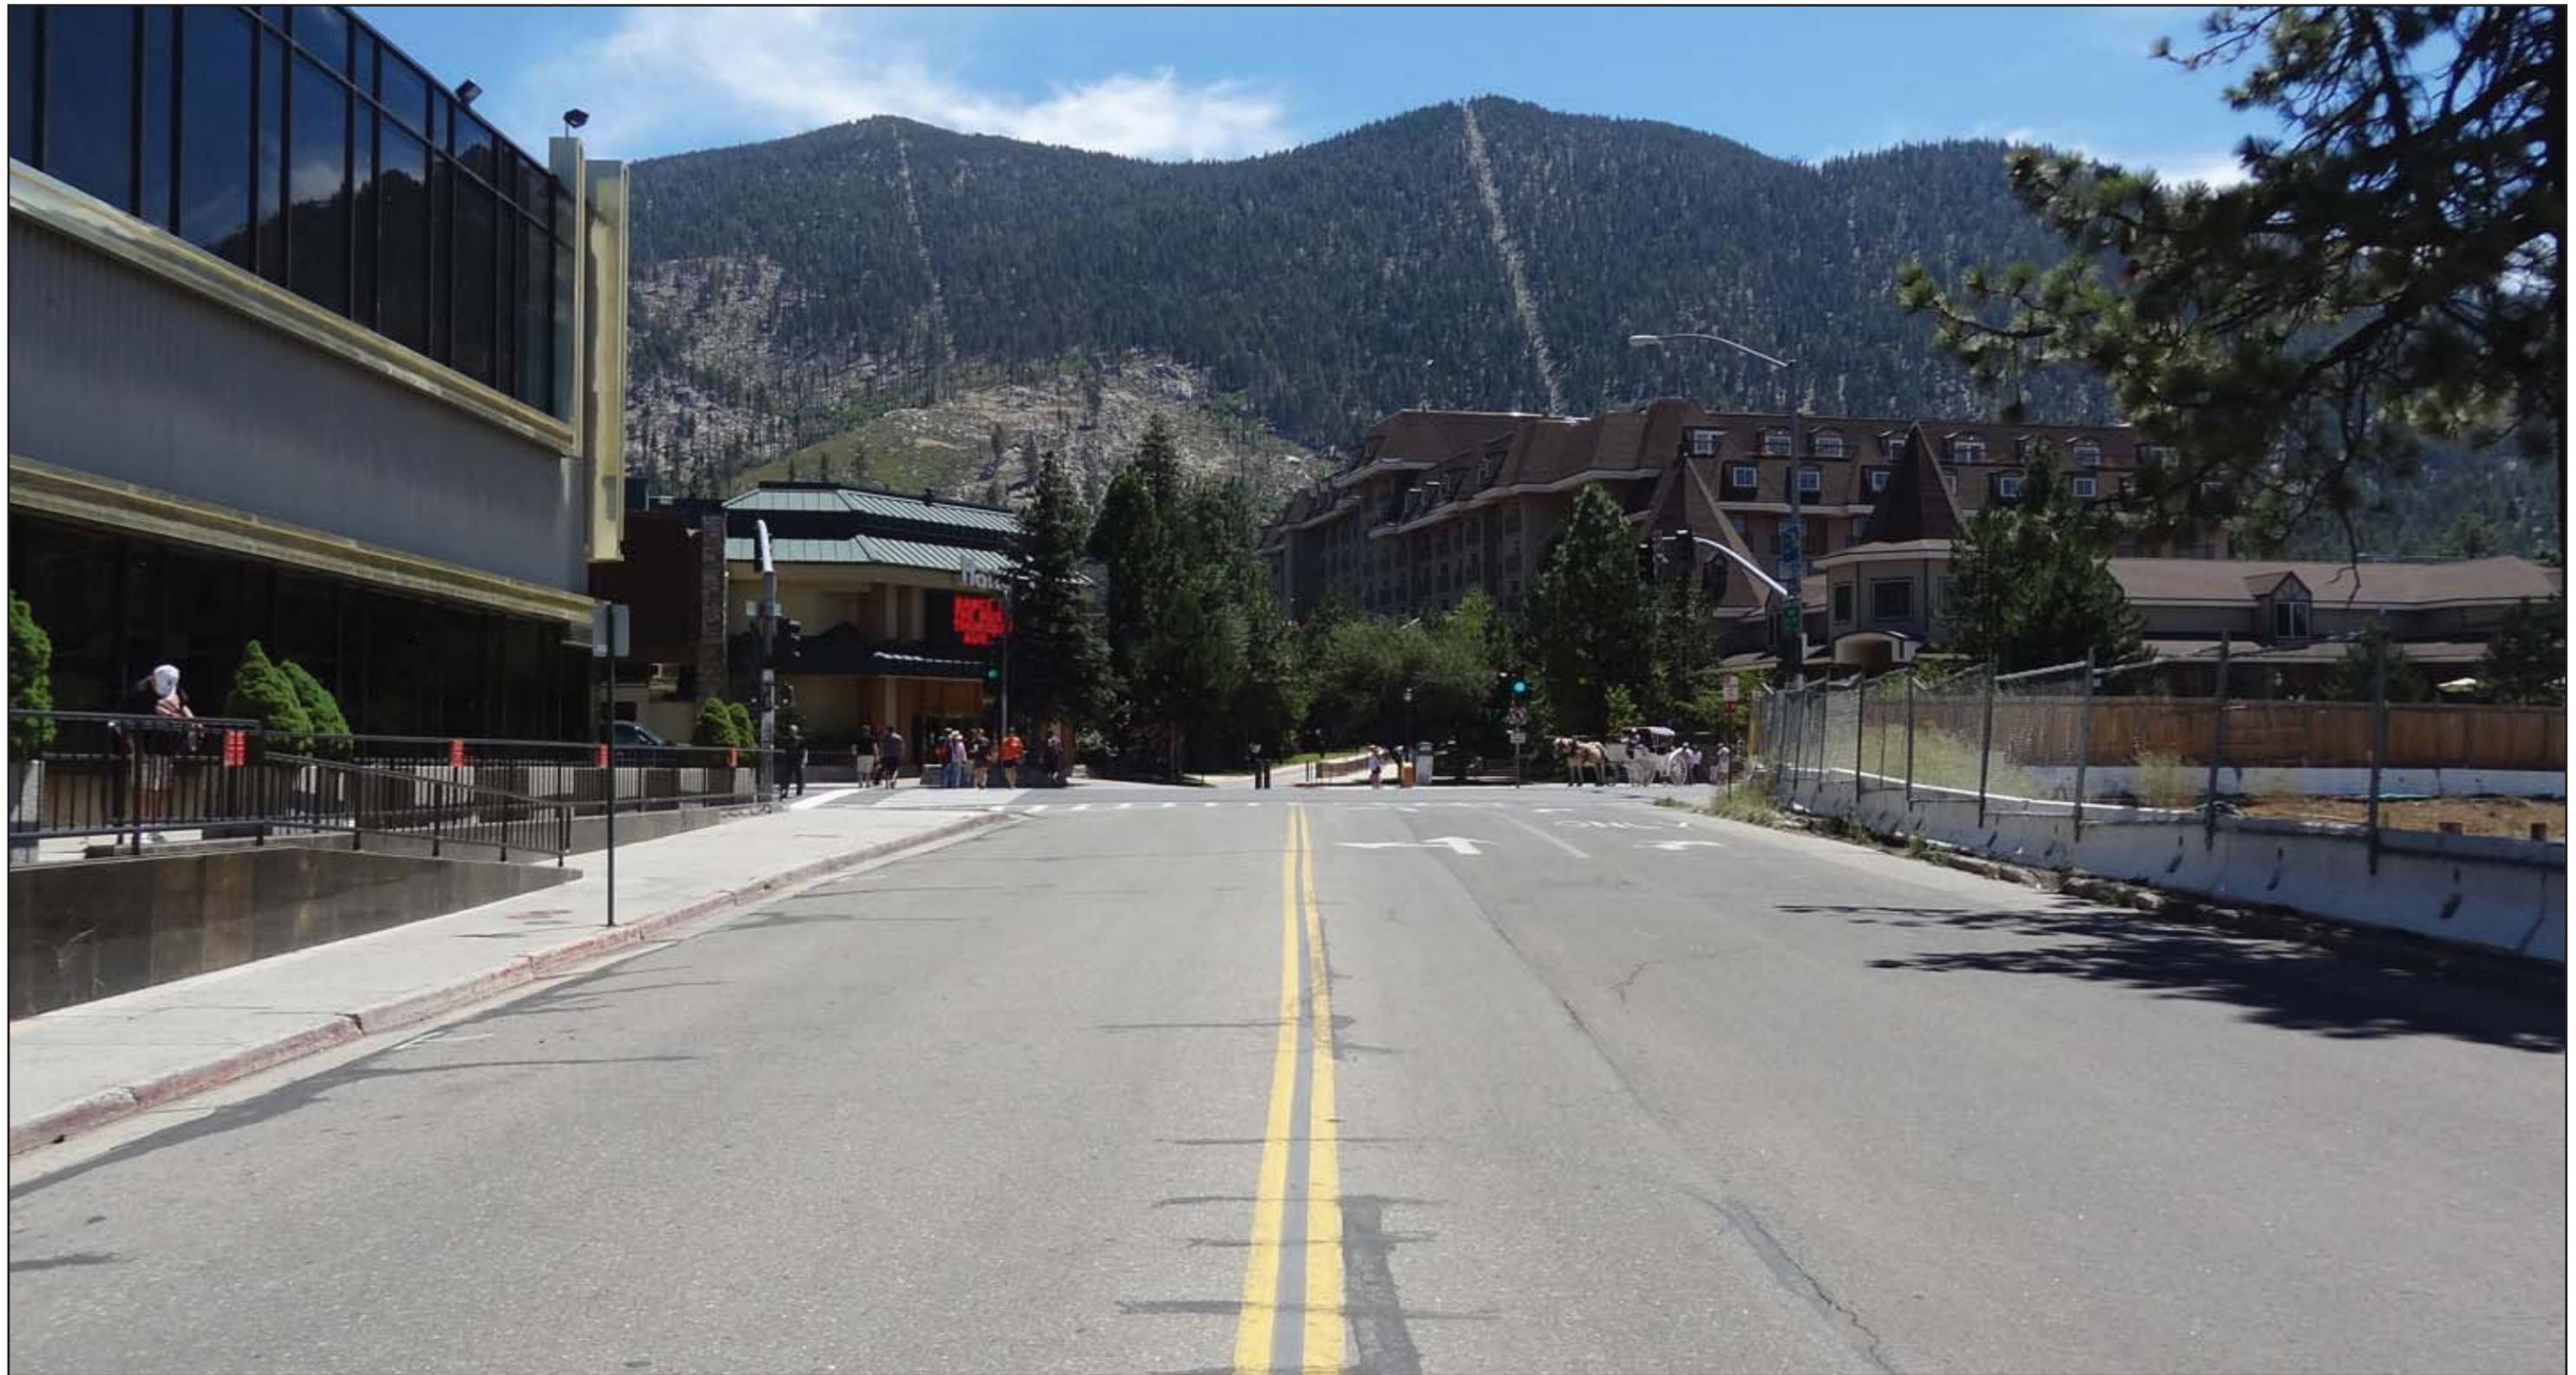
FIGURE 23

Viewpoint 16 is located on Stateline Avenue (between Cedar Avenue and U.S. 50) looking east towards U.S. 50 where features of Alternative E would be visible. Figure 23: Viewpoint 16 Existing Conditions shows the existing visual conditions as seen by motorists, pedestrians, bicyclists, retailers and tourists at this viewpoint.

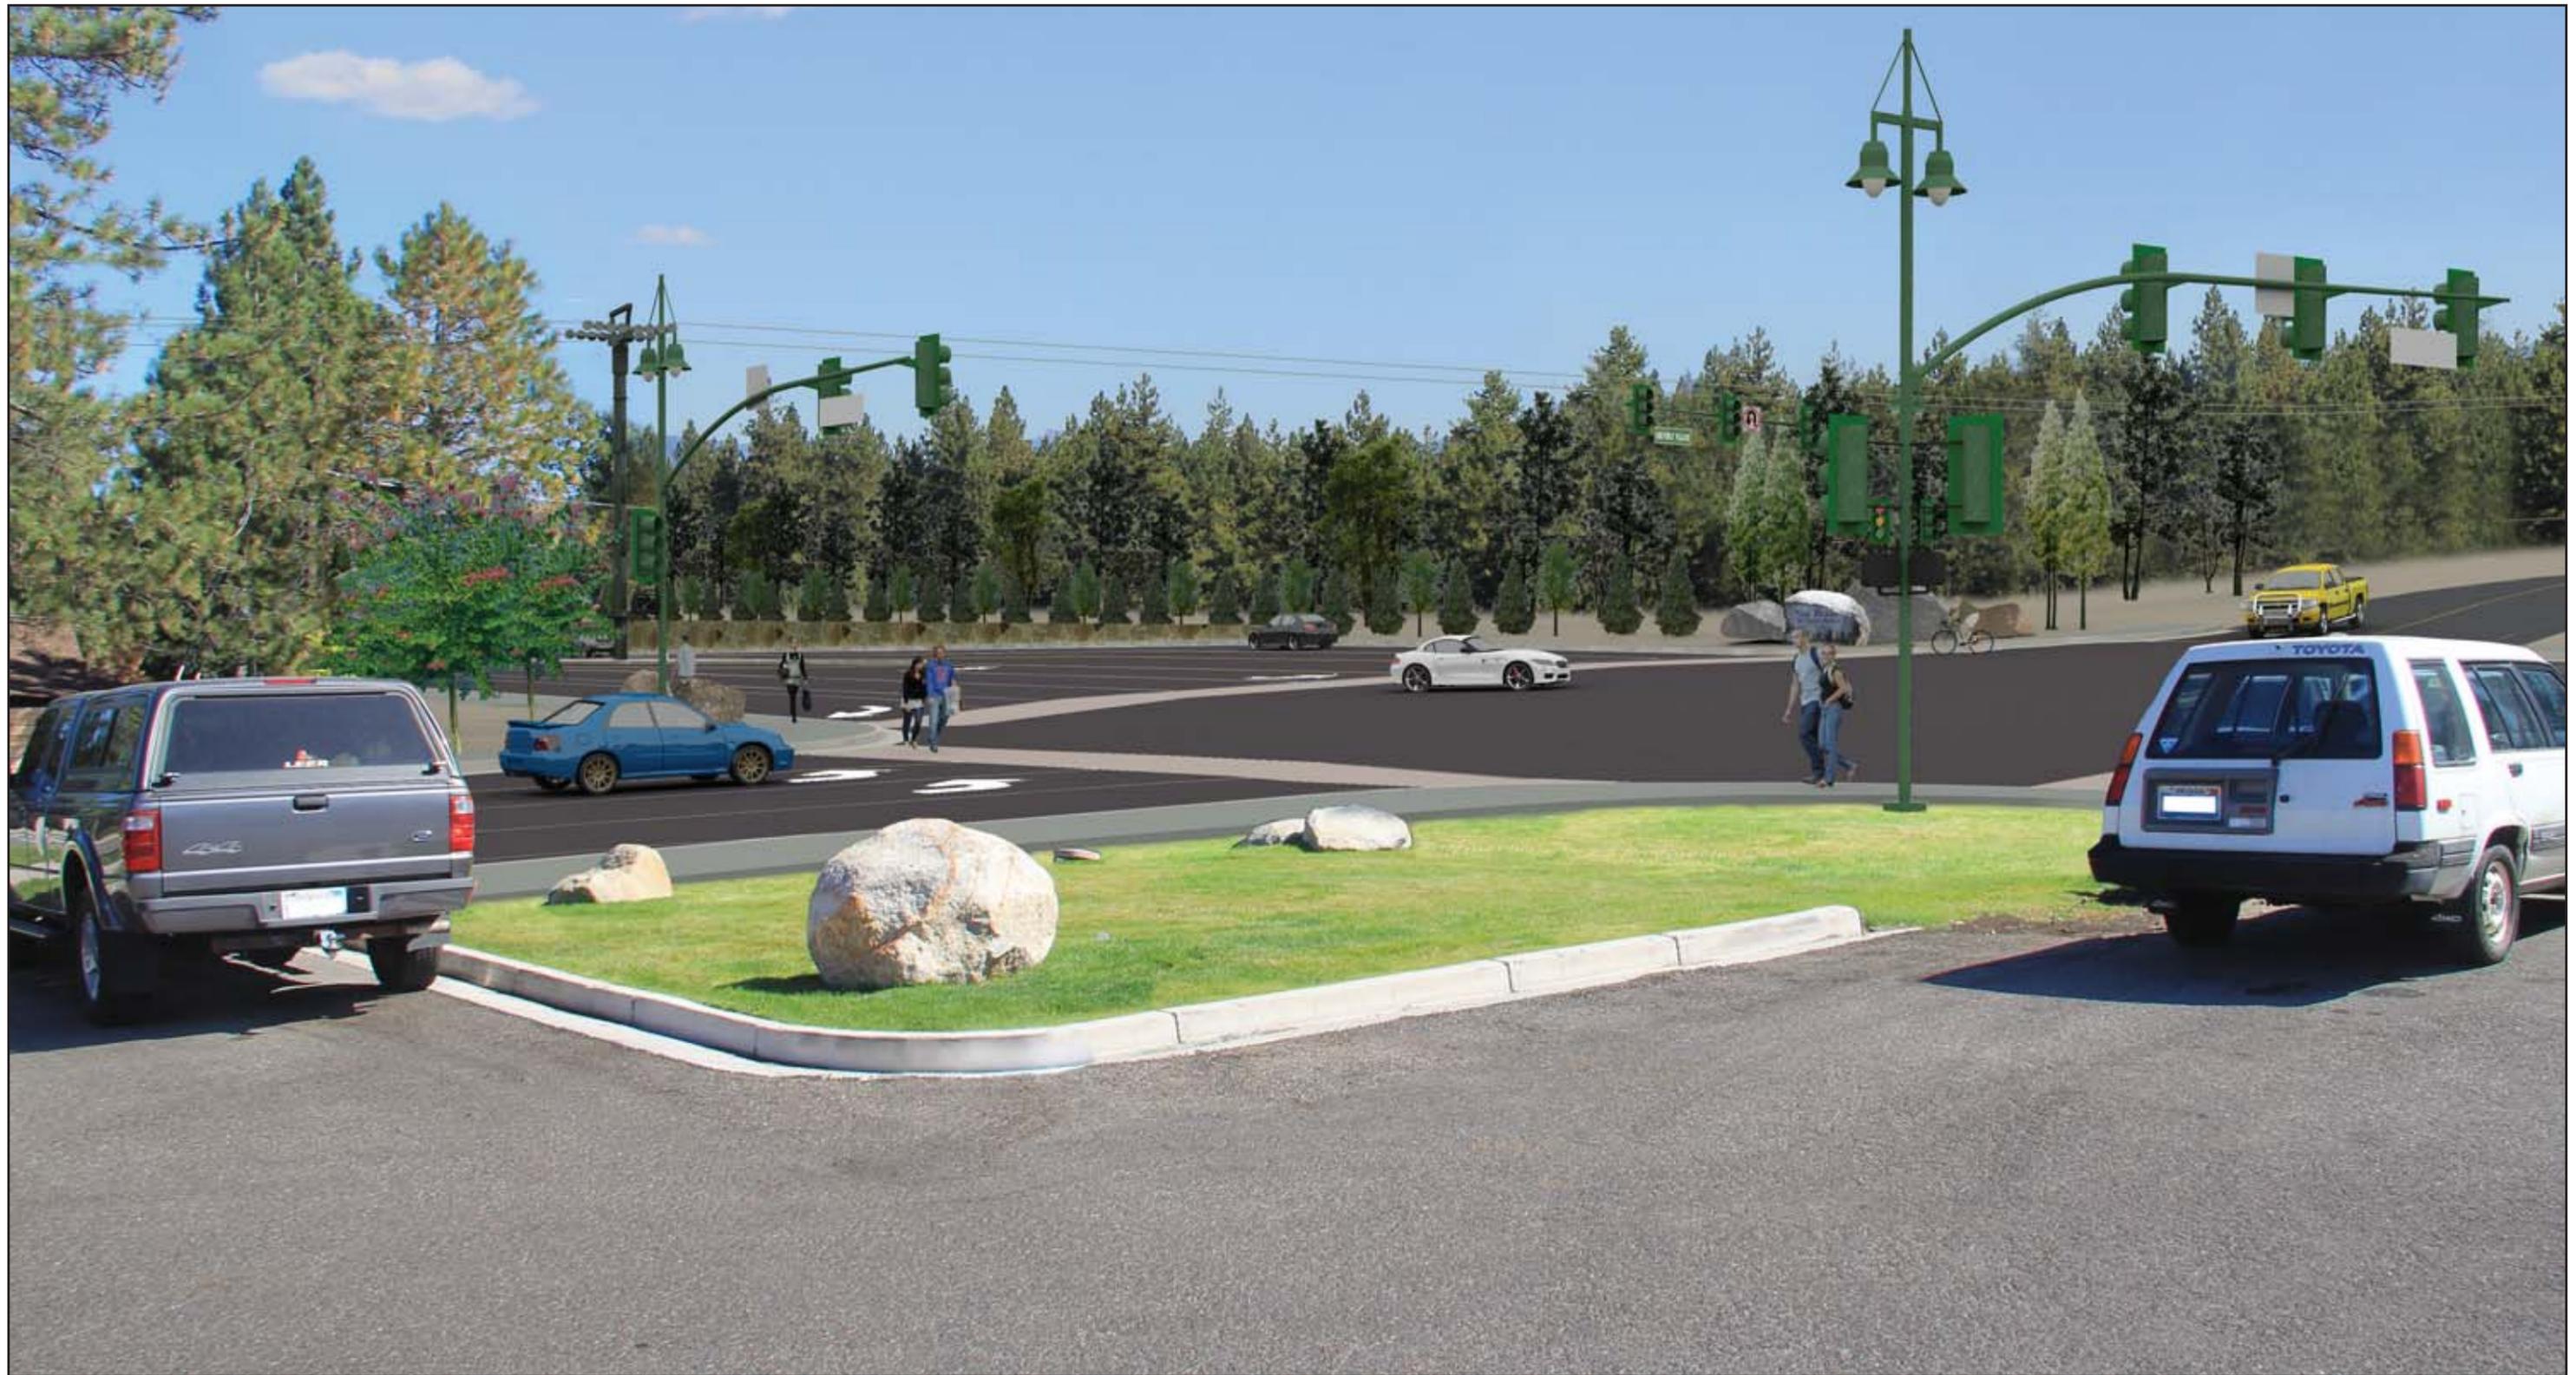
Figure 24: Visual Simulation at Viewpoint 1 for Alternative B (also applicable to Alternatives C and D) shows the simulated visual conditions under Alternative B (it should be noted that this visual simulation also applies to Alternatives C and D).

Alternative B (as well as Alternatives C and D) at this viewpoint would include widening of the roadway and improvements to the intersection. Coniferous trees would be removed from this viewpoint to accommodate road widening and intersection improvement. Street trees would replace some of the coniferous trees to provide a smooth visual transition from manmade feature to natural features. New street lights and intersection signals associated with Alternatives B (as well as

Alternatives C and D) would be painted in a similar color palette as the coniferous trees in the background at this viewpoint. Manmade features, such as the roadway and sidewalks would dominate the middleground from this viewpoint under Alternative B (as well as Alternatives C and D).

Please refer to Section 3.1.2.1 above for a discussion of change in visual character and quality at Viewpoint 1 with implementation of Alternative D. Figure 24 (above) also presents features of Alternative D that would be located at Viewpoint 1. Under

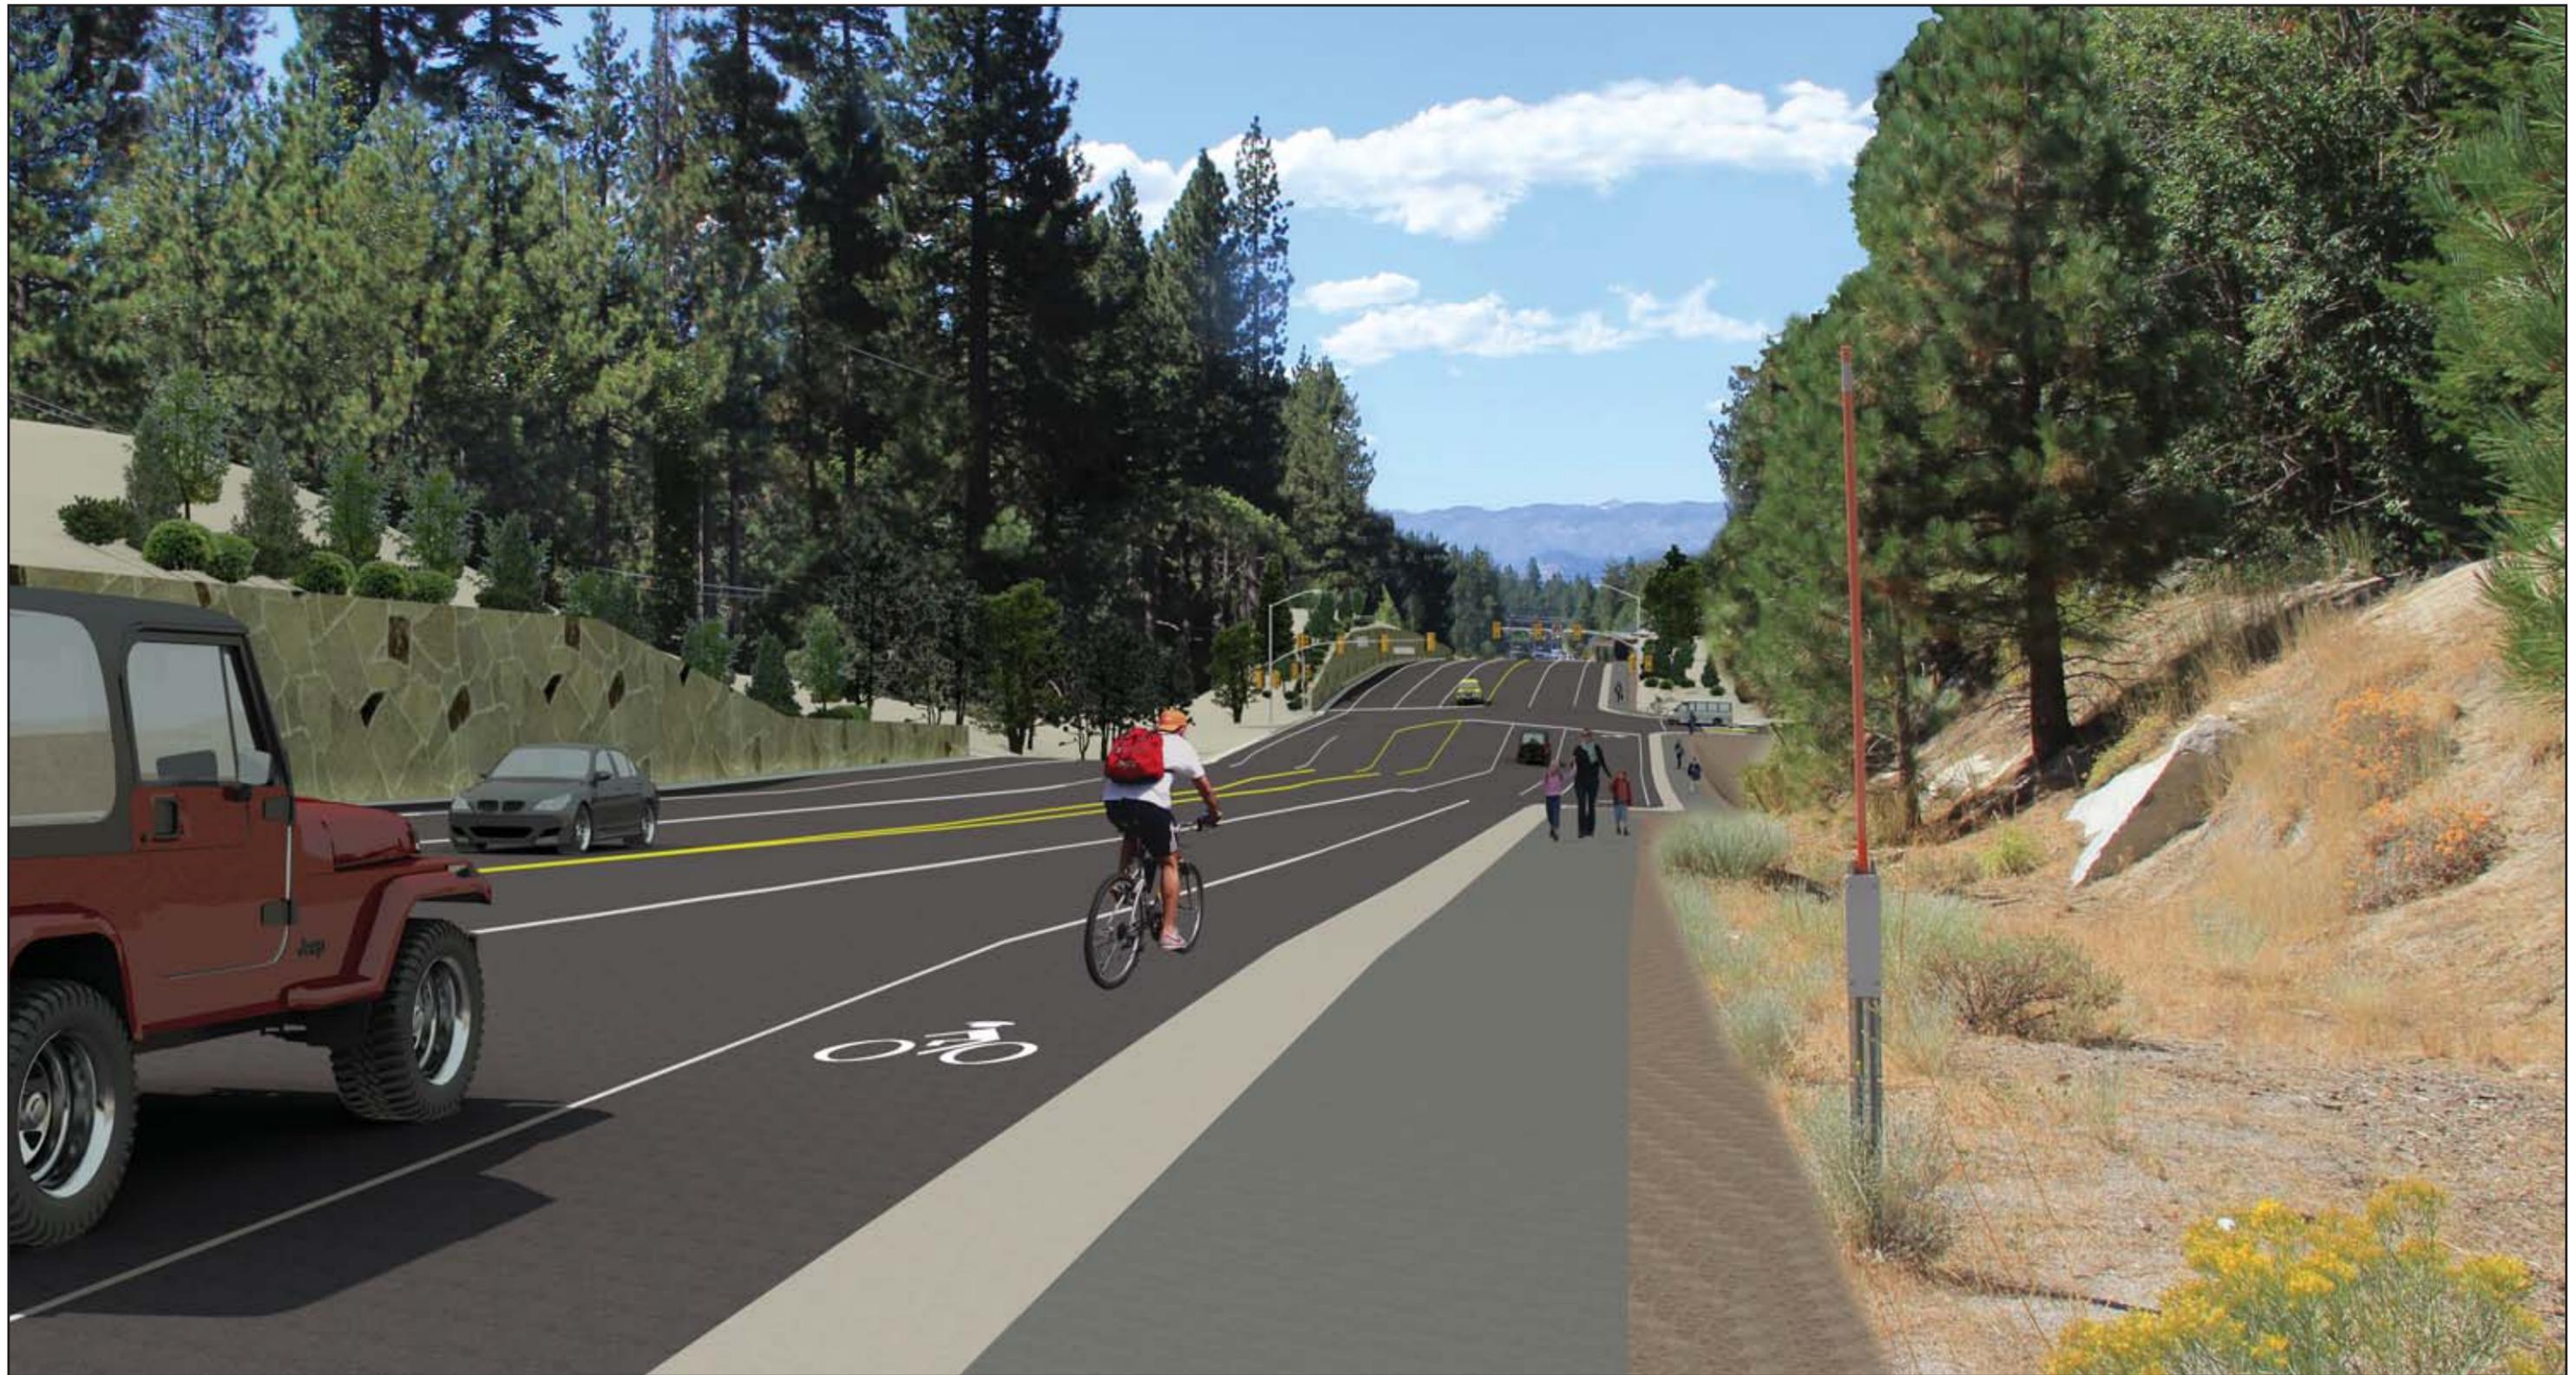
FIGURE 25

Figure 25: Visual Simulation at Viewpoint 2 for Alternative B (also applicable to Alternatives C and D) shows the simulated visual conditions under Alternative B (it should be noted that this visual simulation is also applicable to Alternatives C and D) at Viewpoint 2. Alternative B (as well as Alternatives C and D) would result in a widening of the roadway. A bicycle lane would be added to the western and eastern side of the roadway as well as a pedestrian friendly sidewalk. A retaining wall would be added along the eastern side of the roadway and would be of a color palette similar to the adjacent natural areas. Widening of the roadway in the vicinity of this

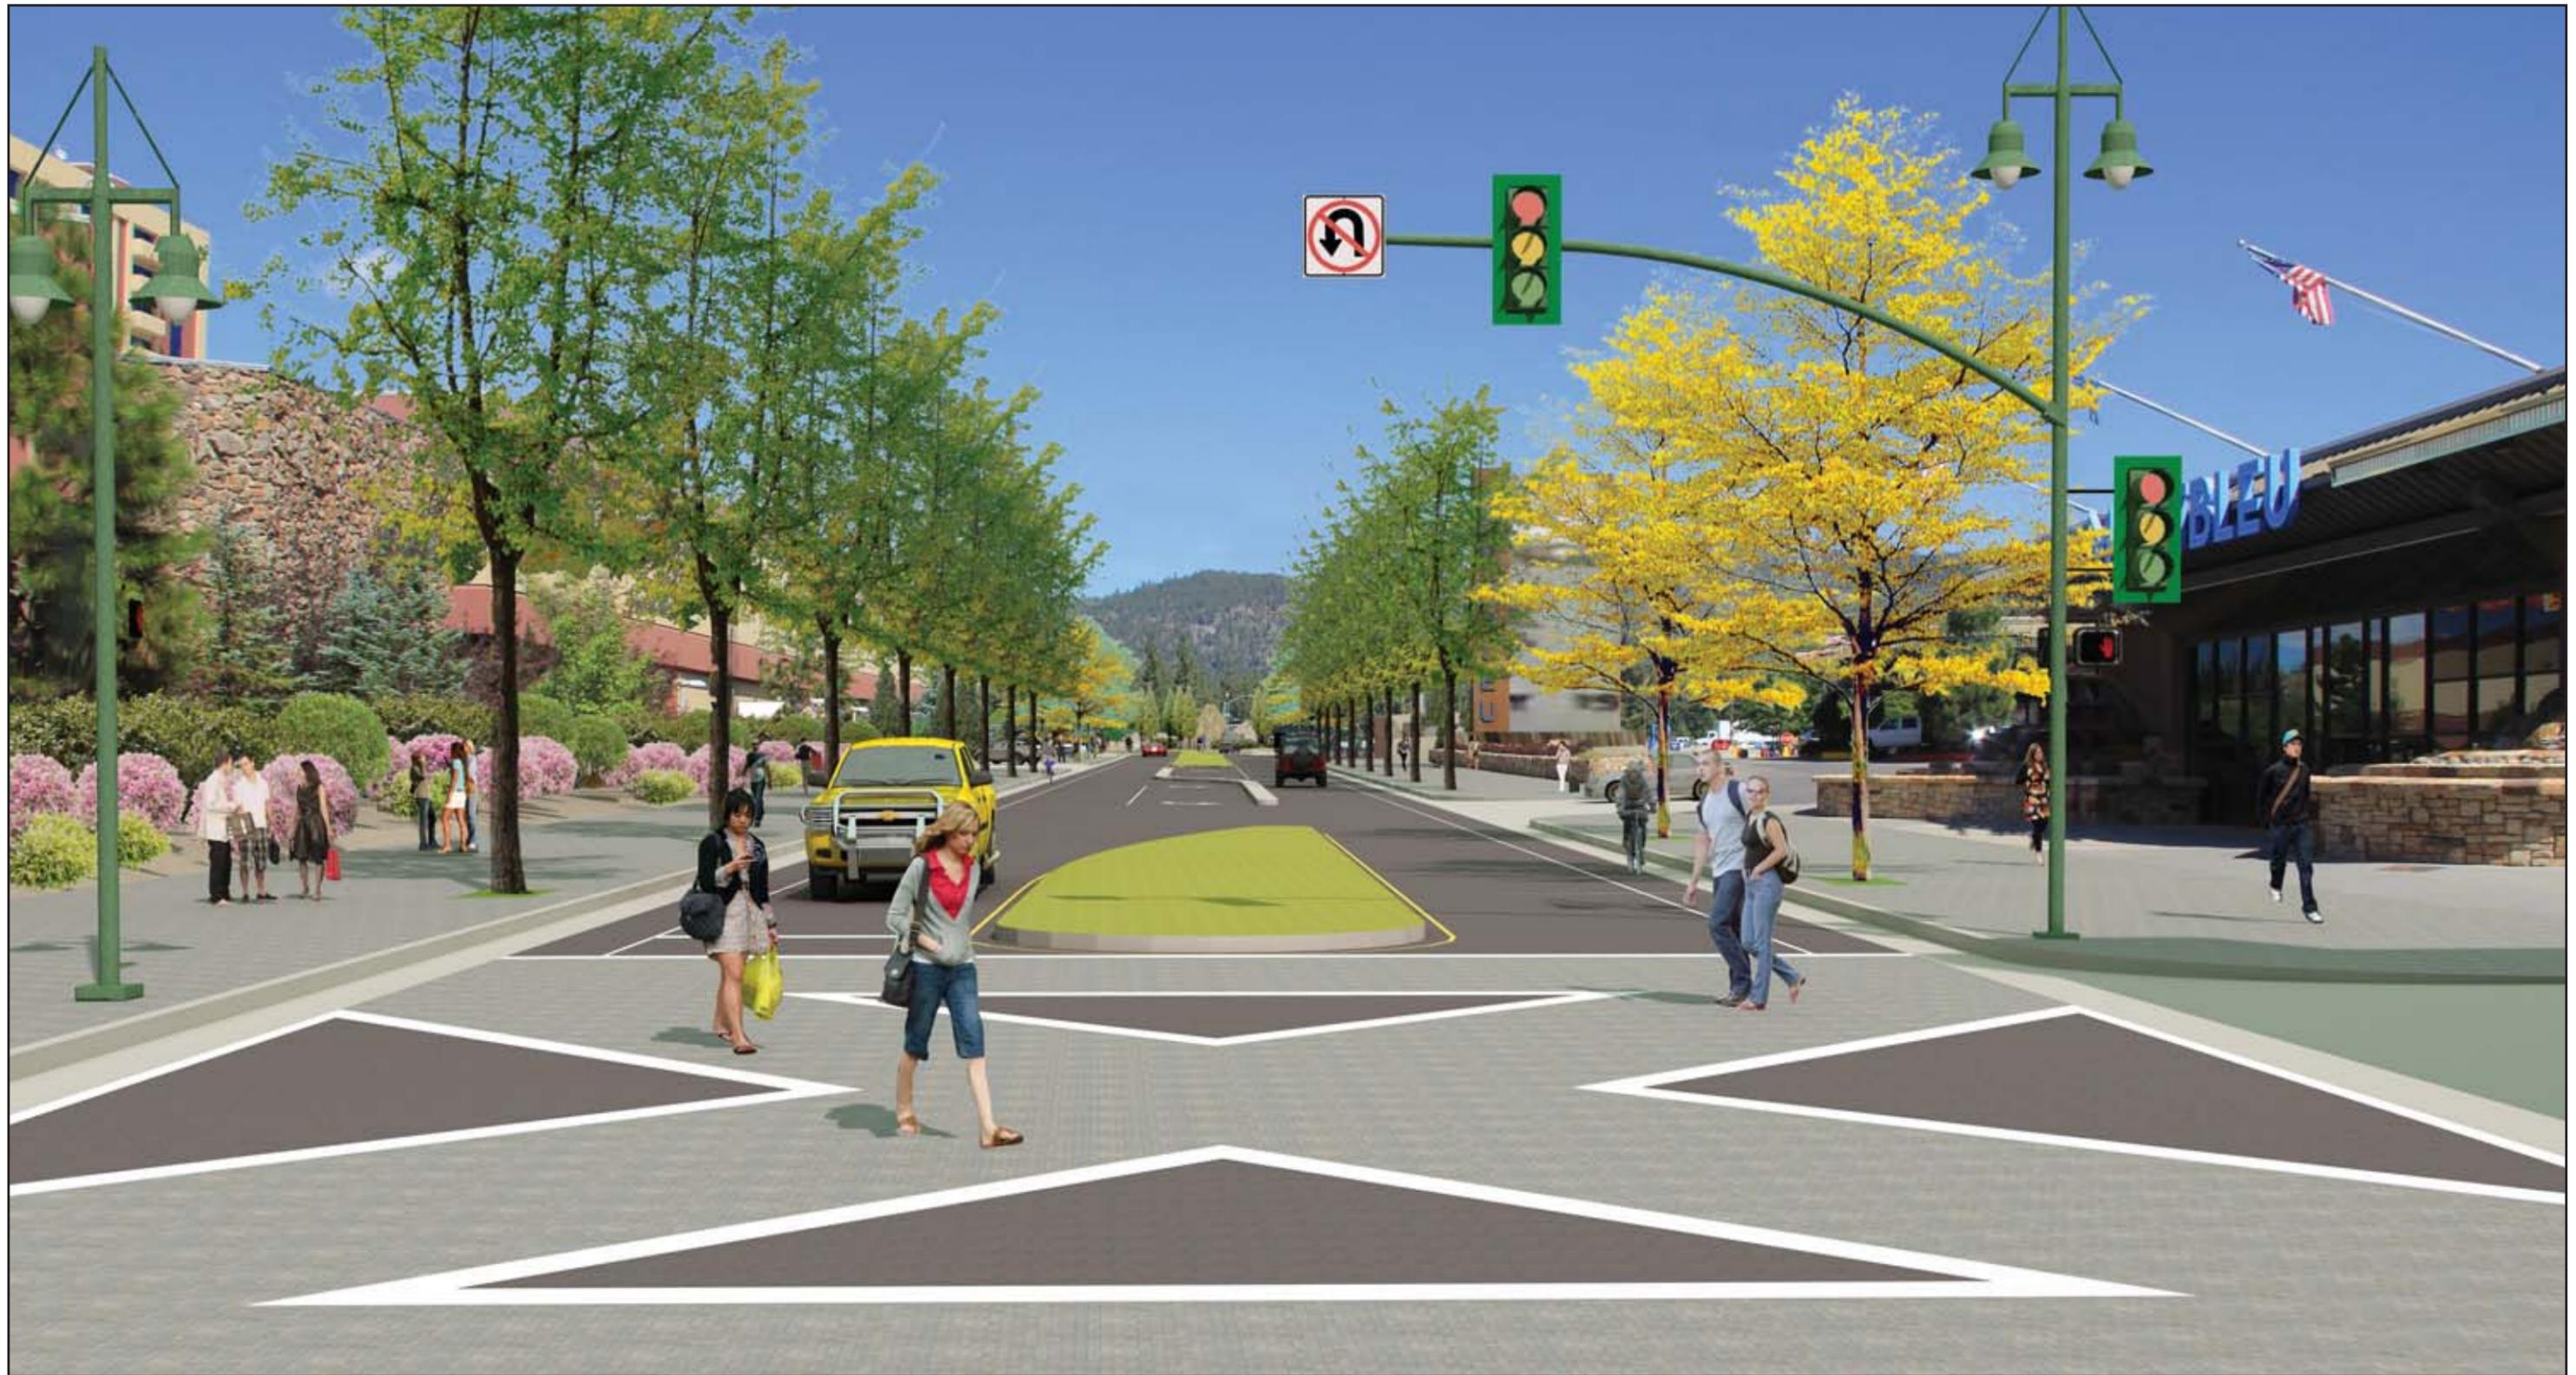
FIGURE 26

Figure 26: Visual Simulation at Viewpoint 3 for Alternative B (also applicable to Alternatives C and D) shows the simulated visual conditions under Alternative B (it should be noted that this visual simulation is also applicable to Alternatives C and D) at Viewpoint 3. Alternative B (as well as Alternatives C and D) would implement a modern streetscape design in the vicinity of this viewpoint. The roadway would be narrowed from two travel lanes in each direction to one travel lane in each direction with a bicycle lane in each direction.

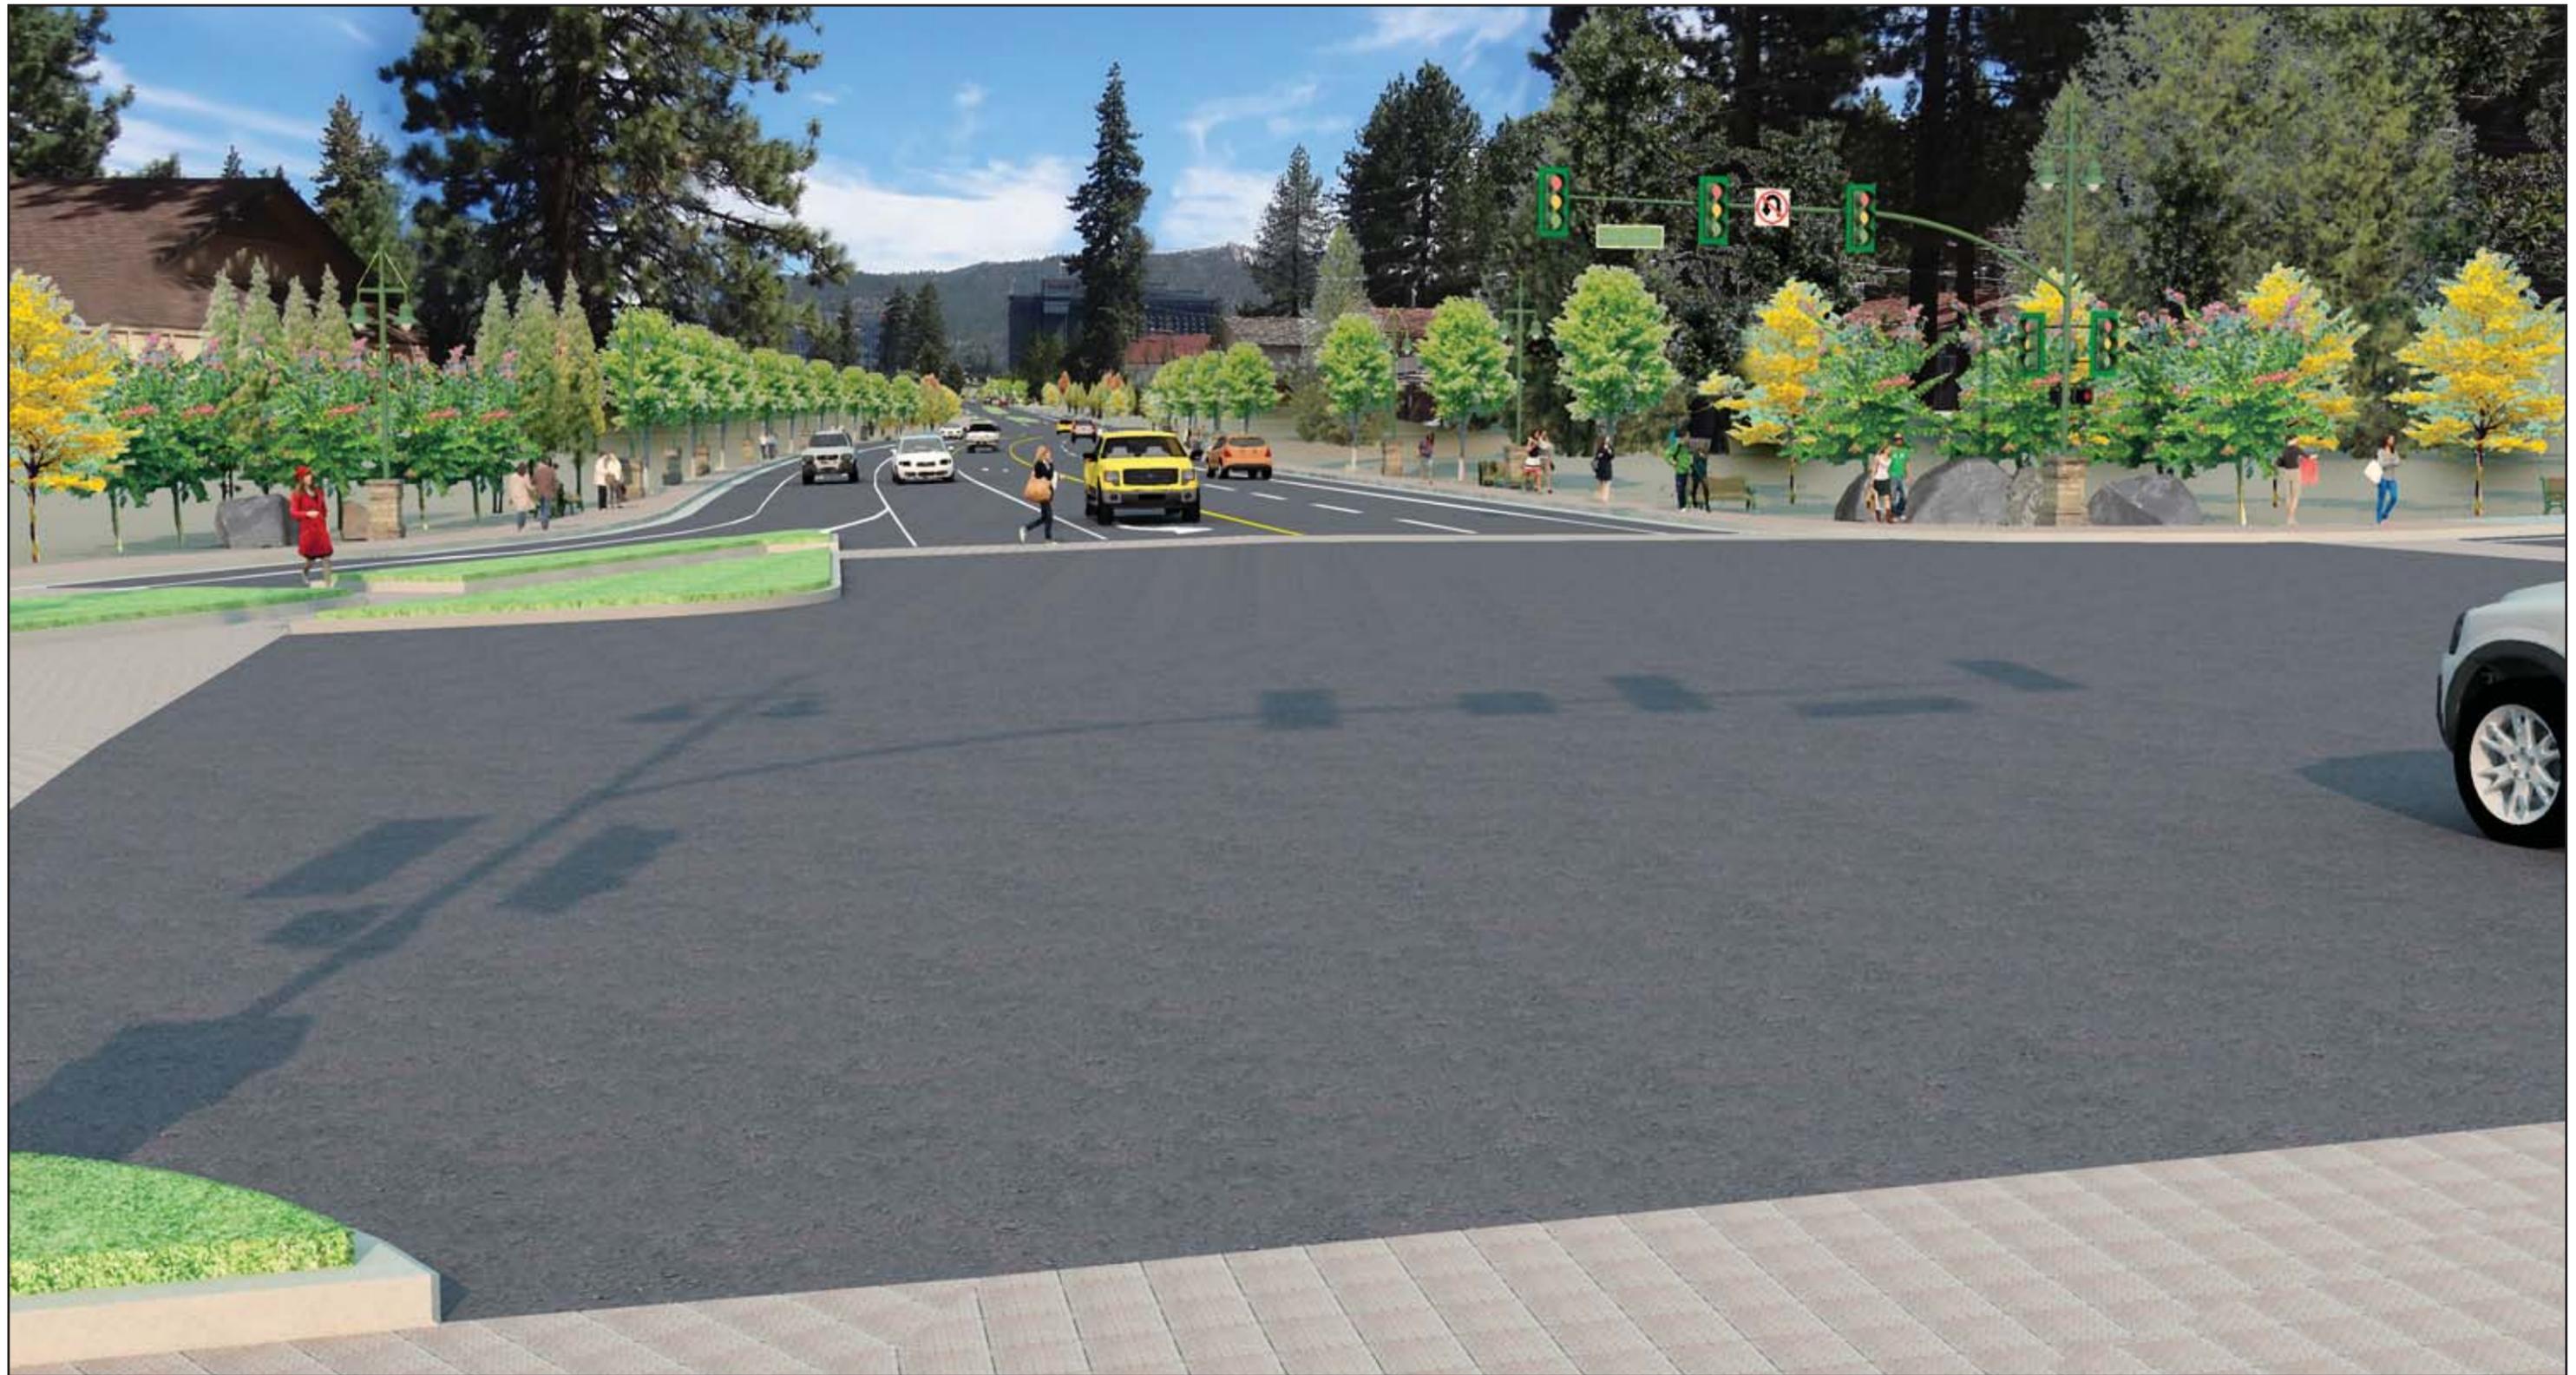
The visual character of Viewpoint 4 under Alternative B would improve when compared to existing conditions. The visual conditions of the streetscape at this viewpoint would change due to removal of existing buildings and placement of street trees paralleling the roadway. The foreground at Viewpoint 4 would provide views of the new intersection developed with modern materials, pedestrian crosswalks (designed to contrast with the roadway), and landscaped pedestrian medians at each of the four corners of the intersection. The middleground at this viewpoint would offer views of the improved U.S. 50 looking north with new roadway surface material and repainted lane stripes.

The new roadway would be paralleled with street trees that would provide a smooth visual transition from the manmade to natural features at this viewpoint. (When compared to existing conditions, the height of the street trees under Alternative B would provide a smoother visual transition from the shorter manmade features to the taller coniferous trees (natural features) on the east and west sides of the street at this intersection.) The ornamental trees would add color to this viewpoint and would provide a transition to the naturally occurring coniferous trees located on the east and west sides of the roadway right-of-way. Other decorative features such as boulders would enhance the natural features from this viewpoint. The street trees would also

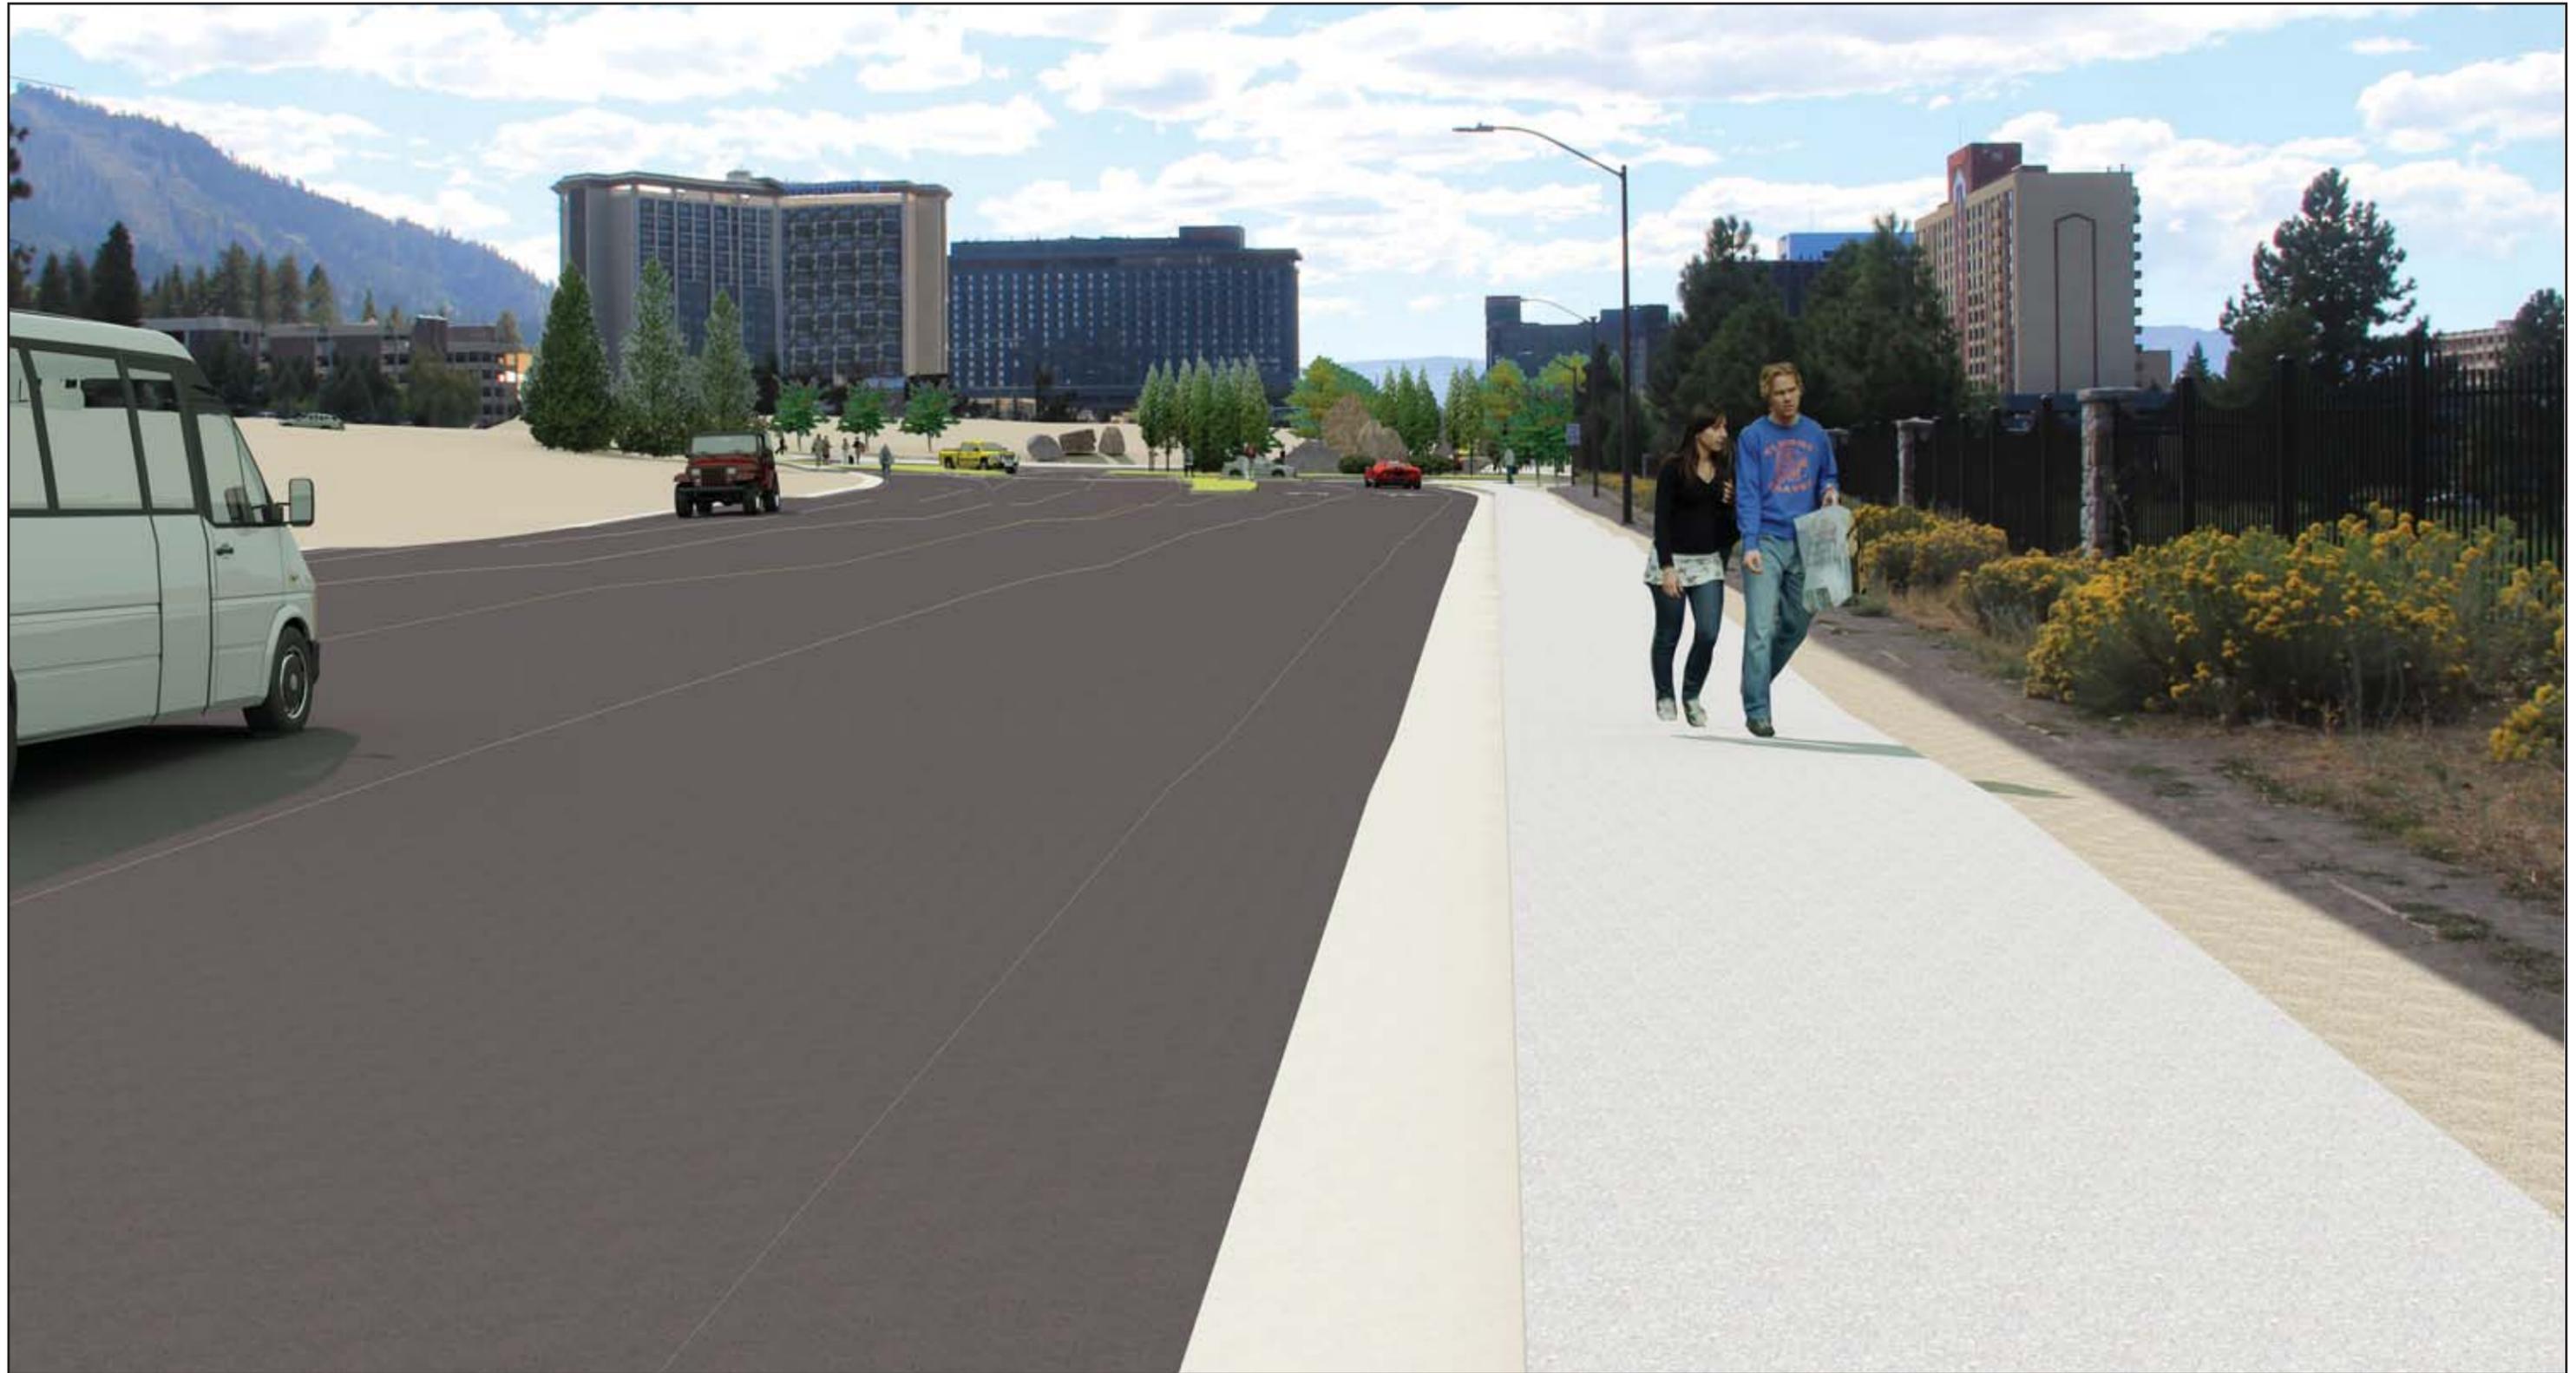
FIGURE 28

Figure 28: Visual Simulation at Viewpoint 5 for Alternative B (also applicable to Alternative D) shows the simulated visual conditions with implementation of Alternative B (this simulation also applies to Alternative D) at Viewpoint 5. The visual conditions of Alternative B (as well as Alternative D) are similar to those under Alternative C and are described in section 3.1.3.5 below.

Please refer to Section 3.1.2.5 above for a discussion of change in visual character and quality at Viewpoint 5 with implementation of Alternative D. Figure 28 (above) also presents features of Alternative D that would be located at Viewpoint 5. Under existing conditions Viewpoint 5 has a visual quality rating of 2.50 which is considered Moderately Low. Implementation of Alternative D would result in a **Moderately Low** visual quality rating of **2.56** at Viewpoint 5.
