**Draft Visual Impact Assessment – US
50/South Shore Community
Revitalization Project**

U.S. 50/South Shore Community Revitalization Project

South Lake Tahoe, California / Stateline, Nevada

**Draft Visual Impact Assessment (VIA) For
U.S. 50/South Shore Community Revitalization Project**

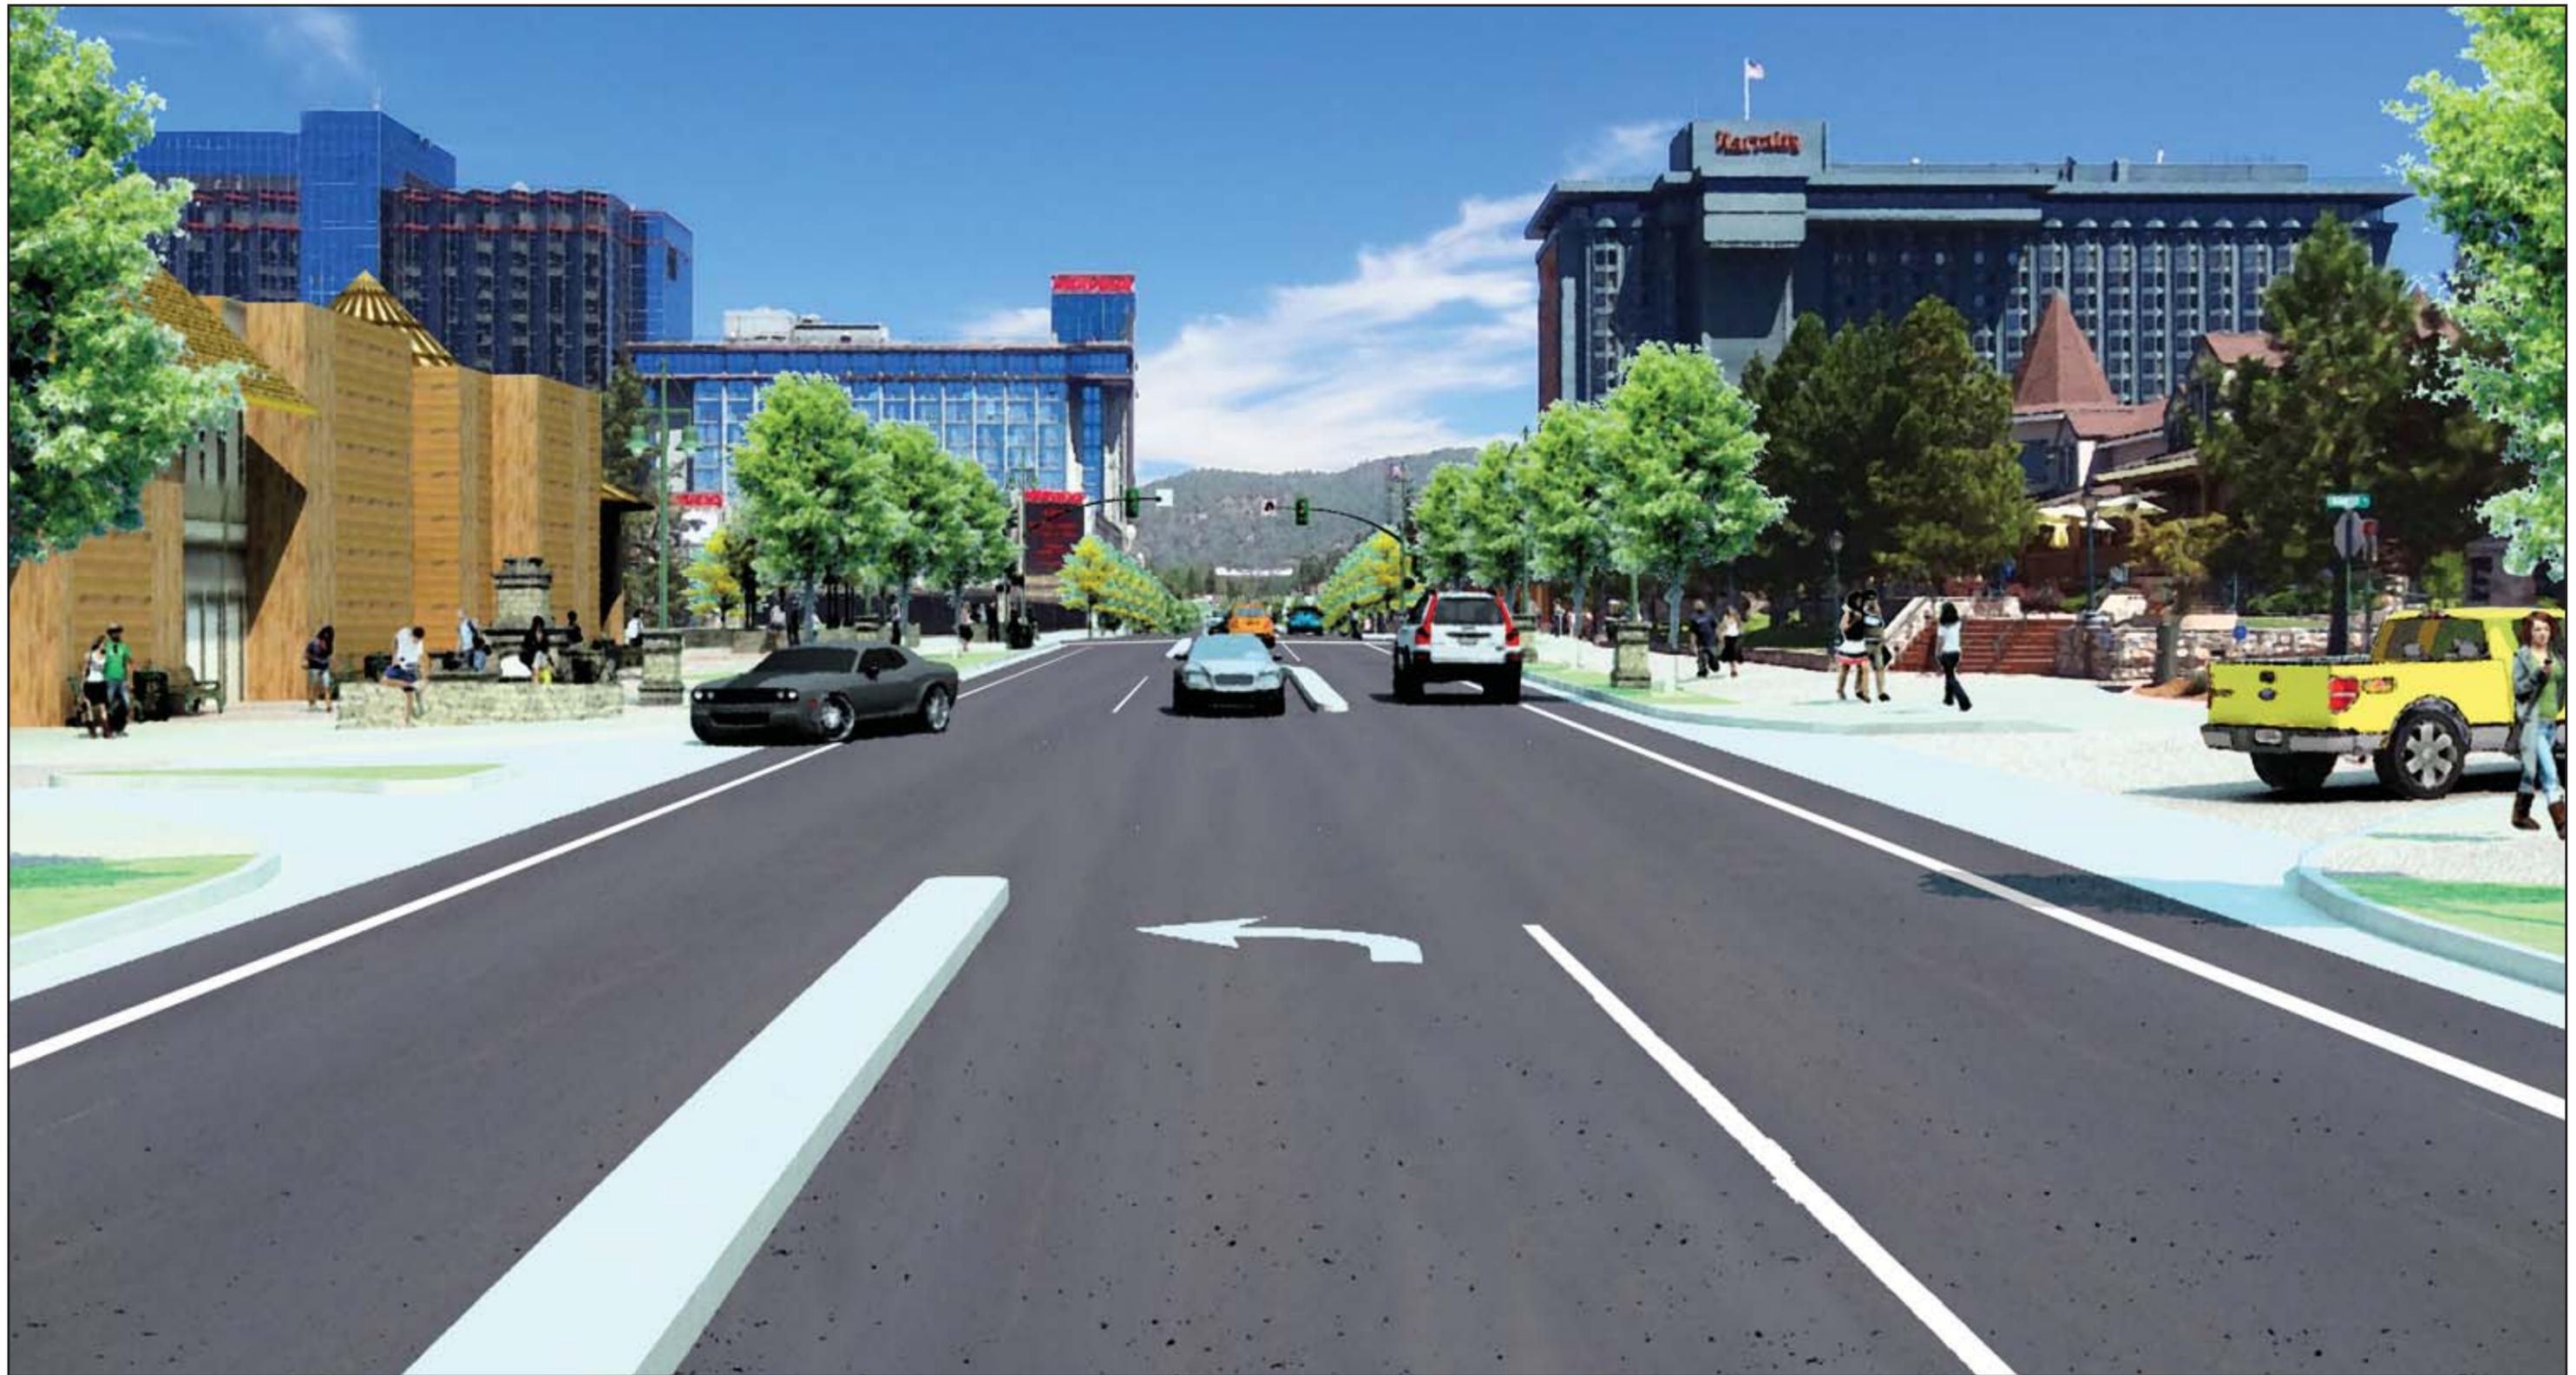
FIGURE 29

Figure 29: Visual Simulation at Viewpoint 6 for Alternative B (also applicable to Alternative D) shows the simulated visual conditions under Alternative B (it should be noted that this visual simulation is also applicable to Alternative D) at Viewpoint 6. U.S. 50 at this viewpoint would be designed as a two-lane roadway (one lane in each direction) with left-turn pockets and cemented medians separating the northbound and southbound lanes. A new pedestrian sidewalk would be developed on the west side of the roadway and the sidewalk on the east side of the roadway would be improved. Ornamental trees would be placed on the eastern and western sides of the roadway and landscaped areas would be developed along the sidewalks. It should be noted that the commercial building on the western side of the roadway (as shown in the simulation in Figure 29) is not part of the Alternative B (as well as Alternative D) design and is included in the simulation on the assumption of planned buildout of this parcel per future City of South Lake Tahoe plans.

Please refer to Section 3.1.2.6 above for a discussion of change in visual character and quality at Viewpoint 3 with implementation of Alternative D. Figure 29 (above) also presents features of Alternative D that would be located at Viewpoint 3. Under existing conditions Viewpoint 6 has a visual quality rating of 3.0, which is considered Moderate. Implementation of Alternative D would result in a ***Moderate*** visual quality rating of **3.06** at Viewpoint 1b.

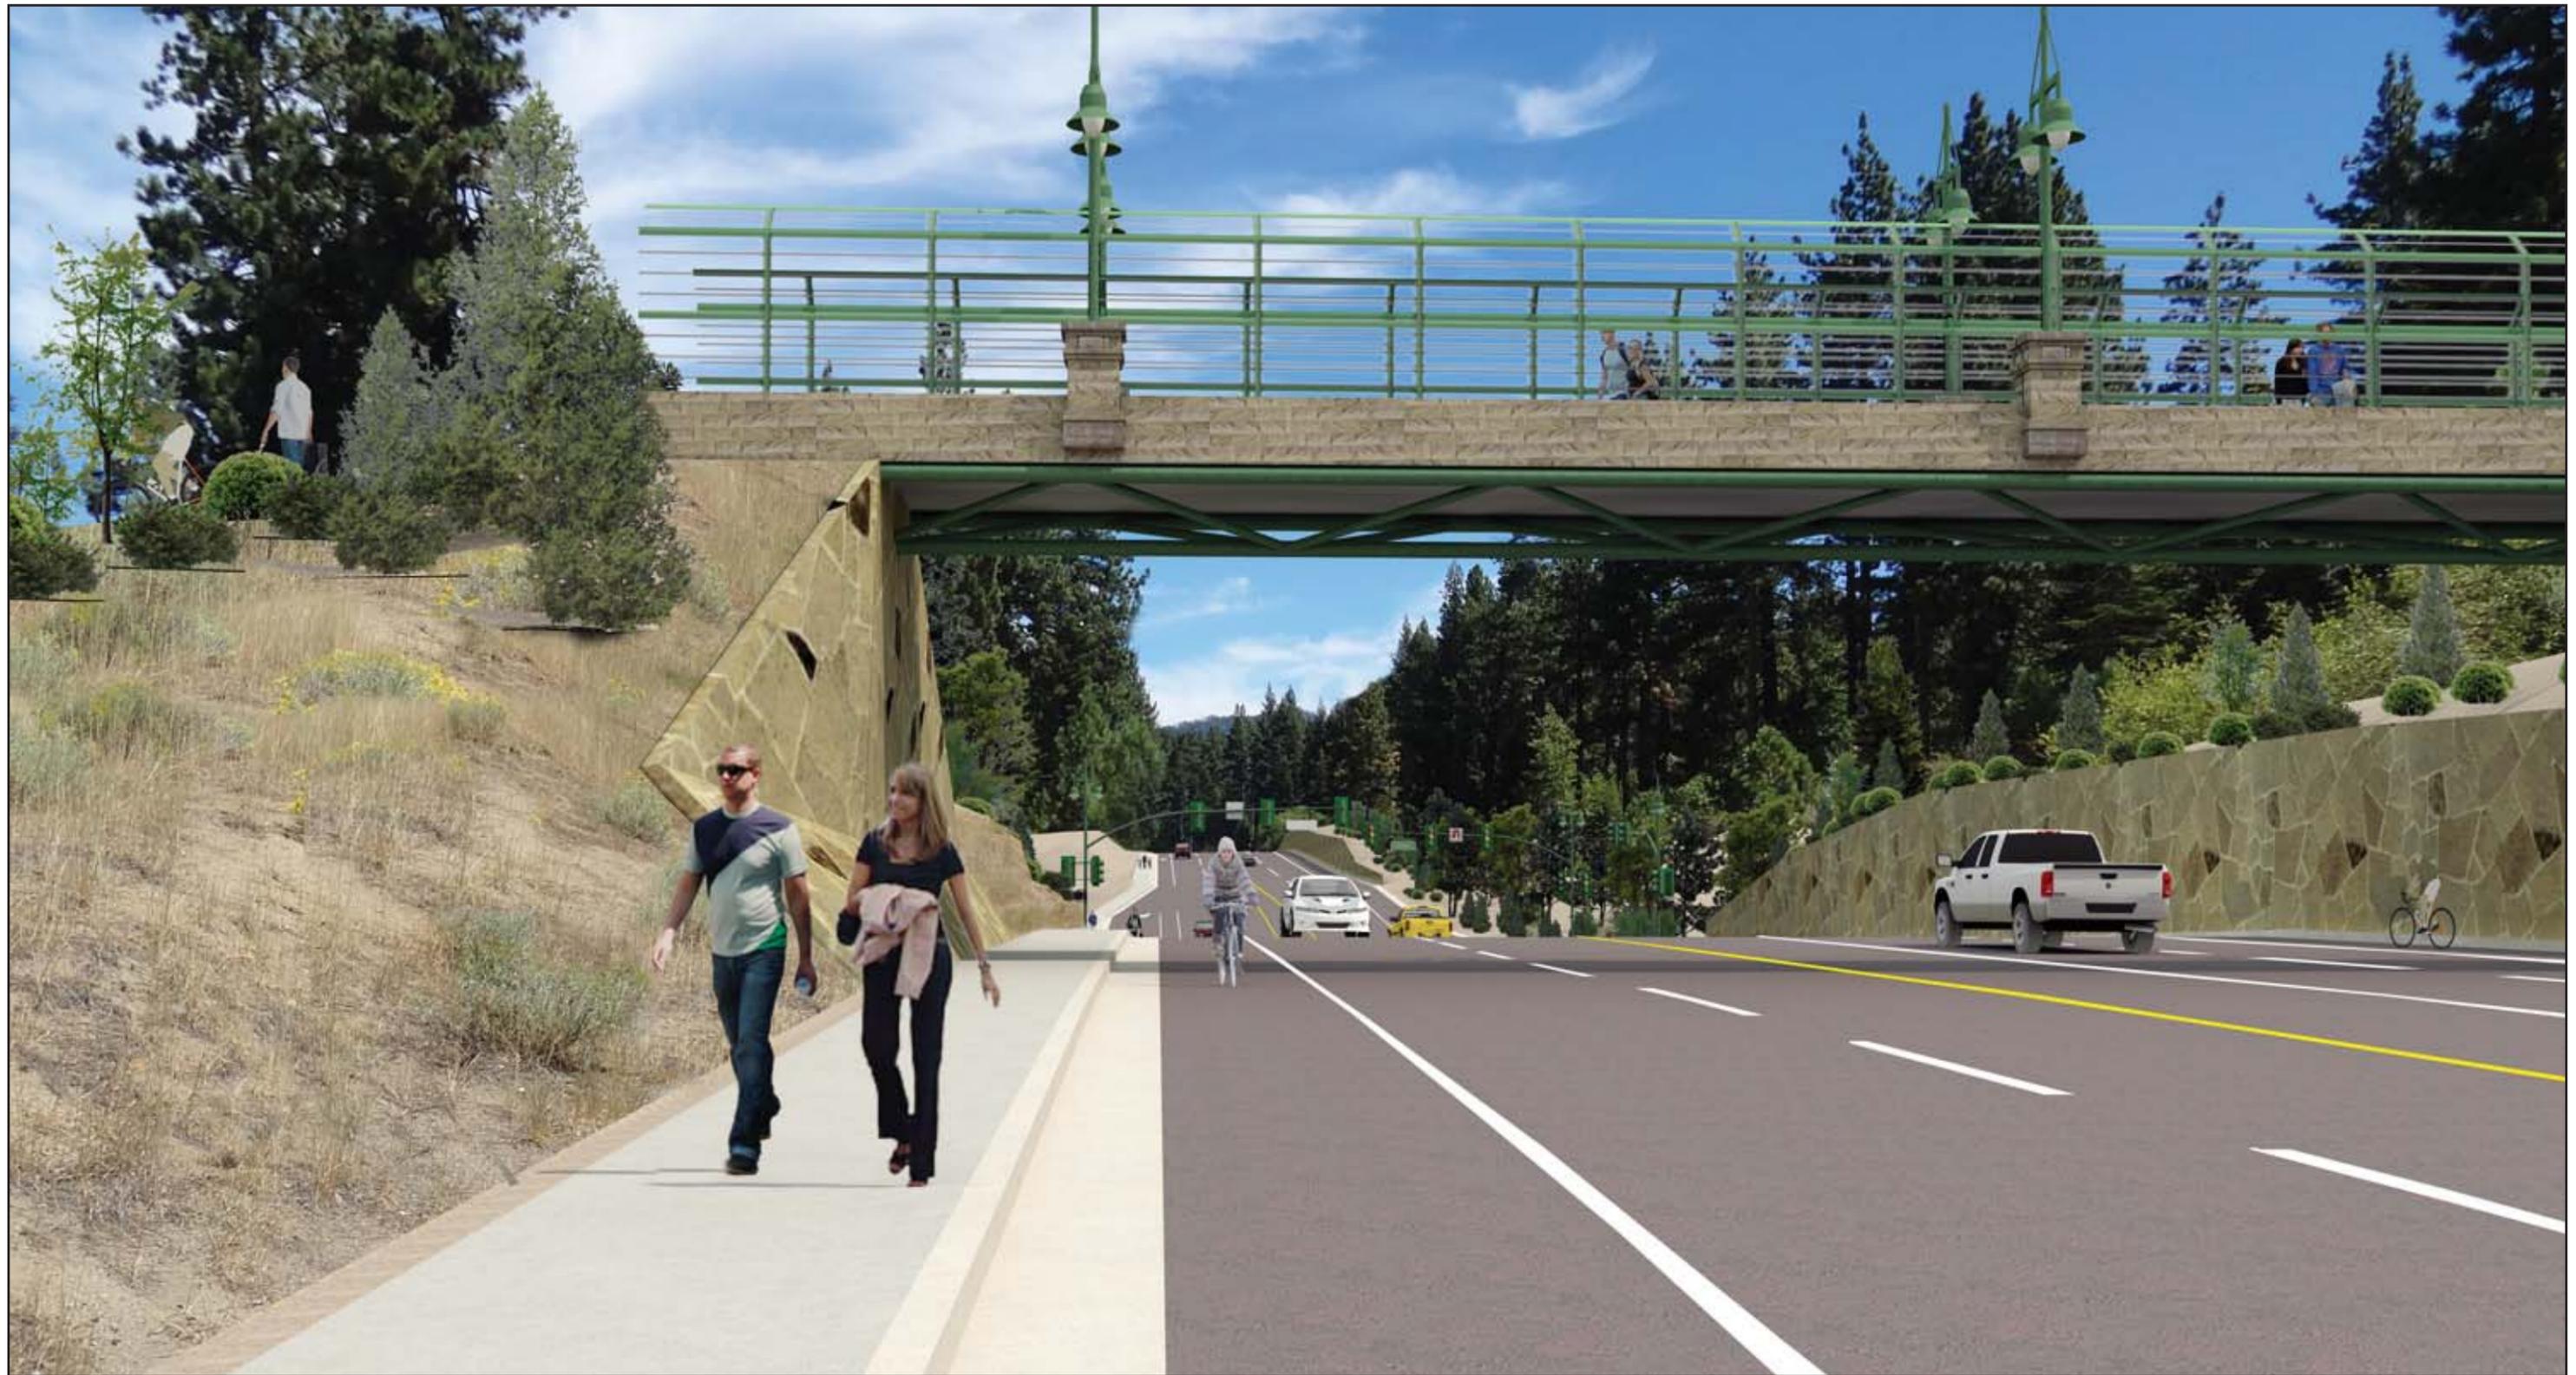
FIGURE 30

Figure 30: Visual Simulation at Viewpoint 7 for Alternative B (also applicable to Alternative D) shows the simulated visual conditions under Alternative B (it should be noted that this visual simulation is also applicable to Alternative D) at Viewpoint 7. Improvements to Lake Parkway would be visible from this viewpoint with implementation of the Alternative B (as well as Alternative D). The roadway would be widened from one travel lane in each direction to two travel lanes in each direction with a left-turn lane down the center. Bicycle lanes would be added to both side of the roadway and a sidewalk would be added to the west side of the roadway. A pedestrian bridge would be added across Lake Parkway connecting the Casino Corridor area with Van Sickle Bi-State Park. The pedestrian bridge would be developed using modern materials and design and would be painted in a color palette consistent with the surrounding natural landscape. Lamp poles would be installed on the pedestrian bridge and painted in a color palette consistent with the coniferous trees on the western and eastern side of Lake Parkway.

Please refer to Section 3.1.2.7 above for a discussion of change in visual character and quality at Viewpoint 3 with implementation of Alternative D. Figure 30 (above) also presents features of Alternative D that would be located at Viewpoint 7. Under existing conditions Viewpoint 7 has a visual quality rating of 4.33 which is considered Moderate. Implementation of Alternative D would result in a ***Moderate*** visual quality rating of **3.22** at Viewpoint 7.

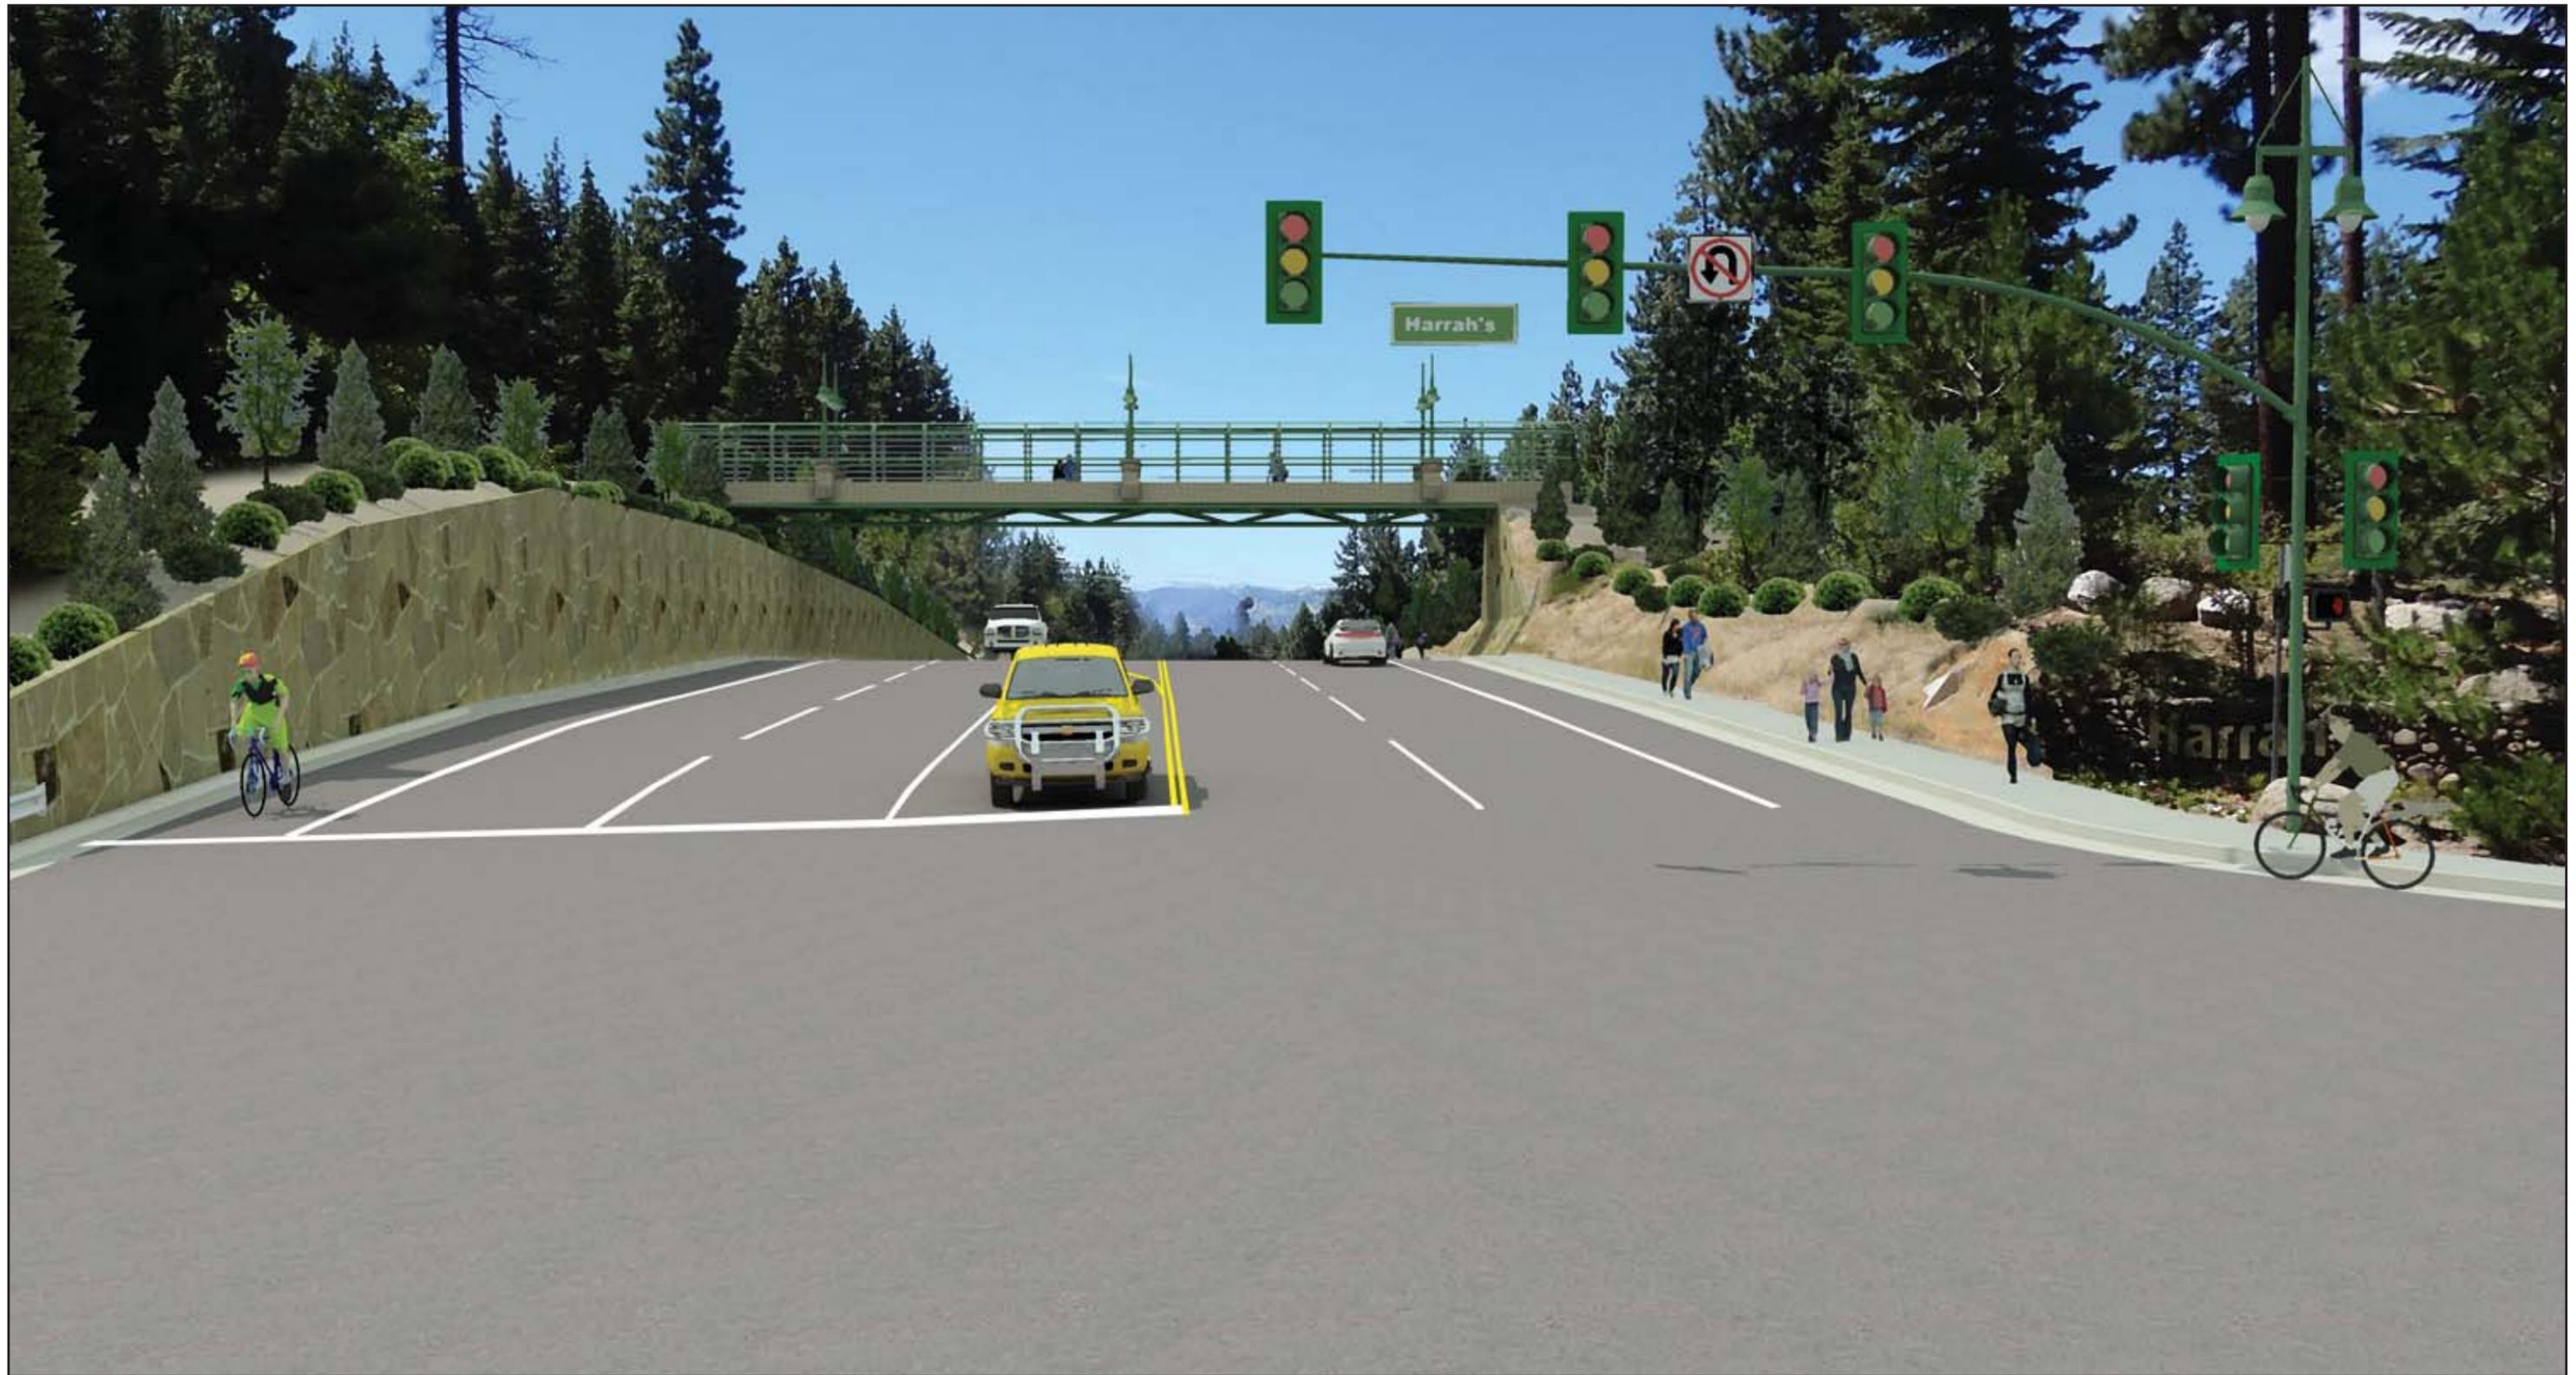
FIGURE 31

Figure 31: Visual Simulation at Viewpoint 8 for Alternative B (also applicable to Alternative D) shows the simulated visual conditions under Alternative B (it should be noted that this visual simulation is also applicable to Alternative D) at Viewpoint 8.

Alternative B (as well as Alternative D) would include improvements to Lake Parkway, such as widening of the roadway to include two travel lanes in the southbound and northbound directions. A new signalized intersection would be developed at this viewpoint with traffic signal poles painted a color palette consistent with the surrounding coniferous forest. Bicycle lanes and new pedestrian friendly sidewalks would be added along the northbound and southbound sides of Lake Parkway. Retaining walls composed of earth-colored materials would be developed along the eastern side of Lake Parkway to reduce erosion susceptibility of the natural areas adjacent to the roadway. A new pedestrian bridge would be constructed as part of Alternative B (as well as Alternative D), crossing over Lake Parkway, and providing pedestrians easy access to natural areas in Van Sickle Bi-State Park.

The pedestrian bridge would be constructed with modern materials and painted a color palette consistent with the surrounding natural areas paralleling Lake Parkway.

Please refer to Section 3.1.2.8 above for a discussion of change in visual character and quality at Viewpoint 8 with implementation of Alternative D. Figure 31 (above) also presents features of Alternative D that would be located at Viewpoint 8. Under existing conditions Viewpoint 8 has a visual quality rating of 4.06 which is considered Moderate. Implementation of Alternative D would result in a ***Moderate*** visual quality rating of **3.28** at Viewpoint 8.

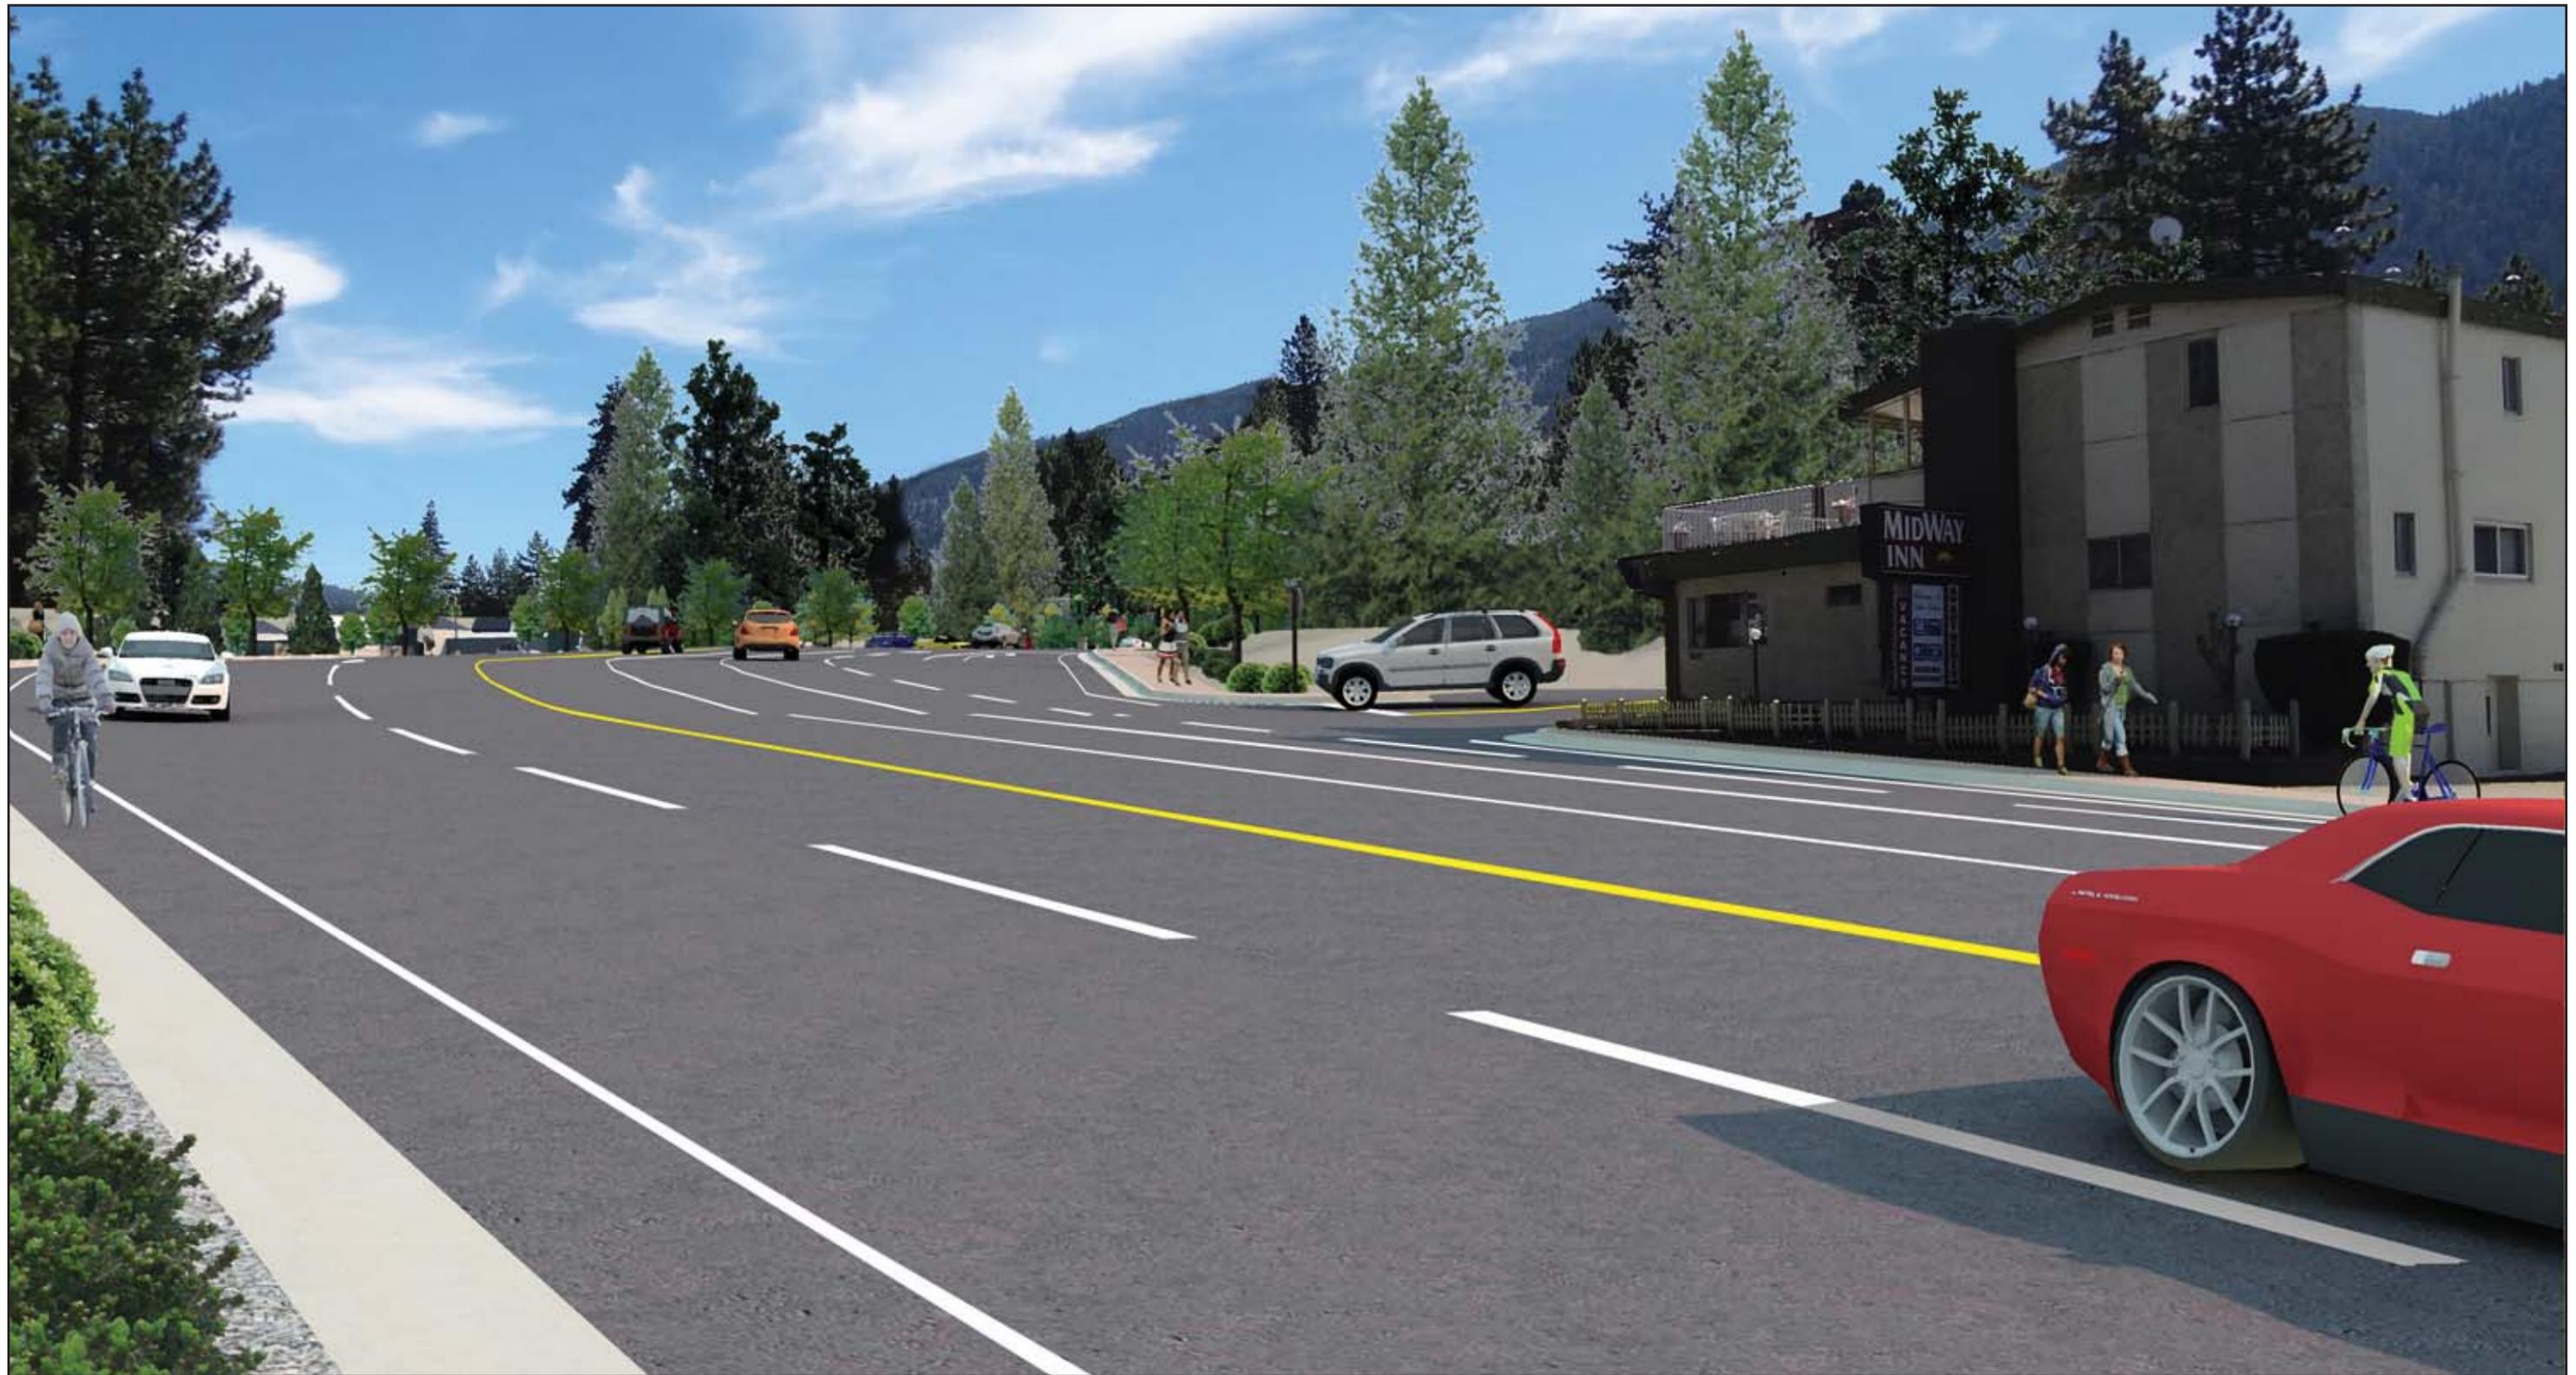
FIGURE 32

Figure 32: Visual Simulation at Viewpoint 9 for Alternative B shows the simulated visual conditions under Alternative B at Viewpoint 9.

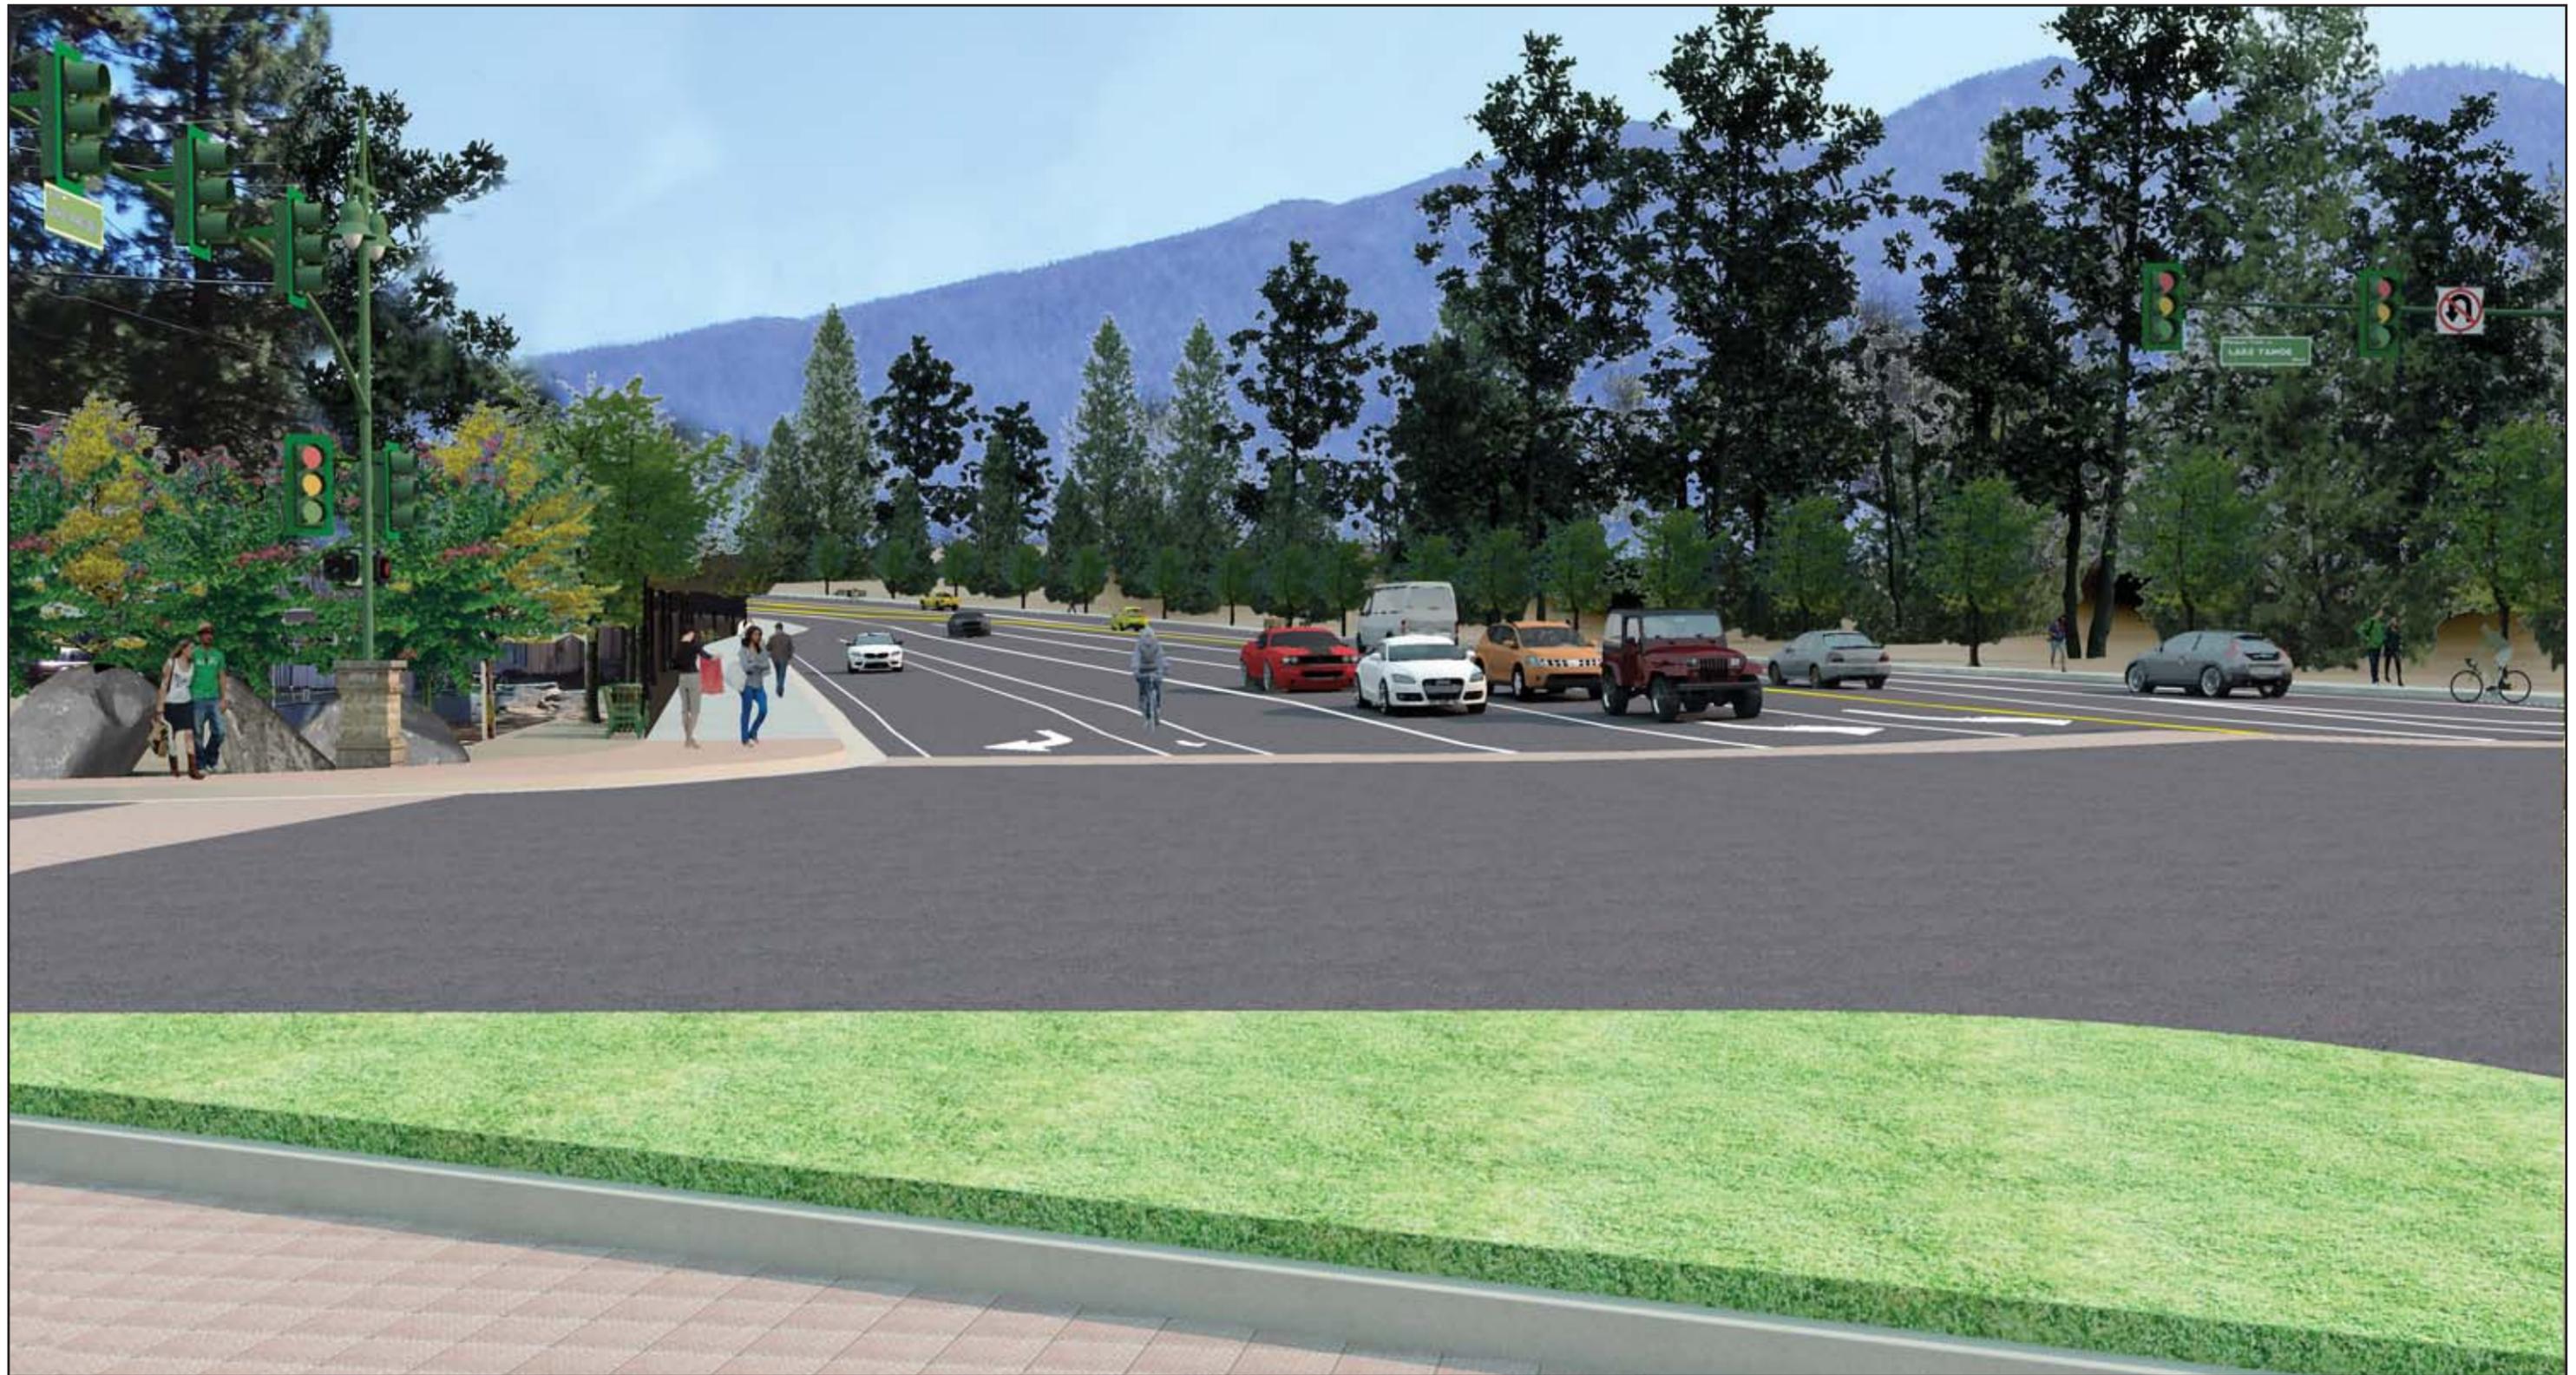
FIGURE 33

Figure 33: Visual Simulation at Viewpoint 10 for Alternative B shows the simulated visual conditions under Alternative B at Viewpoint 10. A new intersection at Pioneer Trail/U.S. 50 would be visible from this viewpoint. Development of the proposed intersection would require the removal of the commercial/lodging buildings currently occupying the parcels to the east of the roadway. The new roadway would consist of two travel lanes in each direction and right- and left-hand turn pockets. Pedestrian friendly sidewalks and bicycle lanes would be added to both sides of U.S. 50. Street trees, landscaped medians, decorative boulders, and modern materials (painted a color palette consistent with the surroundings) would be visible from this viewpoint under Alternative B. Background views of forested areas and mountains would no longer be obscured from this viewpoint with Alternative B design implementation.
