**Draft Visual Impact Assessment – US
50/South Shore Community
Revitalization Project**

U.S. 50/South Shore Community Revitalization Project

South Lake Tahoe, California / Stateline, Nevada

**Draft Visual Impact Assessment (VIA) For
U.S. 50/South Shore Community Revitalization Project**

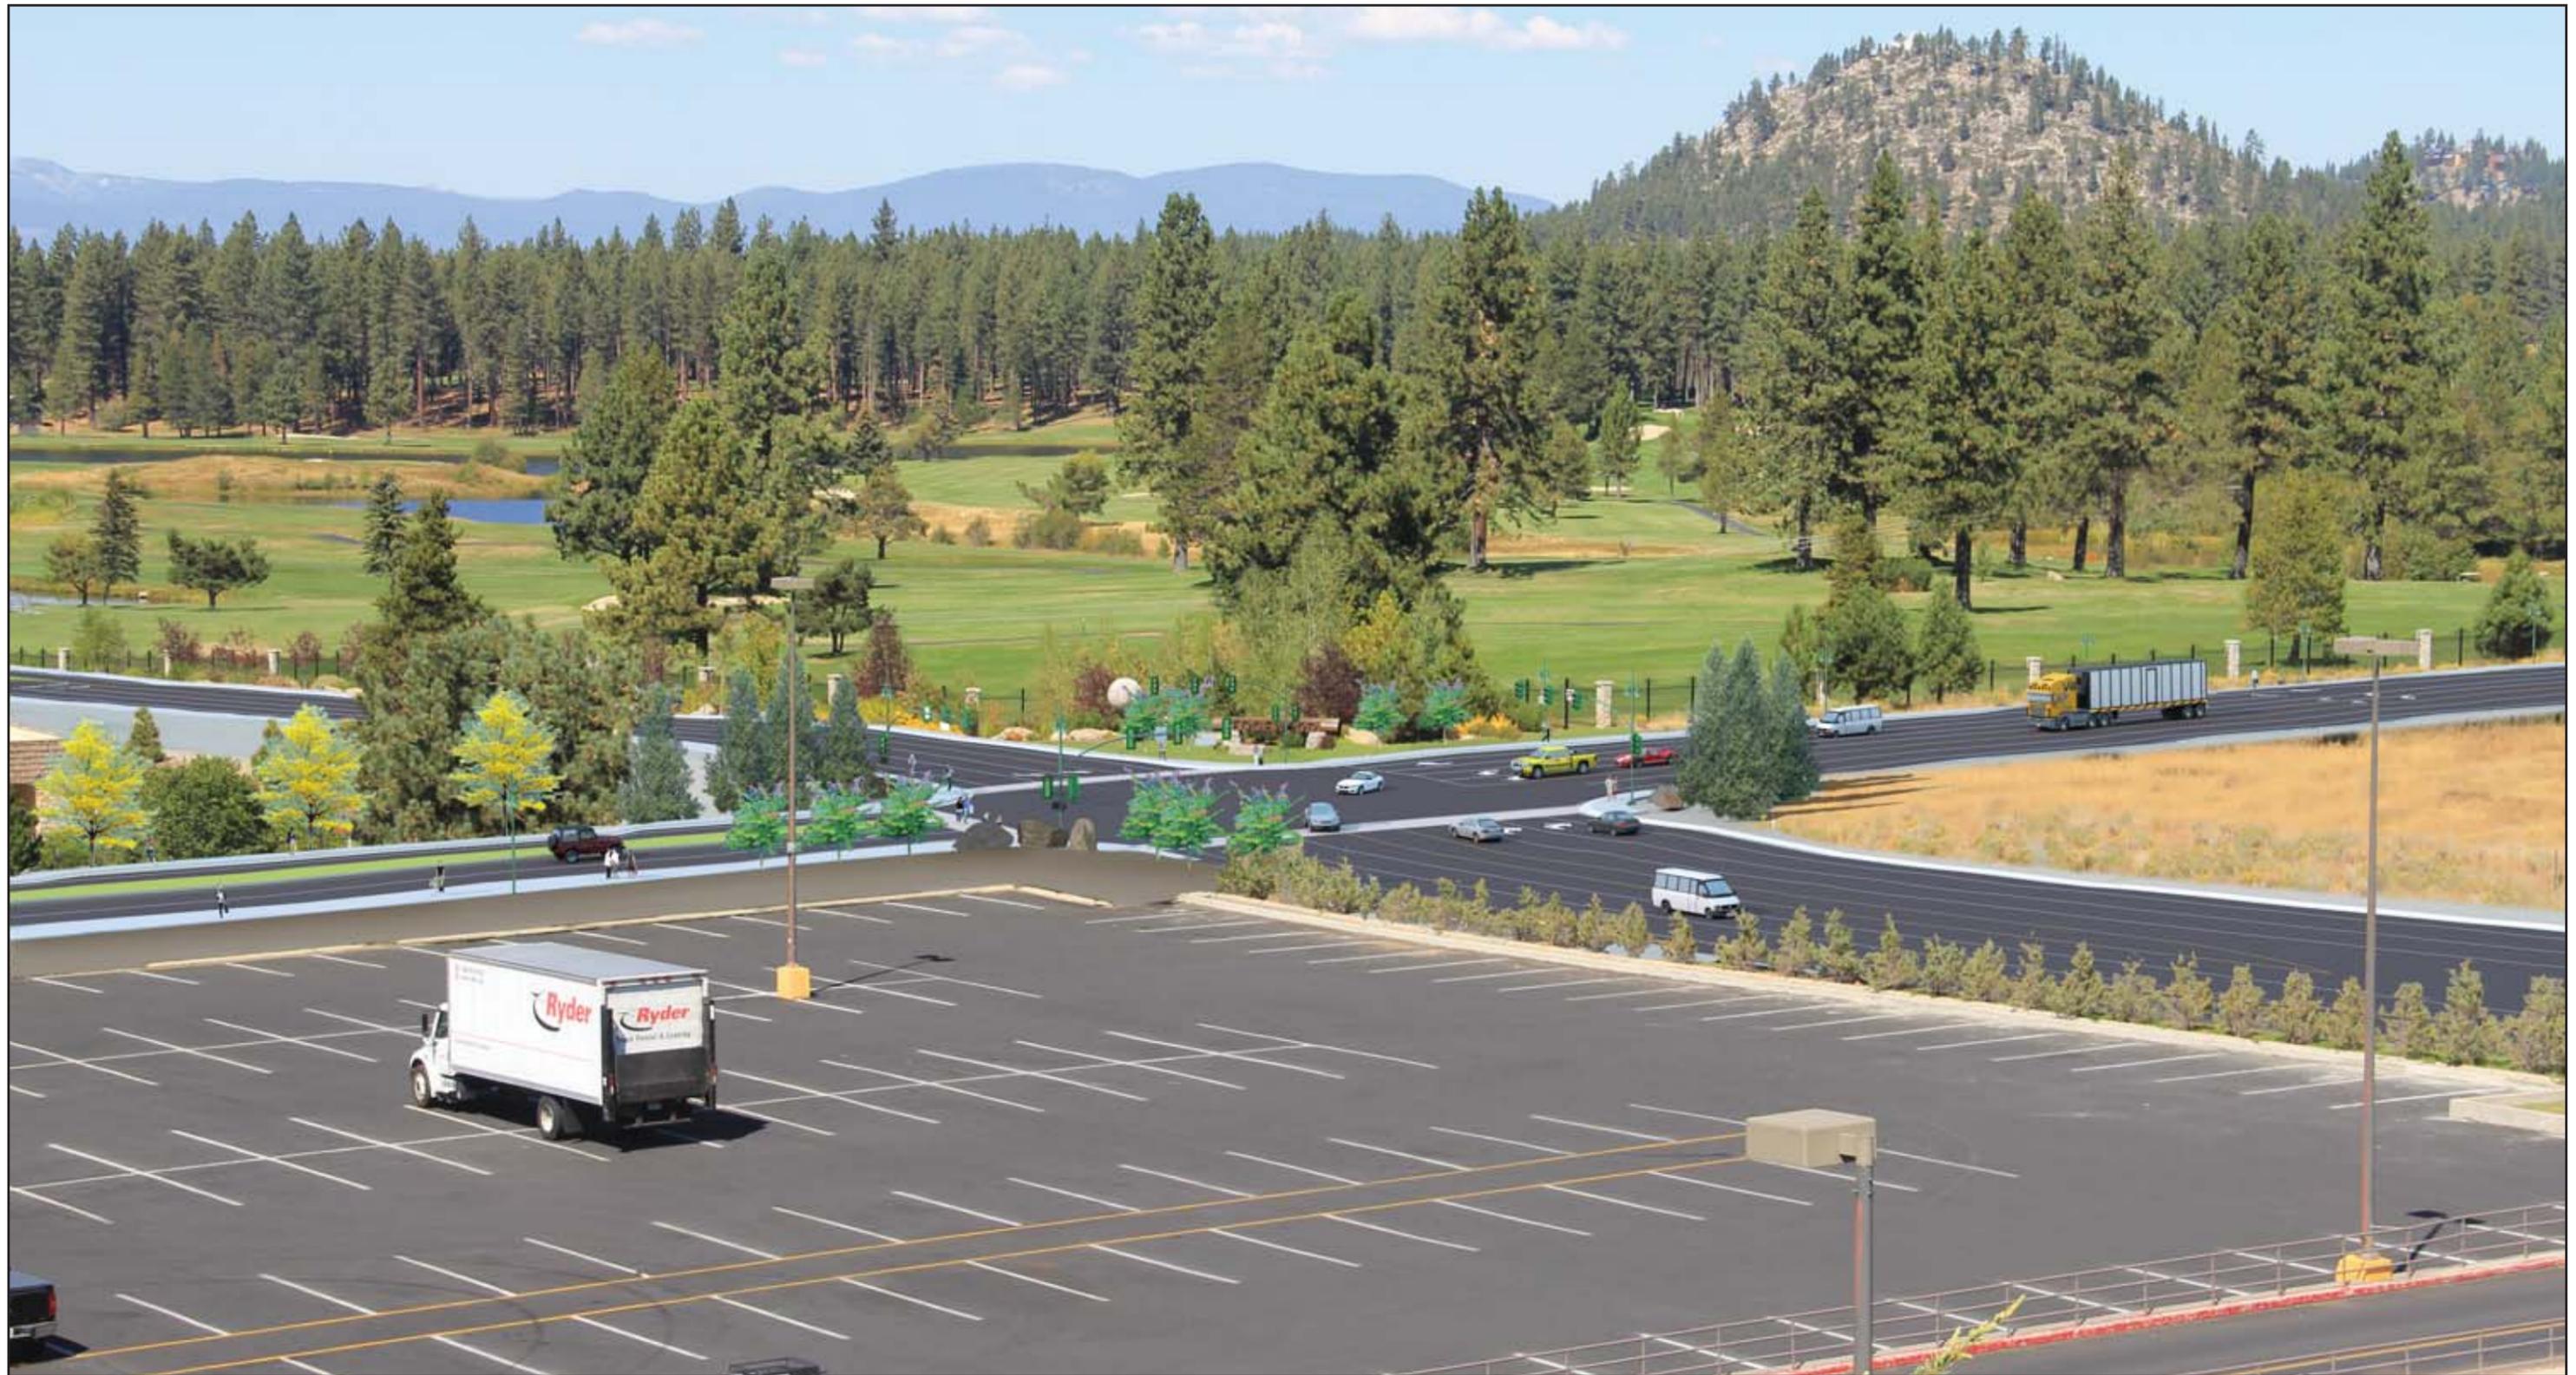
FIGURE 34(A)

Figure 34(A): Visual Simulation at Viewpoint 11 for Alternative B (also applicable to Alternative D) Intersection Design Figure 34(B): Visual Simulation at Viewpoint 11 for Alternative B (also applicable to Alternative D) Roundabout Design and shows the simulated visual conditions under Alternative B (as well as Alternative D) as a signalized and as a roundabout intersection at Viewpoint 11, respectively. An improved U.S. 50/Lake Parkway intersection would be visible from this viewpoint under Alternative B (as well as Alternative D) as either a signalized intersection or roundabout. This location represents the view the parking structure patrons would have of the Project site as they look toward the northwest. The foreground from this viewpoint offers views of a surface parking lot with light poles. Minimal amounts of vegetation exist in the foreground view. The middleground from Viewpoint 11 offers views of the Project site and the improved U.S. 50/Lake Parkway intersection (as a signalized intersection or roundabout as shown in Figure 34(a) and 34(b)).

Visual Simulation at Viewpoint 11 for Alternative B (also Applicable to Alternative D) Intersection Design

Please refer to Section 3.1.2.11 above for a discussion of change in visual character and quality at Viewpoint 11 with implementation of Alternative D (with the normal intersection and roundabout design). Figure 34 (above) also presents features of Alternative D that would be located at Viewpoint 11. Under existing conditions Viewpoint 11 has a visual quality rating of 5.00 which is considered Moderately

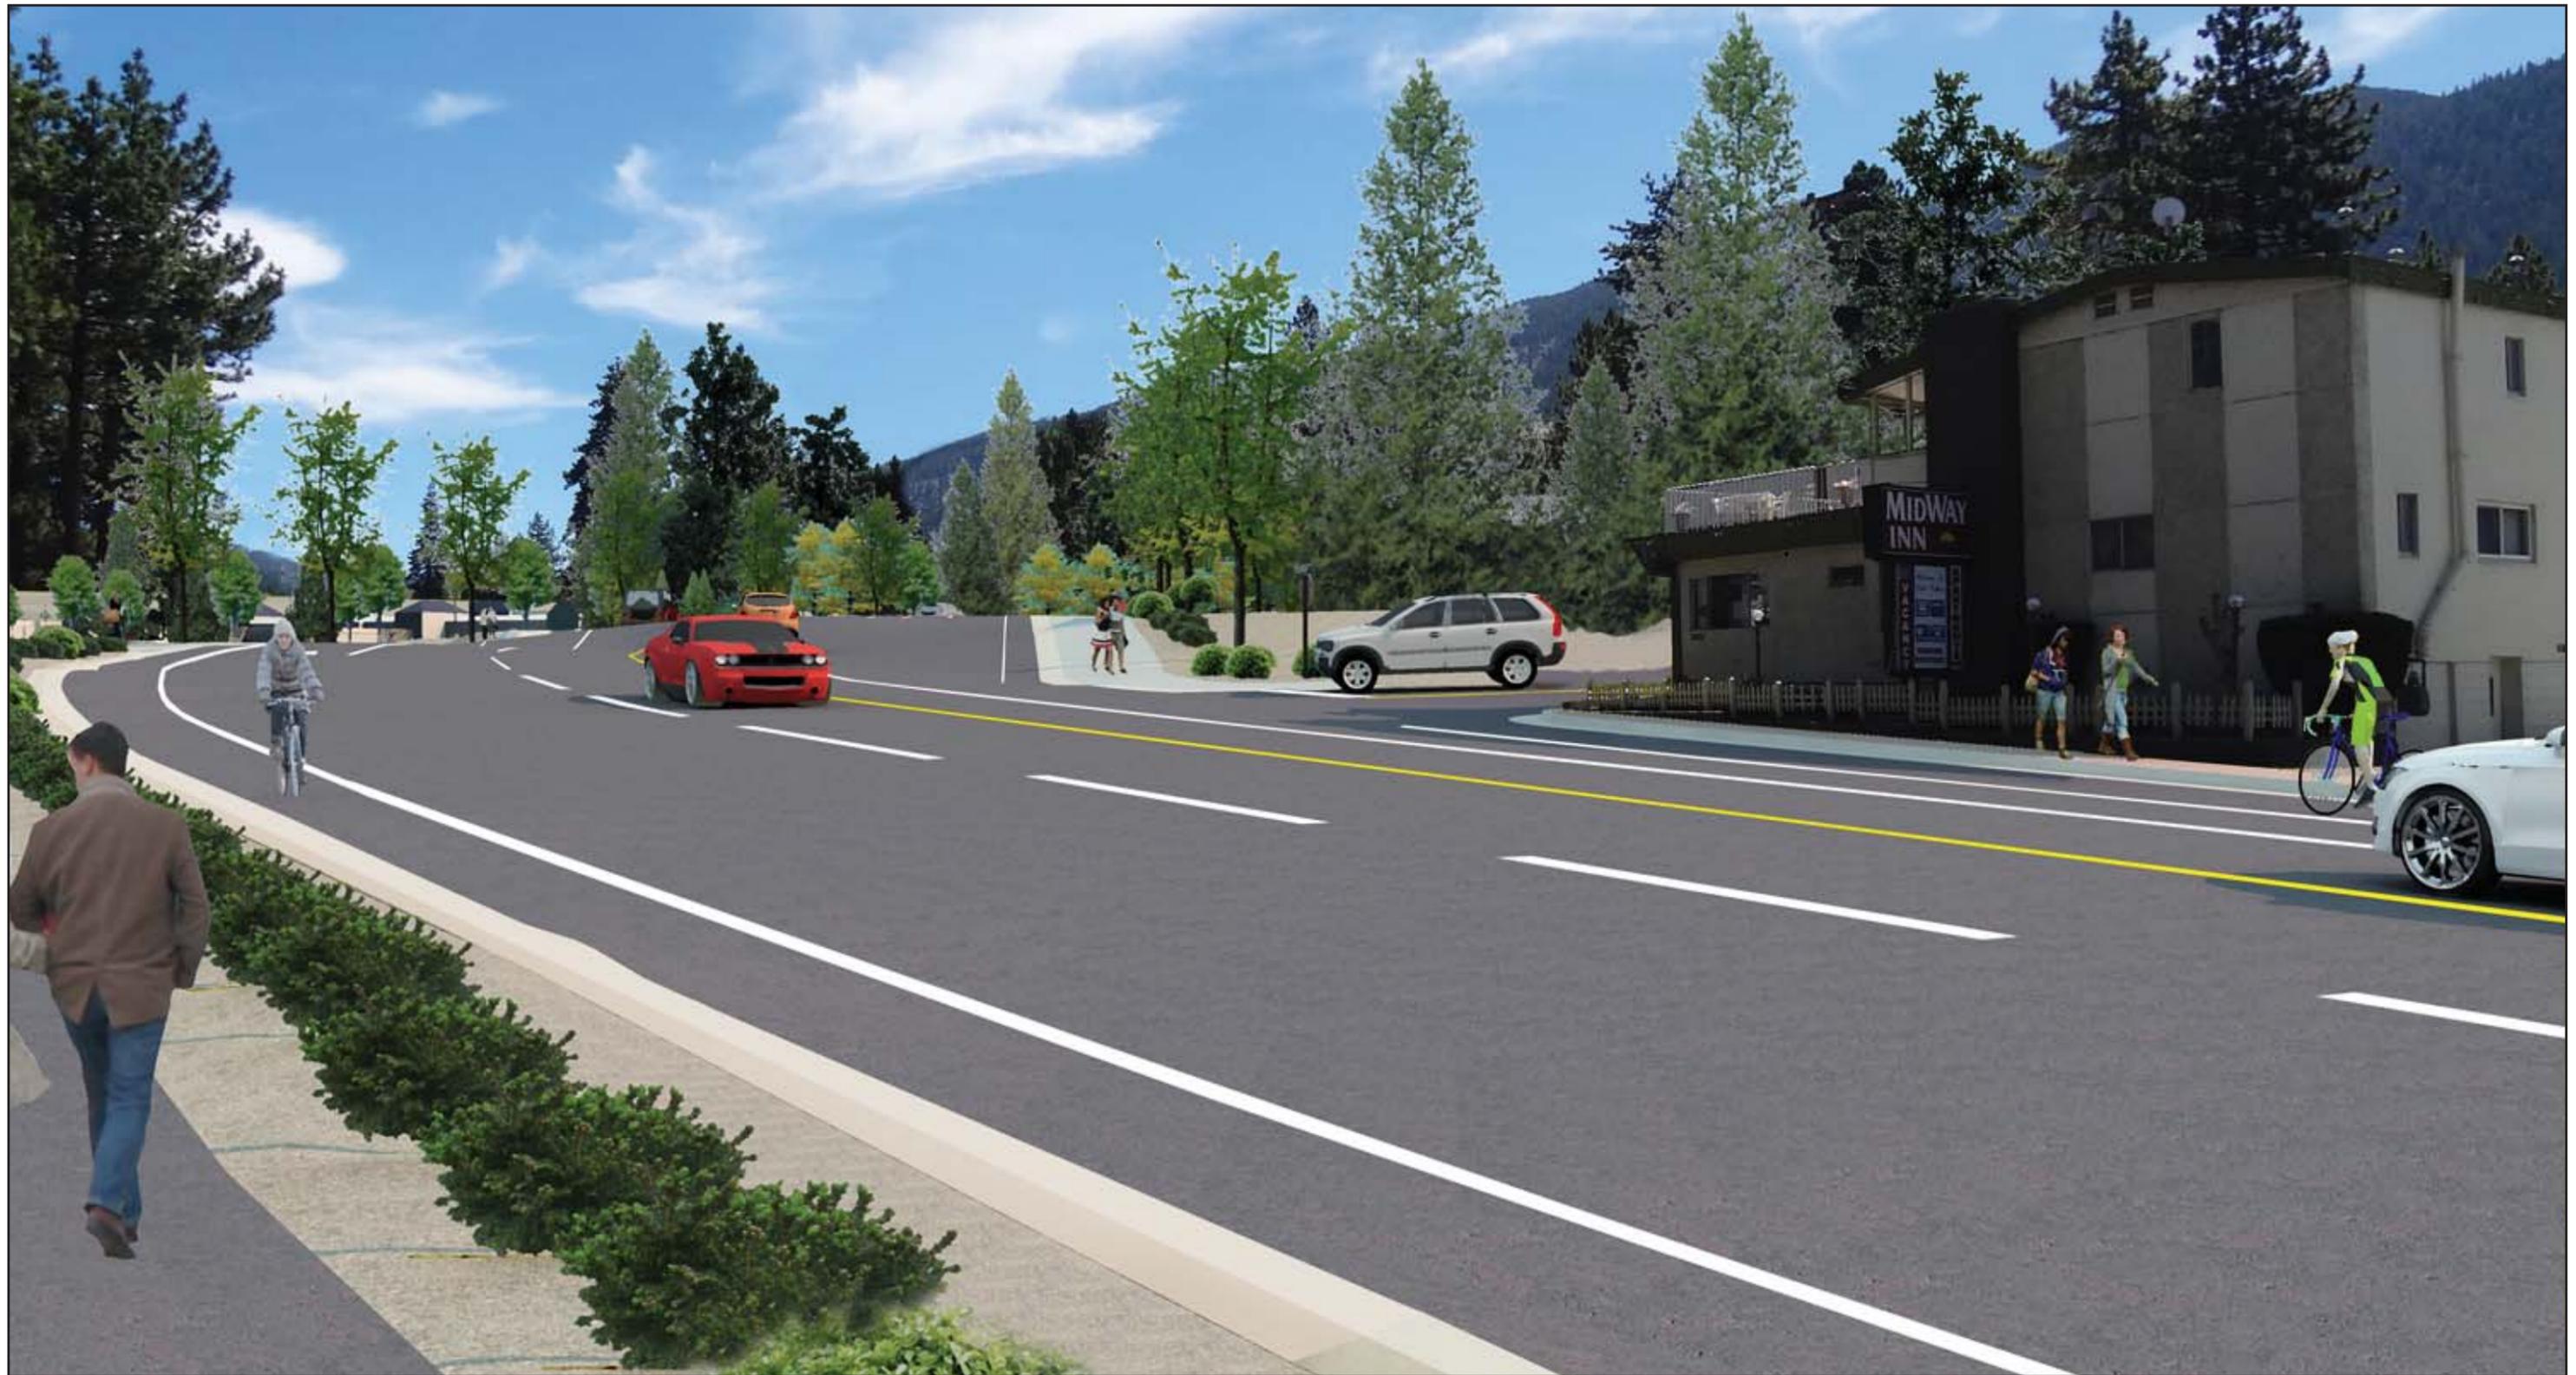
FIGURE 37

Figure 37: Visual Simulation at Viewpoint 9 for Alternative C shows the simulated visual conditions under Alternative C at Viewpoint 9. The design features of Alternative C would be the same as the design features of Alternative B at Viewpoint 9. Please refer to the discussion above in Section 3.1.2.9 for a description of the design features that would be implemented at Viewpoint 9.

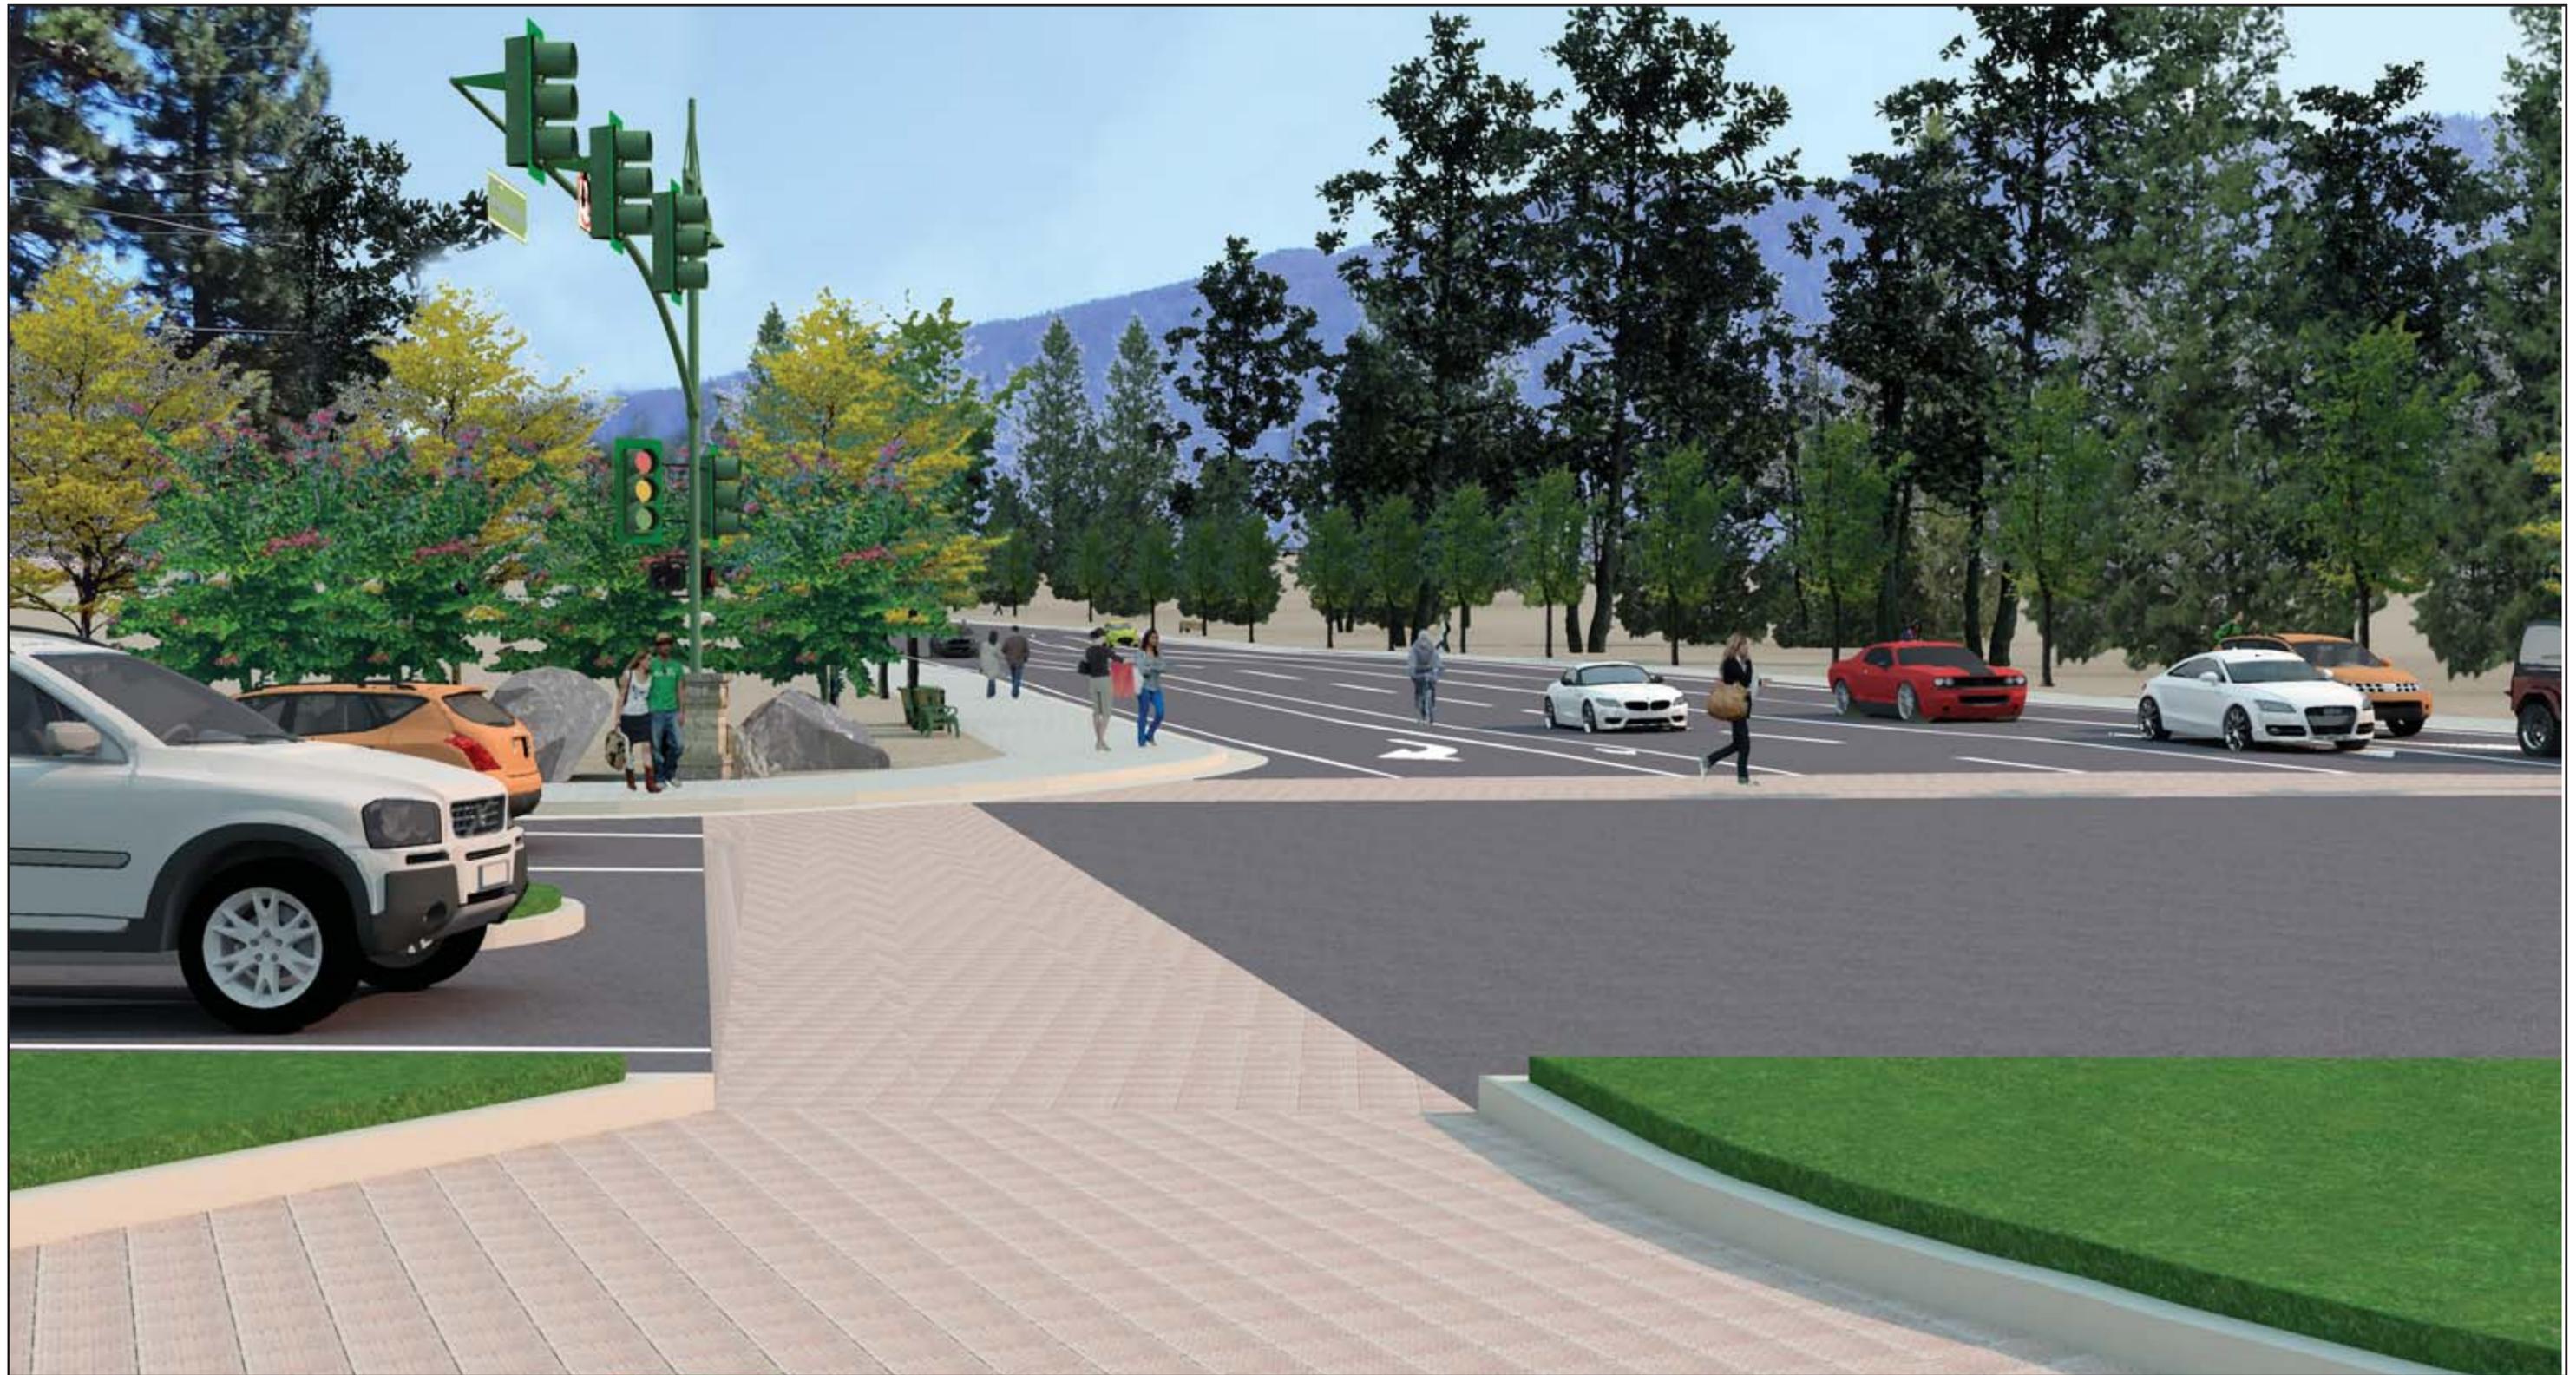
Figure 38: Visual Simulation at Viewpoint 10 for Alternative C shows the simulated visual conditions under Alternative C at Viewpoint 10. The visual conditions at Viewpoint 10 under Alternative C would be similar to the visual conditions under Alternative B. A new intersection at Pioneer Trail/U.S. 50 would be visible from this viewpoint. The existing commercial/lodging buildings currently occupying the parcels to the east of the roadway would be removed with implementation of Alternative C. The new U.S. 50 roadway would be a one-way street with a right turn lane, through lanes, and left turn lanes. Pioneer Trail would be redesigned with a landscaped median separating northbound and southbound traffic lanes.

Sidewalks would be added along U.S. 50 and Pioneer Trail. Ornamental trees/vegetation and decorative boulders would be located along the new portion of U.S. 50 and Pioneer Trail to add to the natural features visible from this viewpoint. Street trees, landscaped medians, decorative boulders, and modern materials (painted a color palette consistent with the surroundings) would be visible from this viewpoint

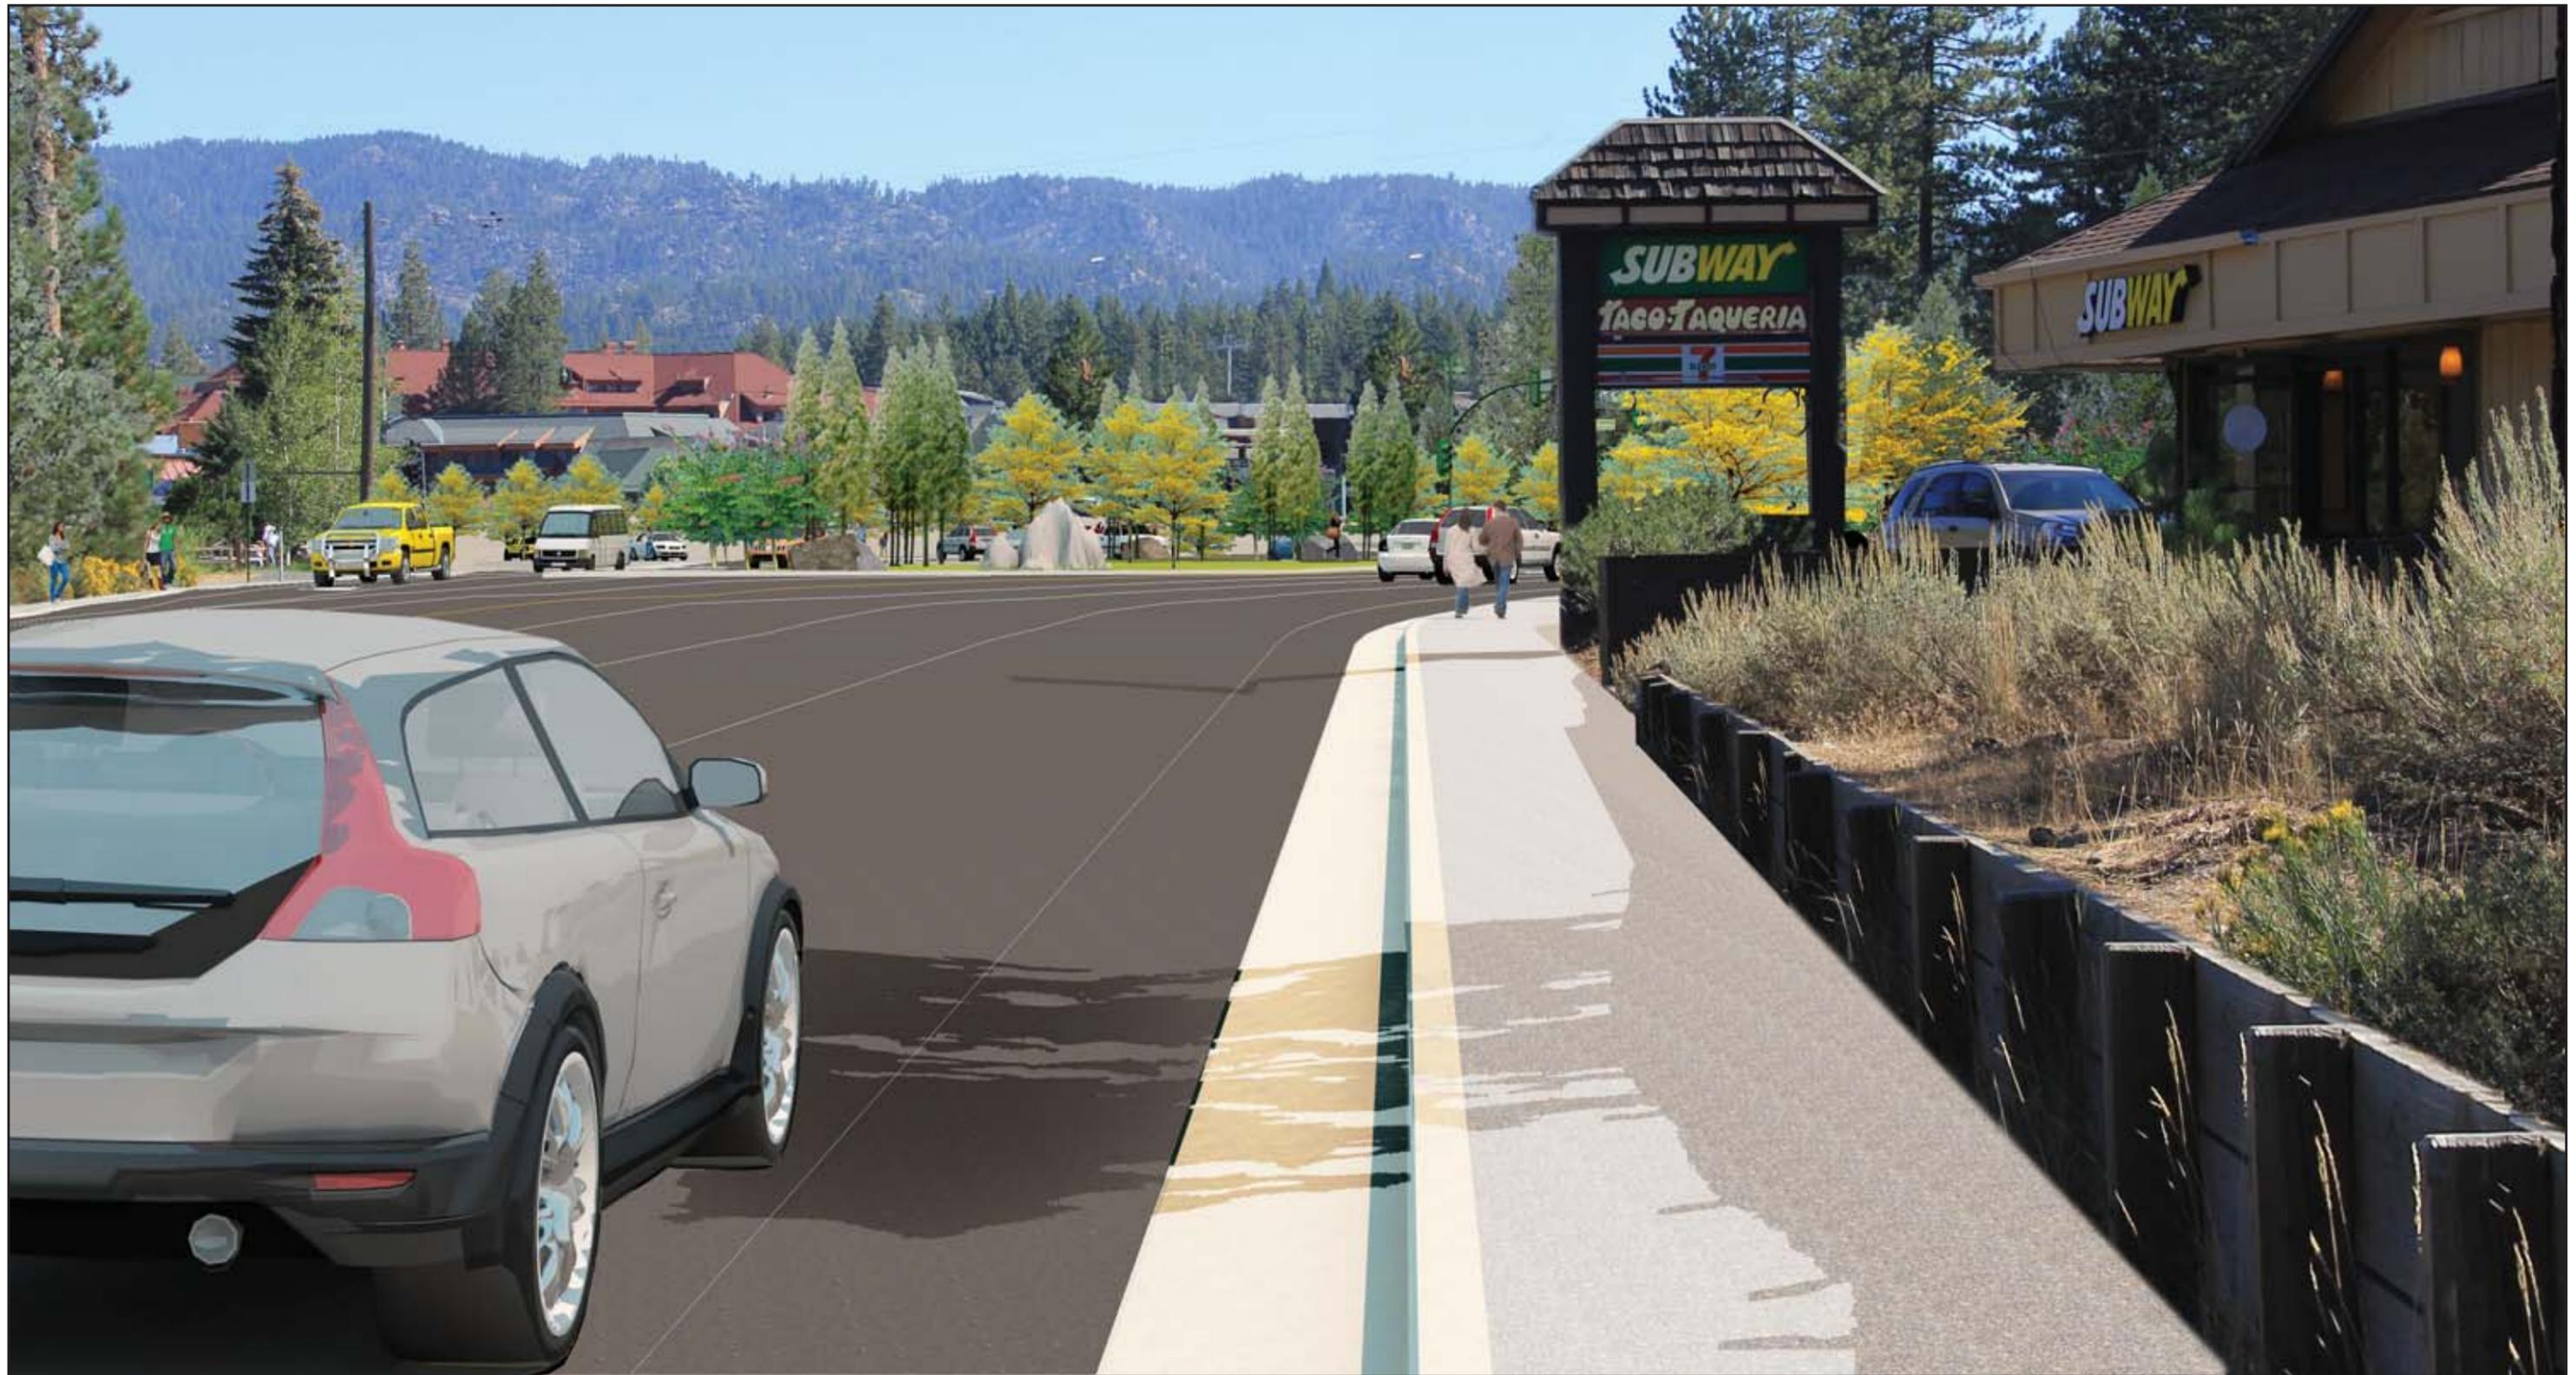
FIGURE 39

Alternative D would include modern landscaping and manmade features that would contribute to improvement of vividness at this viewpoint. The addition of such landscaping features would partially obscure commercial uses that have duller colors and thus would help improve the vividness in the viewshed area of Viewpoint 12.

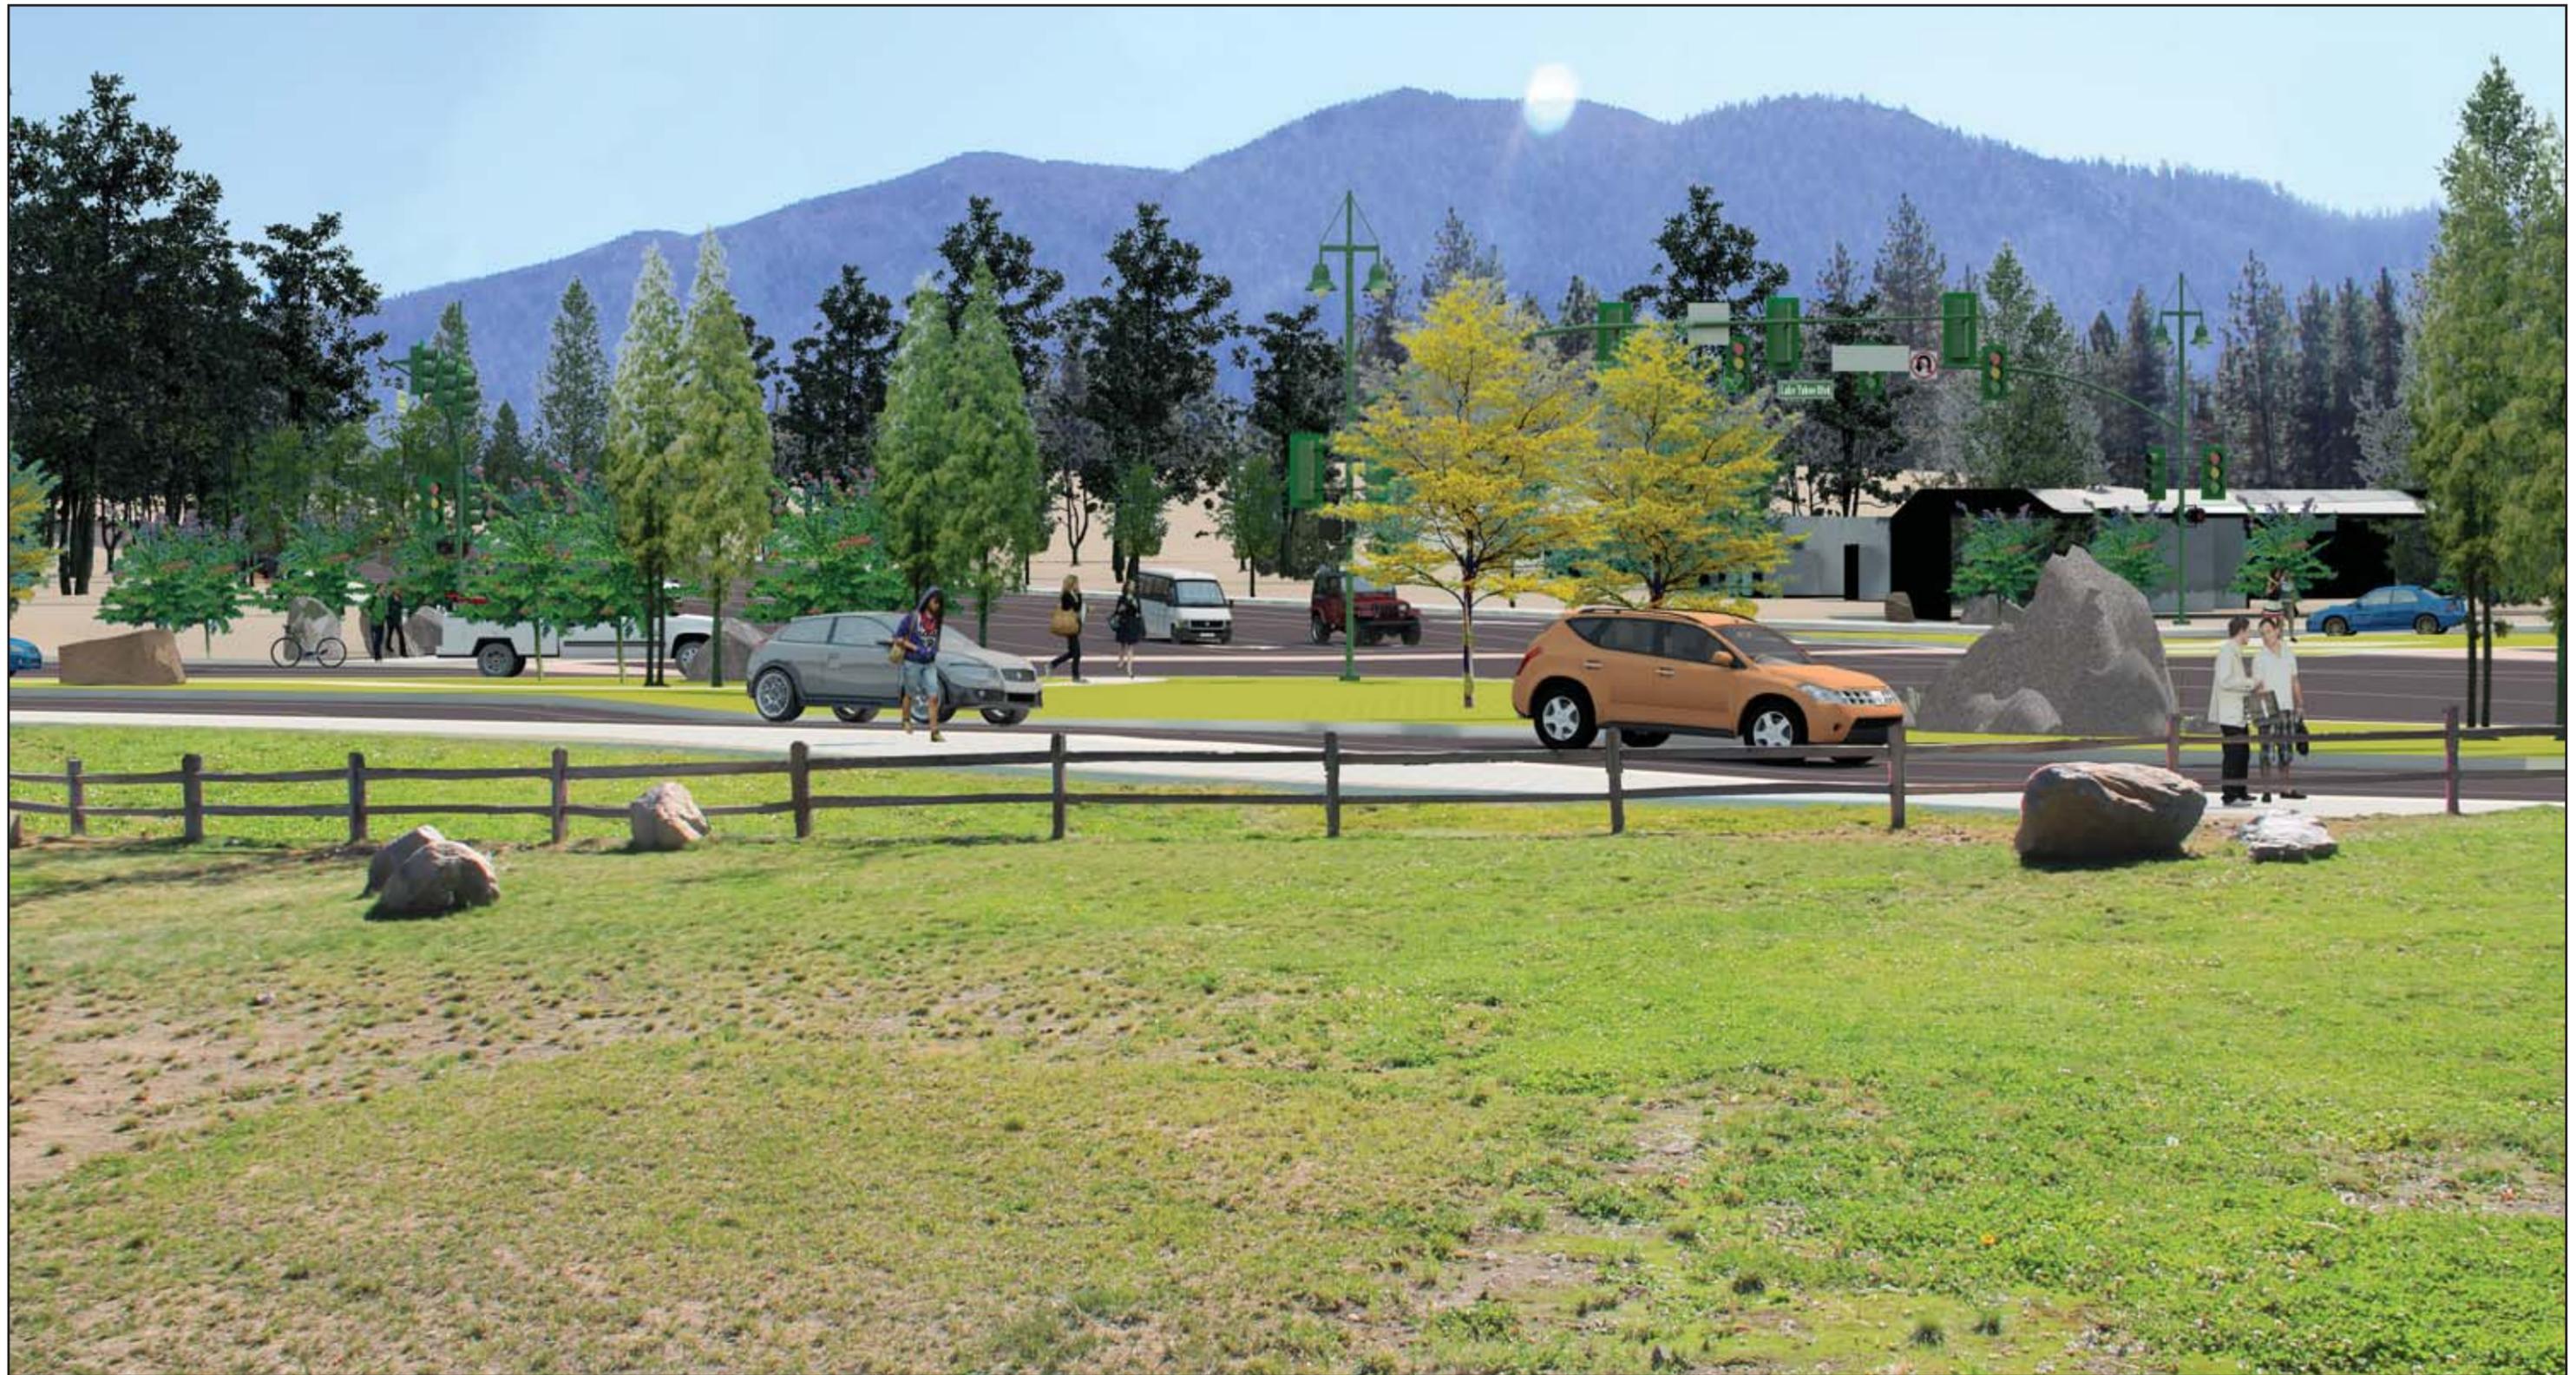
FIGURE 40

Figure 40: Visual Simulation at Viewpoint 13 for Alternative D shows the simulated visual conditions at Viewpoint 13 under Alternative D. Alternative D include improvements to the existing roadway and the U.S. 50/Pioneer Trail intersection. Improvements would include reconfiguration of the existing intersection, the addition

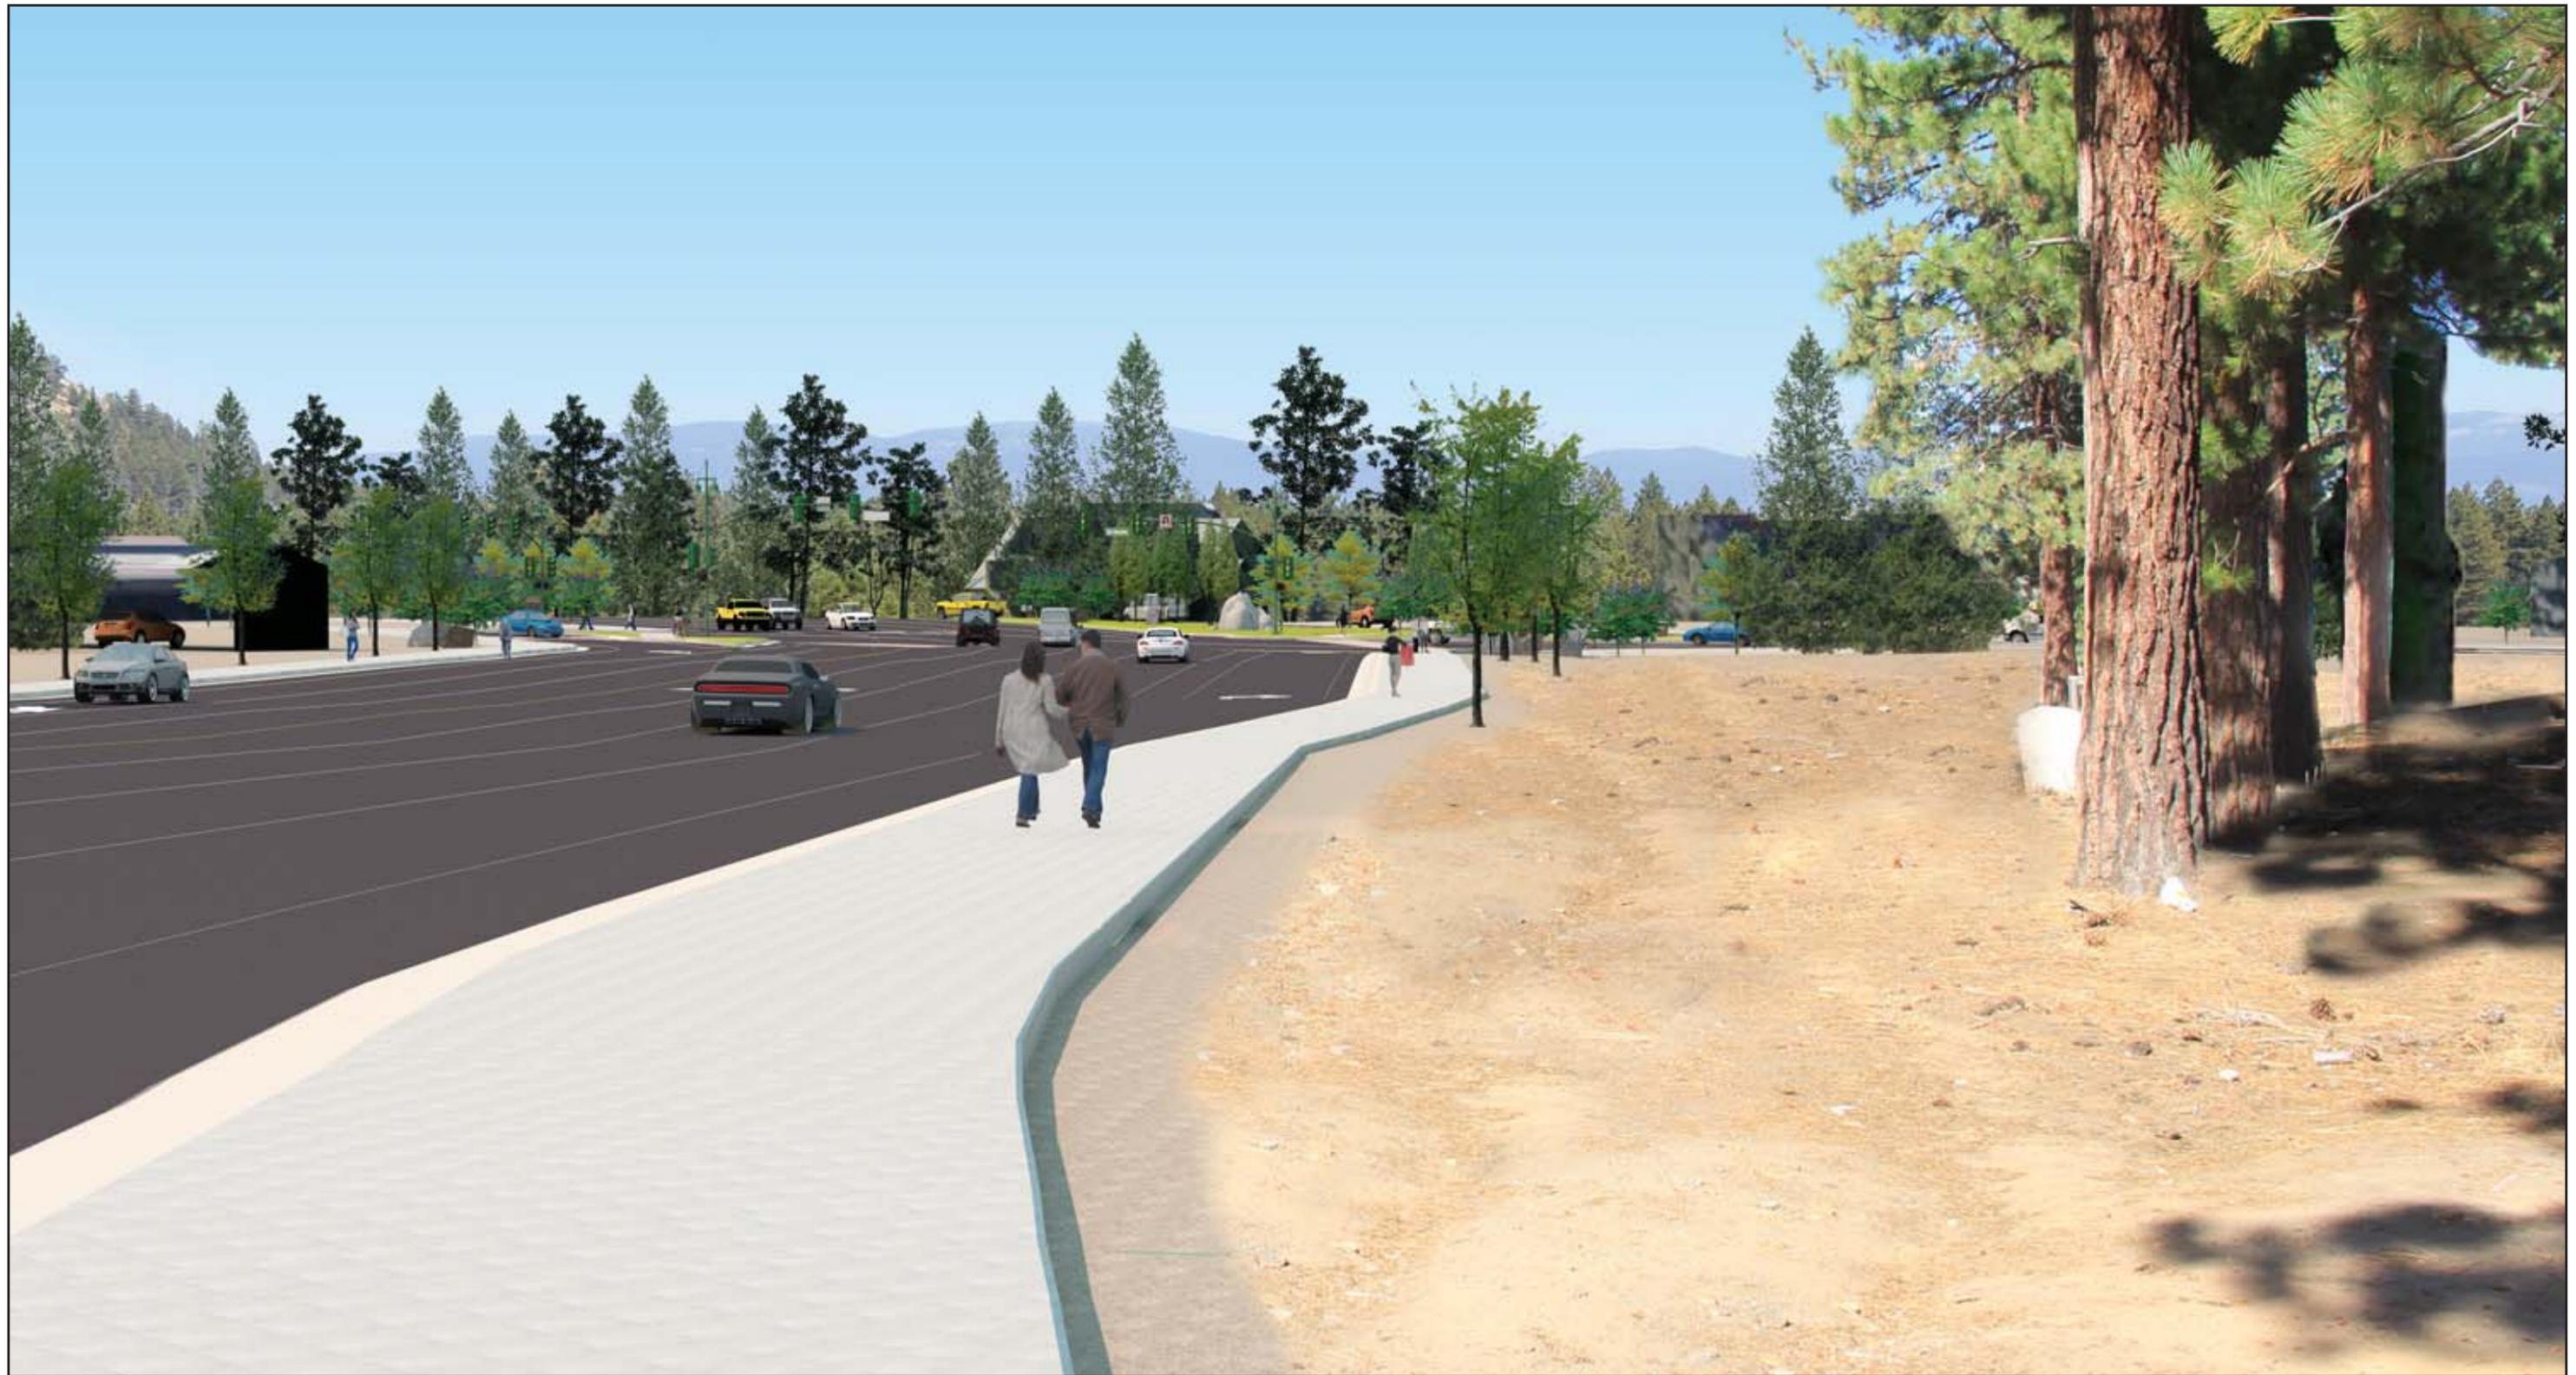
FIGURE 41

Figure 41: Visual Simulation at Viewpoint 14 for Alternative D shows a simulation of the visual conditions at Viewpoint 14 under Alternative D. Under Alternative D the roadway would be widened from two lanes (one lane in each direction) to four lanes (two through lanes in the northbound and southbound direction and a paved median). Coniferous trees visible from this viewpoint would be removed to accommodate roadway modifications associated with Alternative D.

The foreground and middleground from the simulated viewpoint shows an expansion of roadway features, reduction in natural vegetation, and a reduction in residential buildings paralleling the roadway. Implementation of Alternative D would also result
