**Draft Visual Impact Assessment – US
50/South Shore Community
Revitalization Project**

U.S. 50/South Shore Community Revitalization Project

South Lake Tahoe, California / Stateline, Nevada

**Draft Visual Impact Assessment (VIA) For
U.S. 50/South Shore Community Revitalization Project**

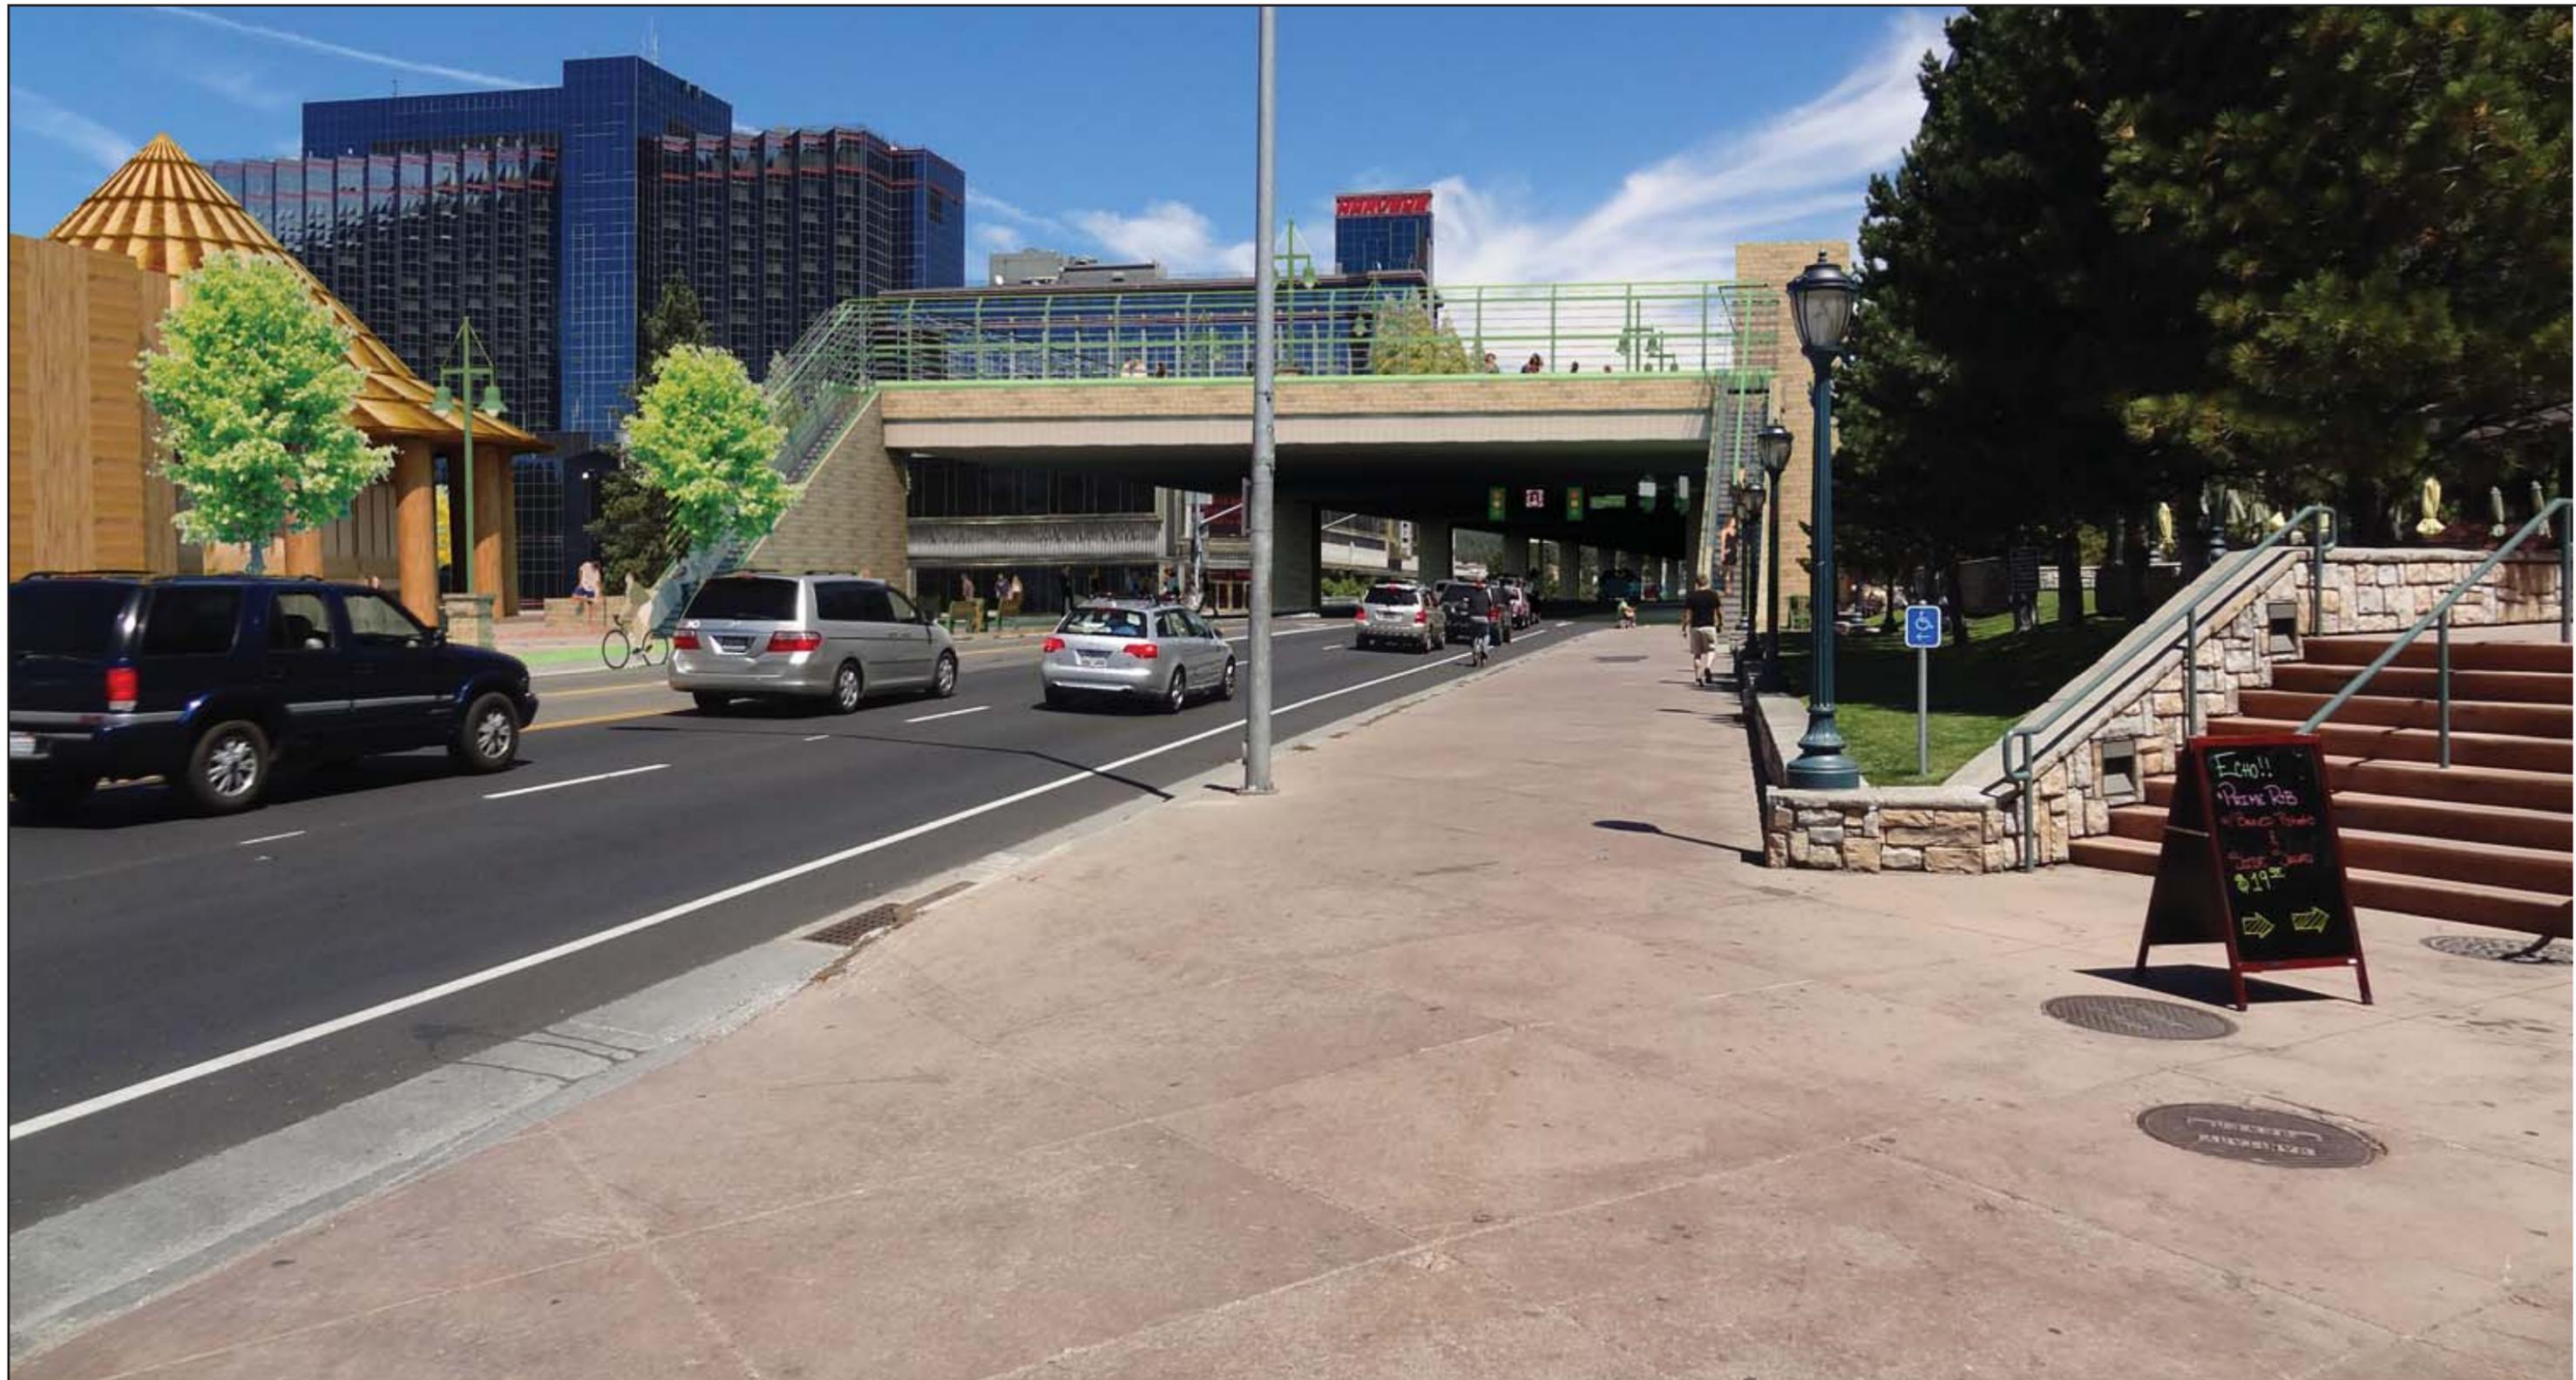
Figure 42: Visual Simulation at Viewpoint 15 for Alternative E shows the simulated visual conditions under Alternative E at Viewpoint 15. Alternative E would develop a “Skywalk” over the U.S. 50 corridor from just south of Stateline Avenue to the northern end of the Montbleu hotel/casino property. The “Skywalk” would be accessed via escalators and elevators located along the U.S. 50 corridor.

The deck of the “Skywalk” structure would be designed with ornamental vegetation and light poles. The “Skywalk” structure would partially obstruct views for motorists, pedestrians, and bicyclists of the mid-rise hotels/casinos on the eastern and western sides of U.S. 50. The “Skywalk” structure would fully obstruct views of the distant mountains to the north of the Project footprint. It should be noted that the commercial building to the southwest of the “Skywalk” (as shown in the simulation in Figure 42) is not part of the Alternative E design and is included in the simulation on the assumption of planned buildout of this parcel per future City of South Lake Tahoe plans.

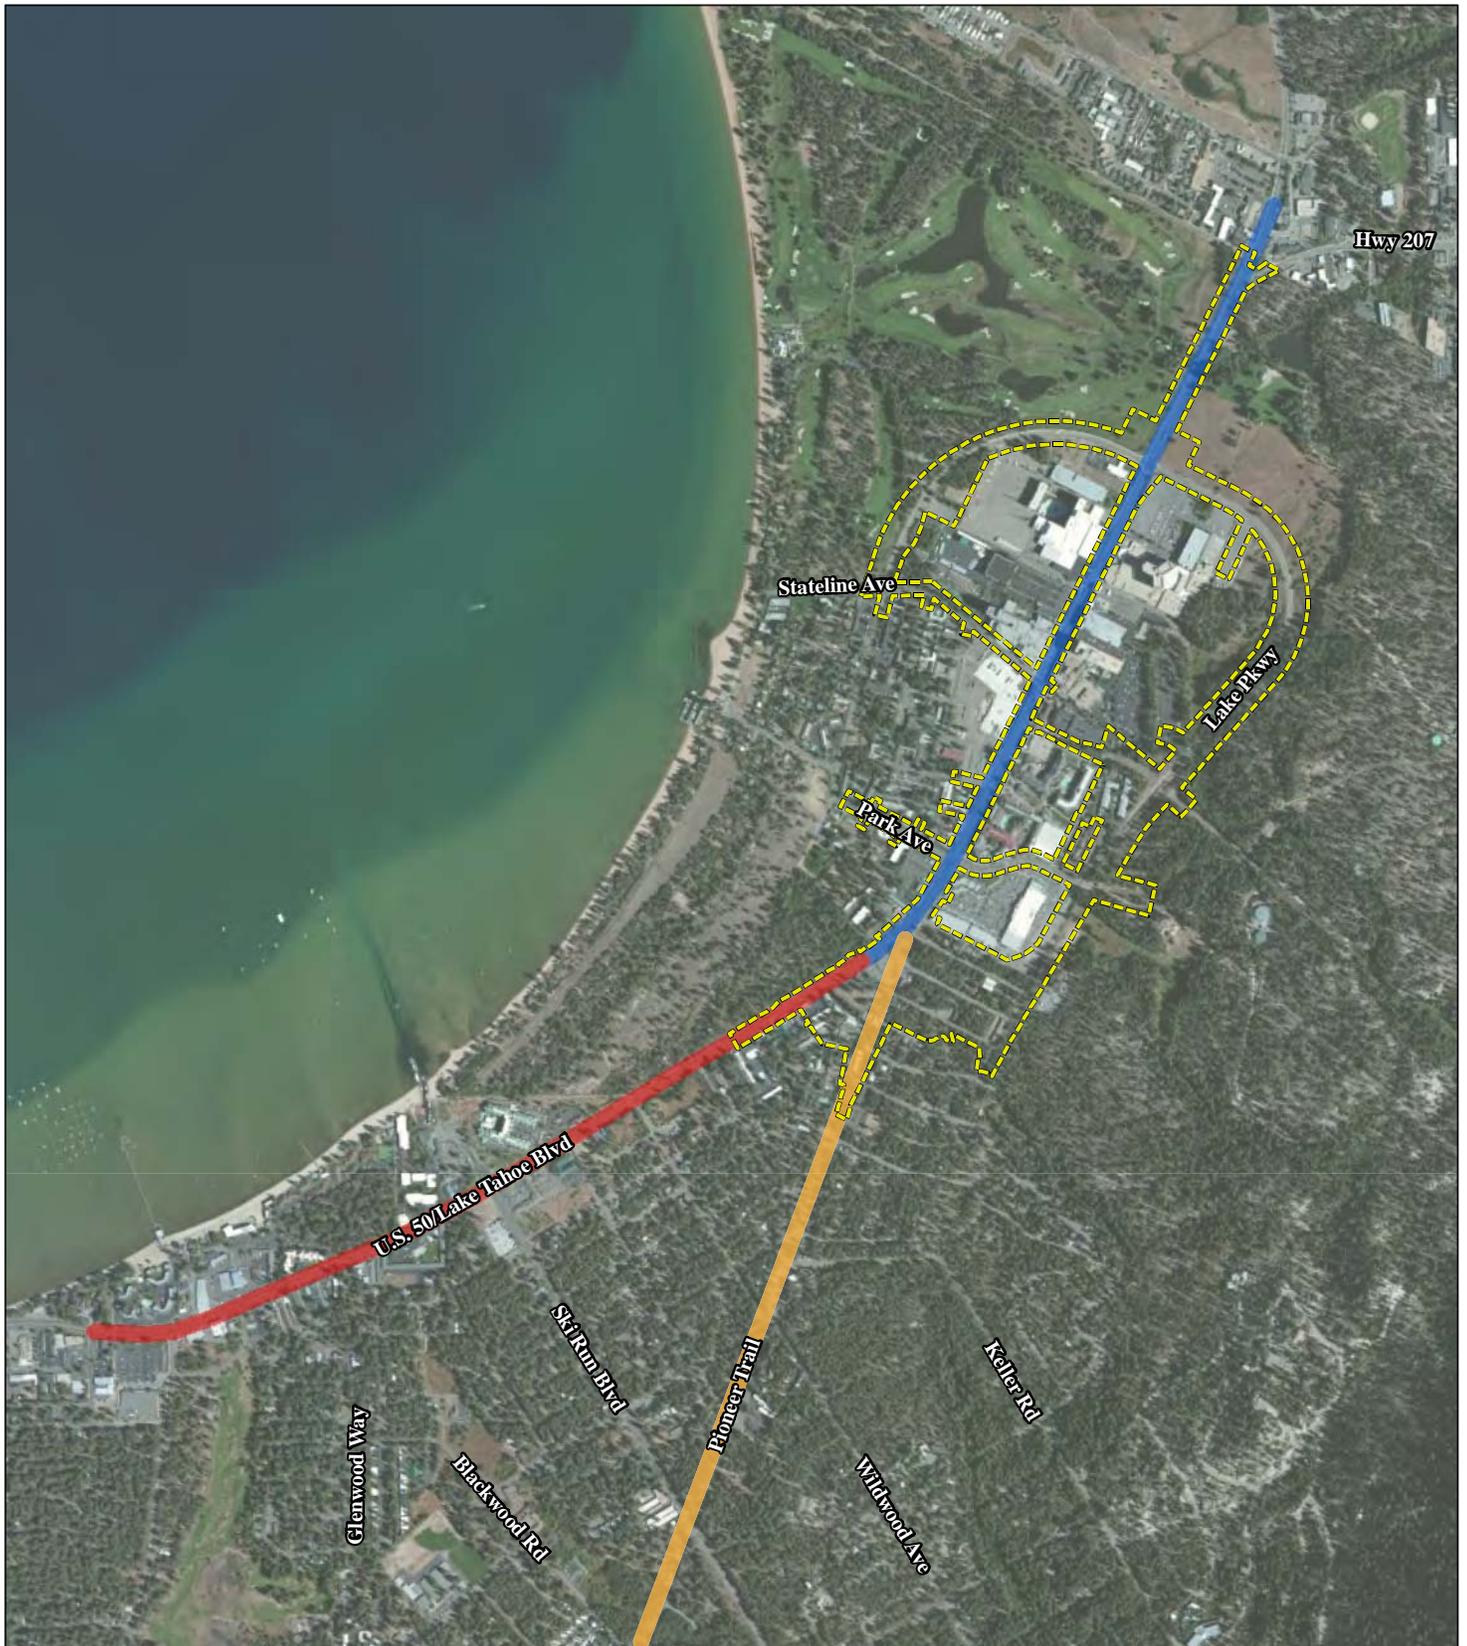
FIGURE 44

Portions of U.S. 50 within the Project footprint are designated as TRPA’s Roadway Travel Unit 32 (Casino Area), Roadway Travel Unit 33 (The Strip), and Roadway Travel Unit 45 (Pioneer Trail North). Figure 44: TRPA Roadway Travel Unit Boundaries shows the approximate boundaries of Roadway Travel Unit 32,33, and 45 and the portions of the proposed Project that are within these units. Approximately 1.24 miles of the Project footprint is within Roadway Travel Unit 32 and approximately 0.25 mile of the Project footprint is within Roadway Travel Unit 33 and 45.
